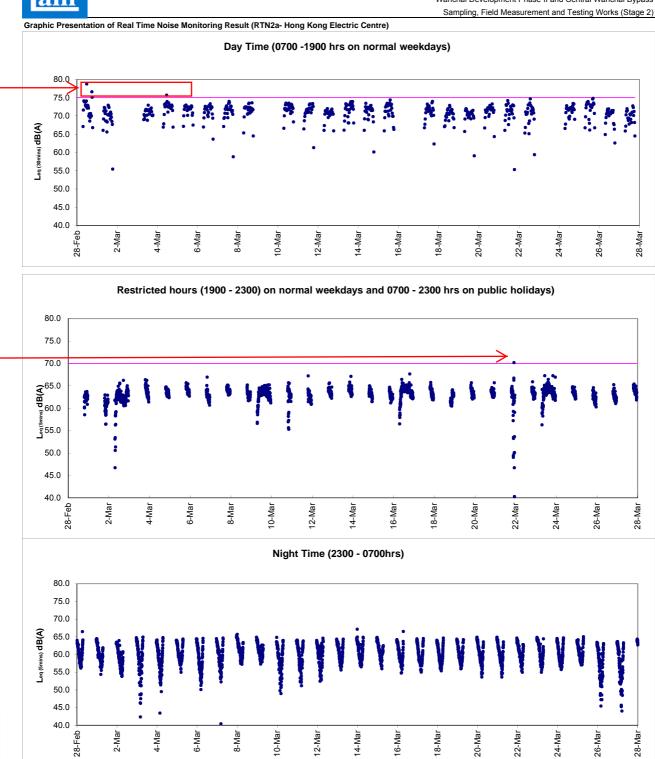
After checking with contractor HY/2009/19, no construction works were conducted at the concerned location during the recorded period. As such, the exceedances were considered to be contributed by nearby IEC traffic and nearby non- CWB Projects.

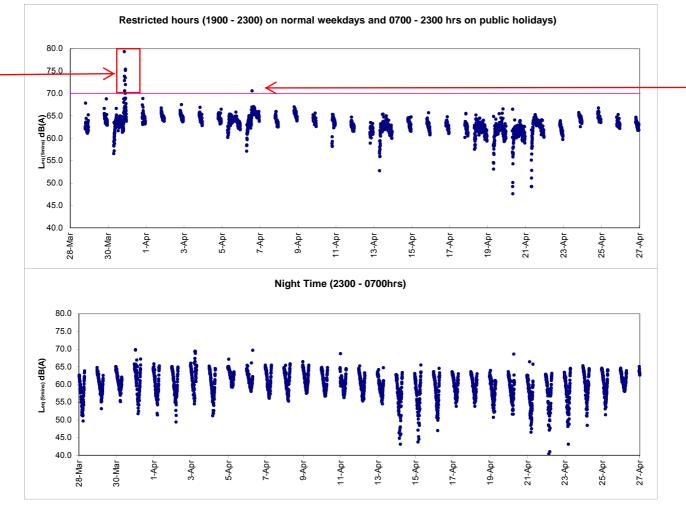
After checking with contractor HY/2009/19, no construction works were conducted at the concerned location during the recorded period and the major contribution was considered to be contributed by the adverse weather condition during the hoisting period of Black Rainstorm Warning Signal and not related to Projects

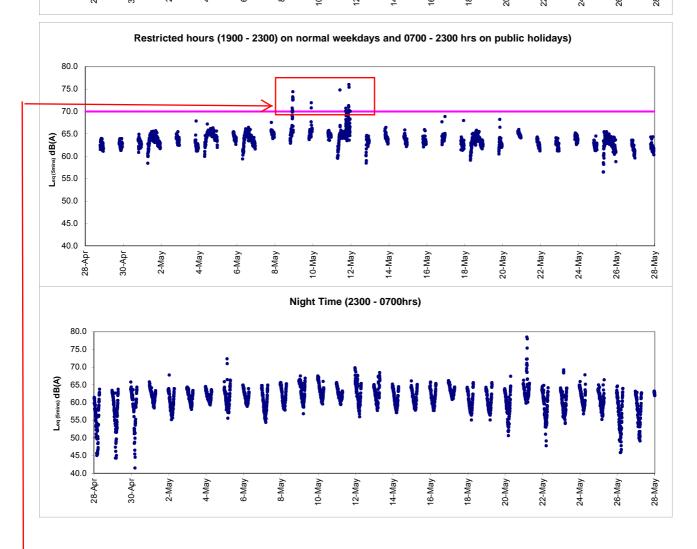
After checking with contractor HY/2009/19, no major noisy construction works were conducted at the concerned location during the recorded period and the major contribution was considered to be contributed by the adverse weather condition during the hoisting period of Rainstorm Warning Signal and not related to Projects
