**Contract No. HK/2012/08**  
**Wan Chai Development Phase II – Central – Wan Chai Bypass at Wan Chai West – Tunnel Works**

**Final Landscape Plan (Rev. 1)**

**Final Landscape Plan**

Revision 1

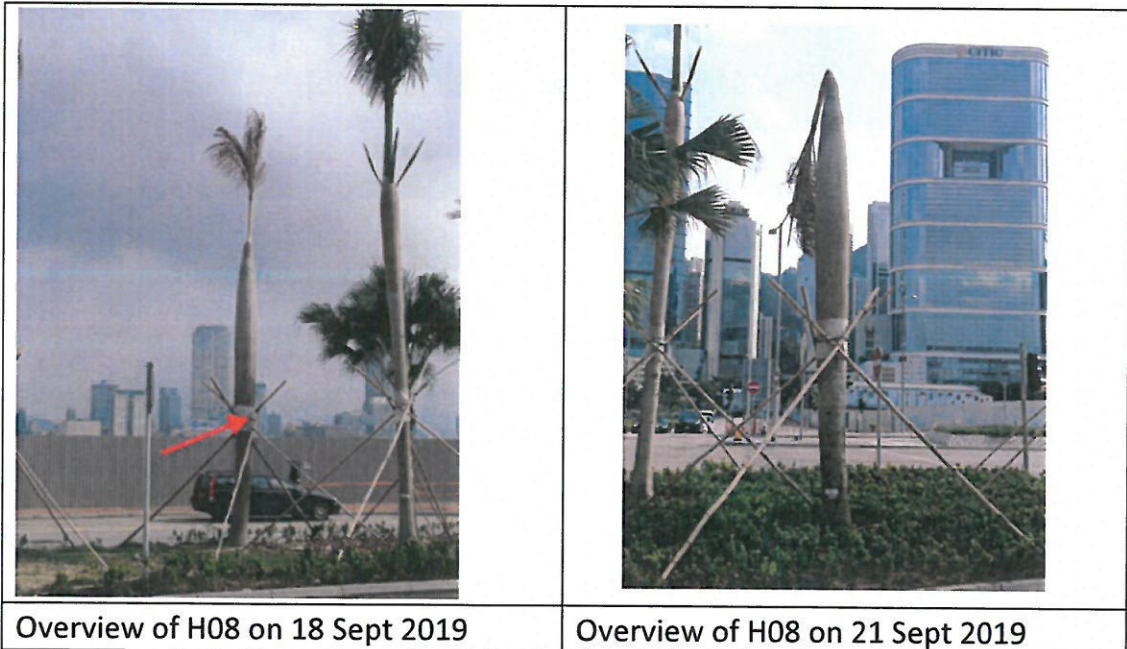
A transplanted trees, named H08 (C2) was observed dead during the site inspection on 21 September 2019. The general information of the tree is listed in the following table:

Overview of H08 on 18 Sept 2019

Overview of H08 on 21 Sept 2019

During this inspection, this tree is obviously dead after transplanting within 1 month. Tree felling may require but it will subject to the condition of TPRP under this Contract. Compensatory planting may necessary considered. Detail assessment of this tree please refers to the Form 2 attached.

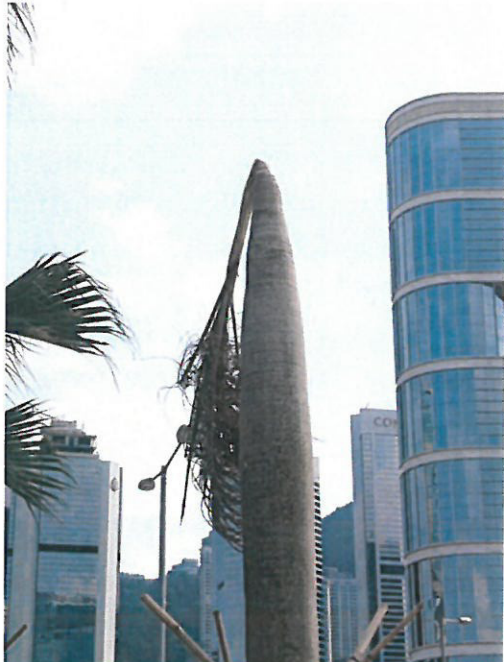
<p>Crown wilting was observed on 18 Sept 2019</p>	<p>Growing point of the tree was dead on 21 Sept 2019</p>

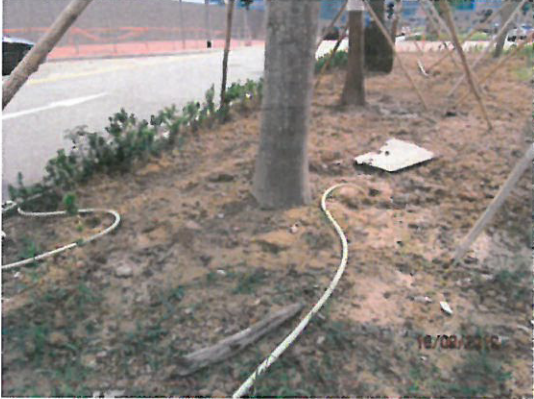
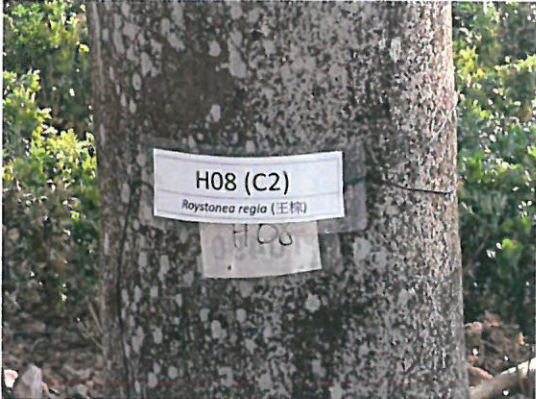
<p>Tree root area</p>	<p>Tree tag</p>

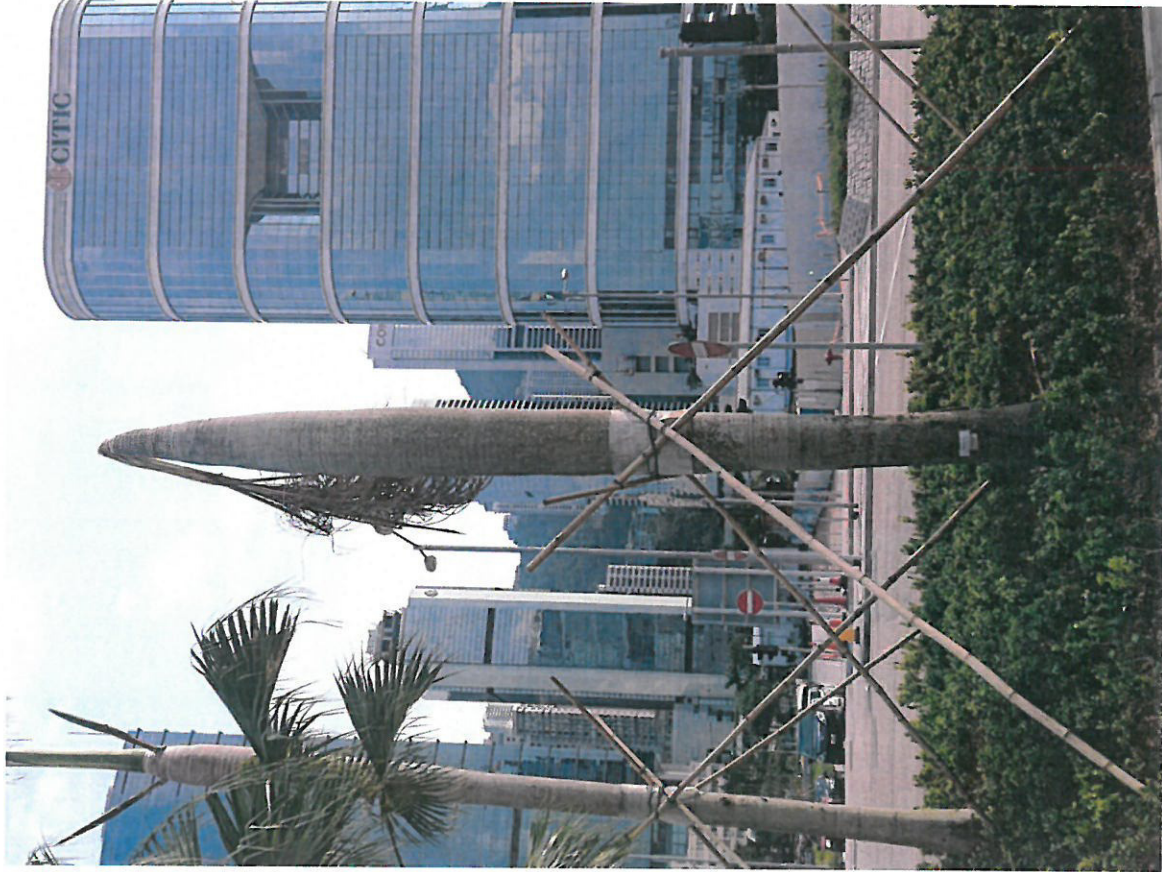
Overview of H08

This tree is designated for transplanting, but health condition of this tree declined after transplanting from holding nursery. Tree removal may required.

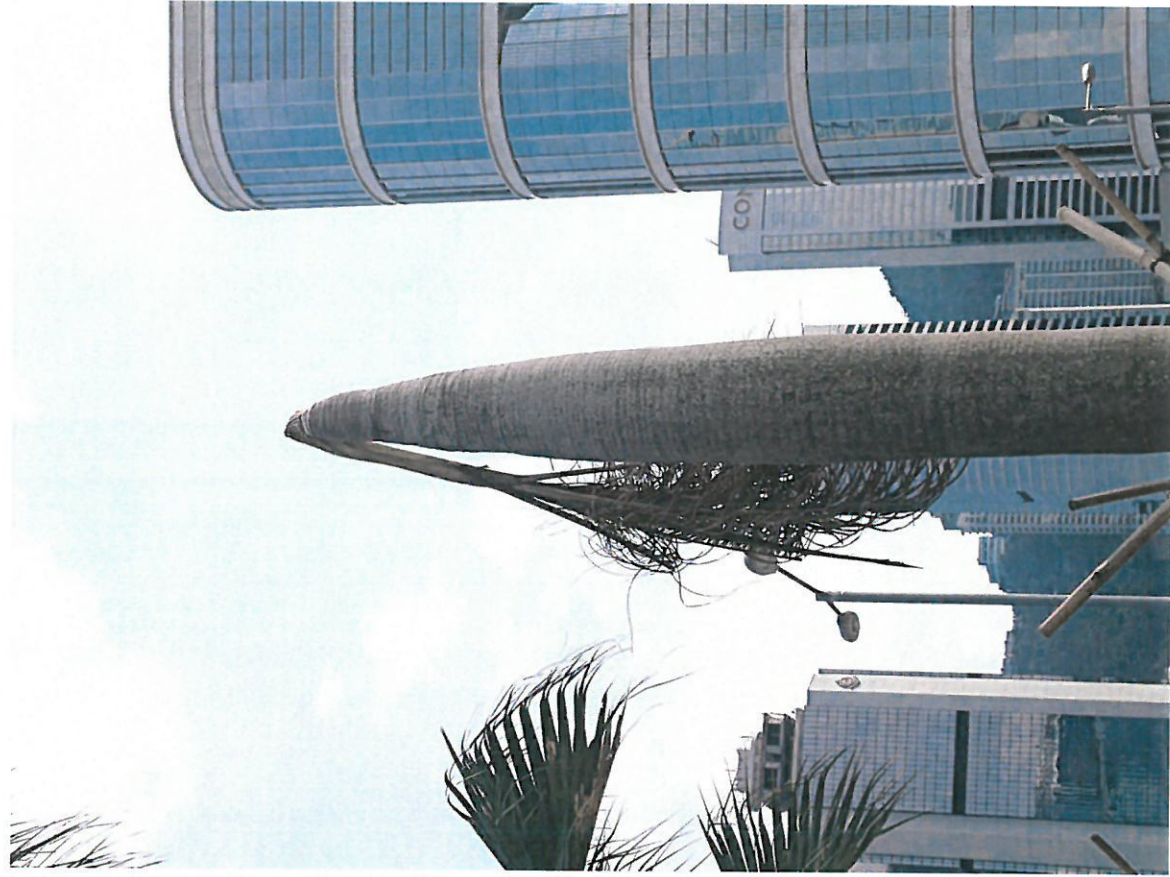
Wilted tree crown (Dead of growing point)

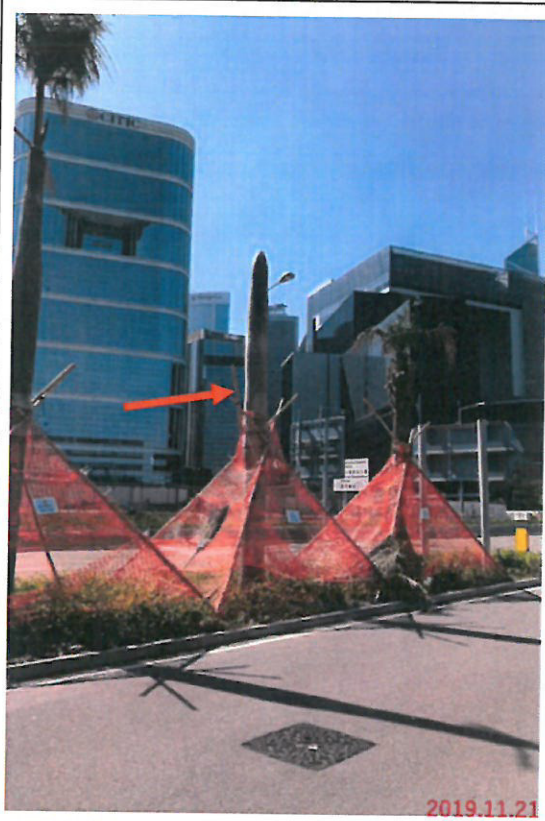
A transplanted tree, named H28 (C2) was observed dead during the site inspection on 21 November 2019. The general information of the tree is listed in the following table:

Overview of H28 on 22 Nov 2019

Tree felling is recommended and compensatory planting may necessary considered under the condition of TPRP of this Contract, detail assessment of this tree please refers to the Form 2 attached.

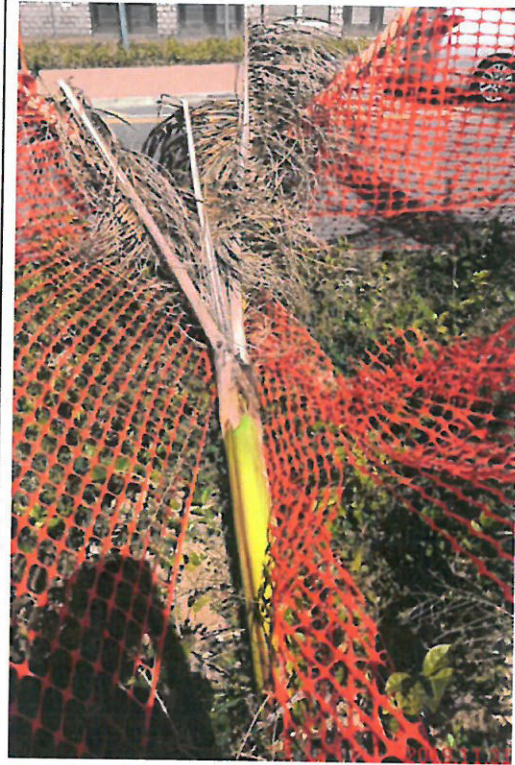
Tree crown fell on ground

During this inspection, it is observed that the tree crown was fell on ground. As the growing point of palm tree (at the tip of the trunk) was damaged, the tree is unlikely to recover.

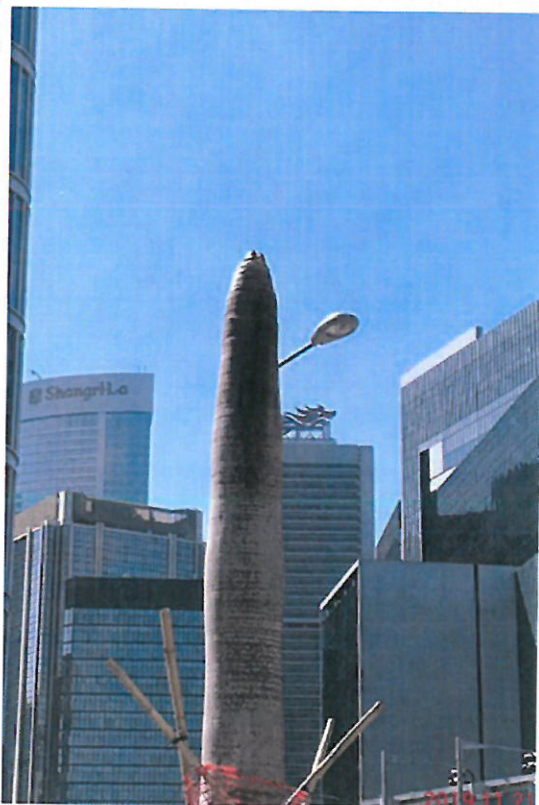
Close up of the tip of trunk

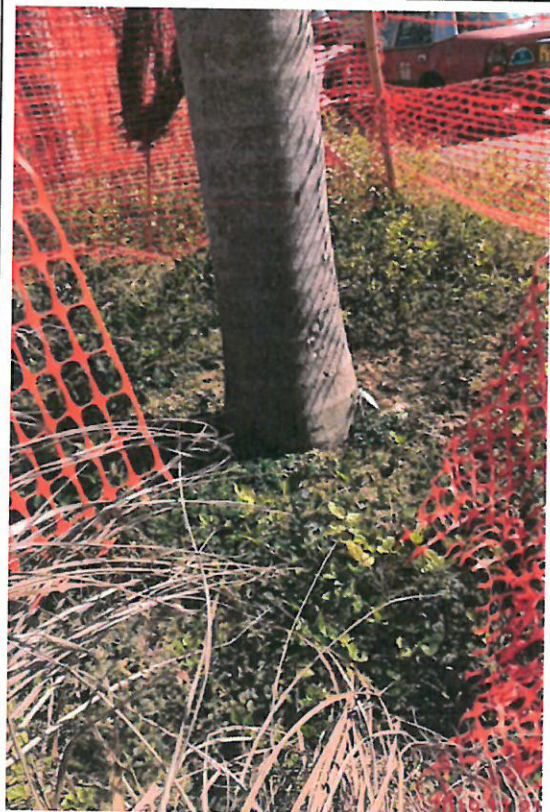
Tree root area

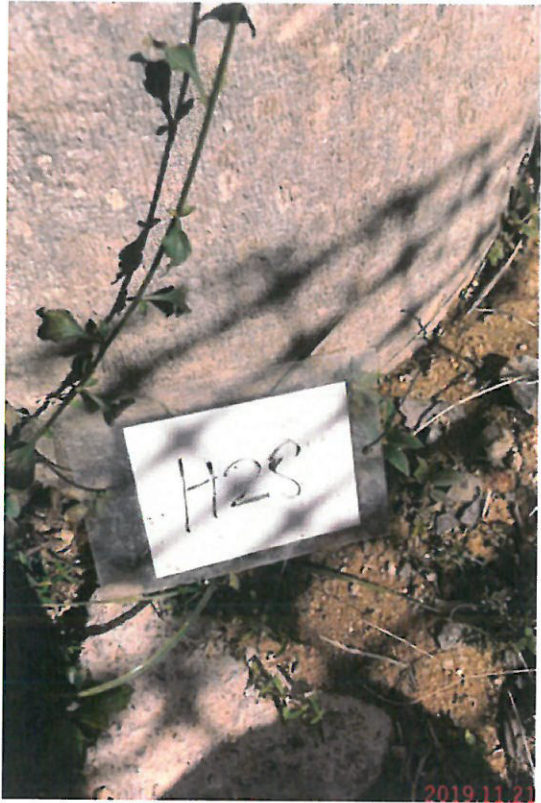
Tree tag

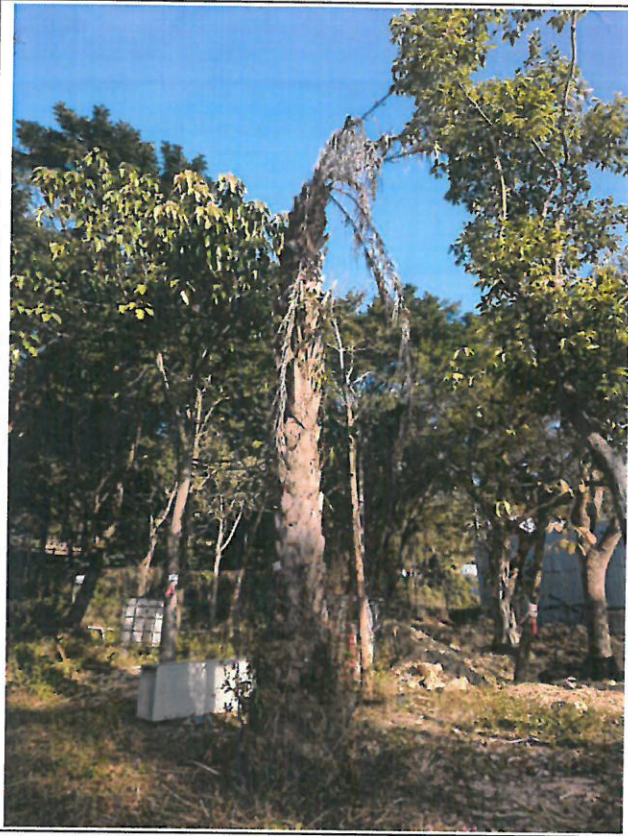
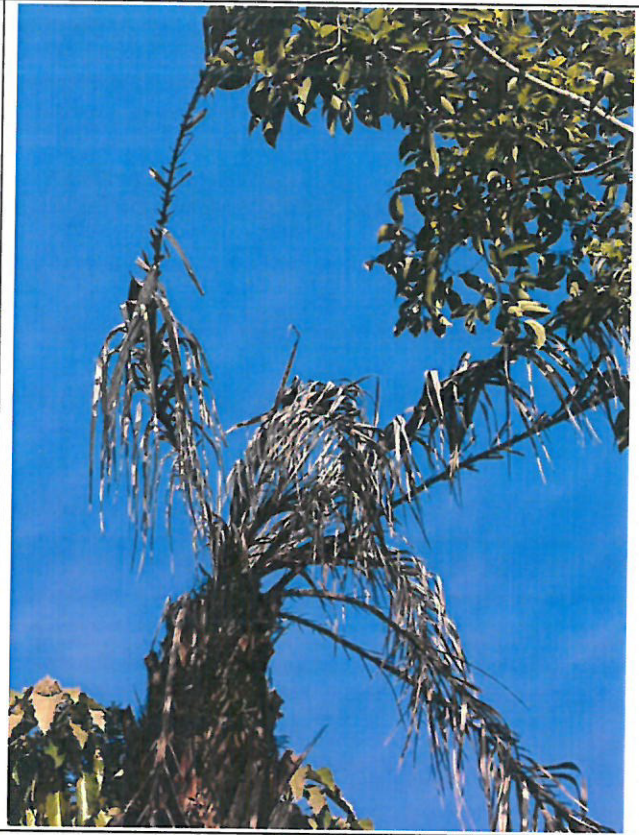
T462- *Phoenix hanceana* (刺葵)

The tree is dead. Tree removal and compensatory planting is required.

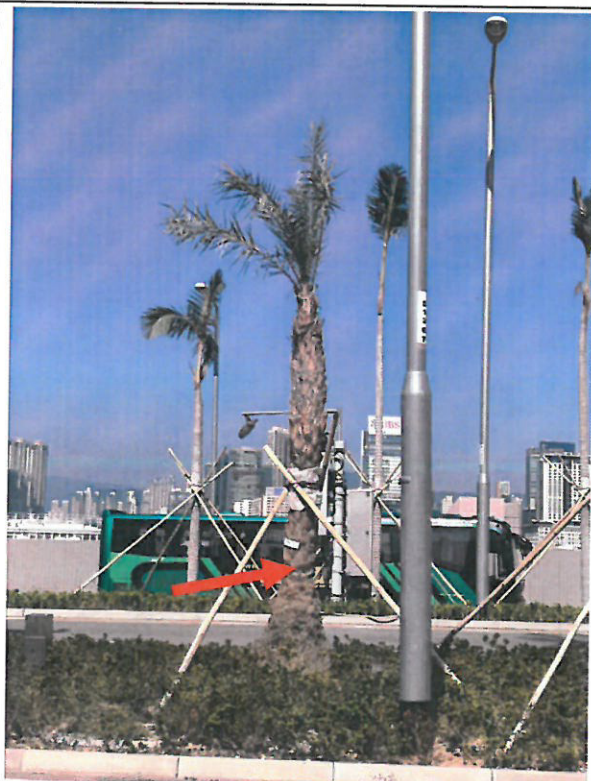
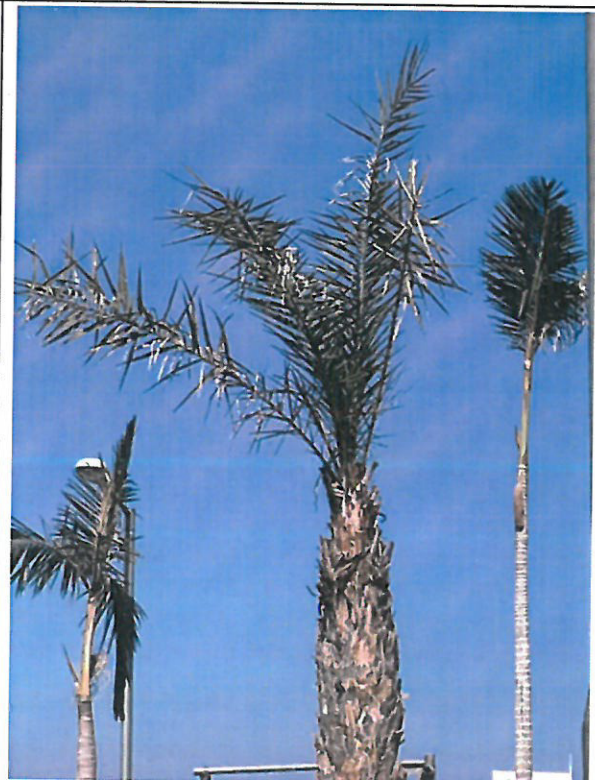
T464- *Phoenix hanceana* (刺葵)

Health condition improved and was transplanted to receptive location

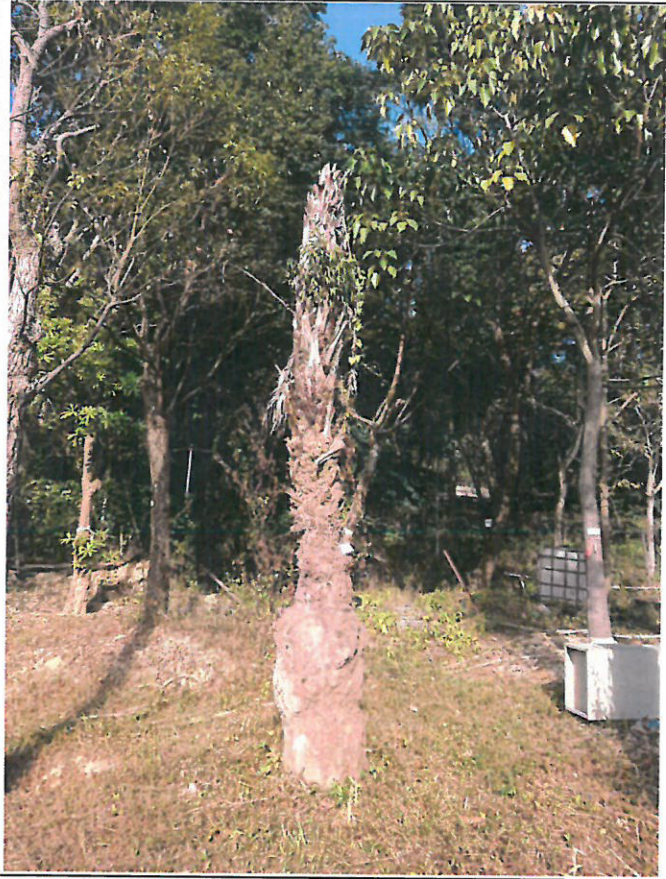
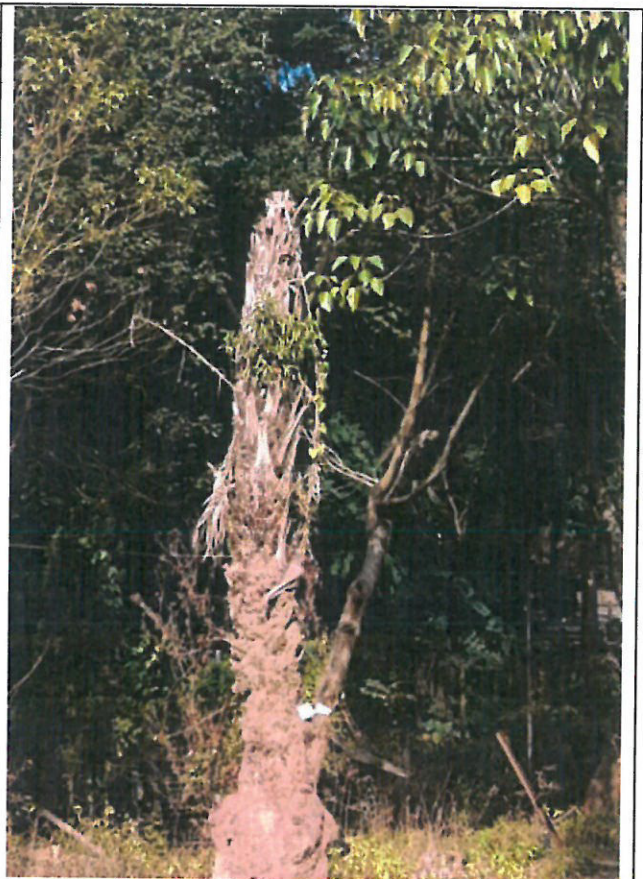
T466 -*Phoenix hanceana* (刺葵)

The tree is dead. Tree removal and compensatory planting is required.
