Graphic Presentation of Water Quality Result of C4w - WCT and GEC (Western)

Graphic Presentation of Water Quality Result of WSD21 - Wan Chai

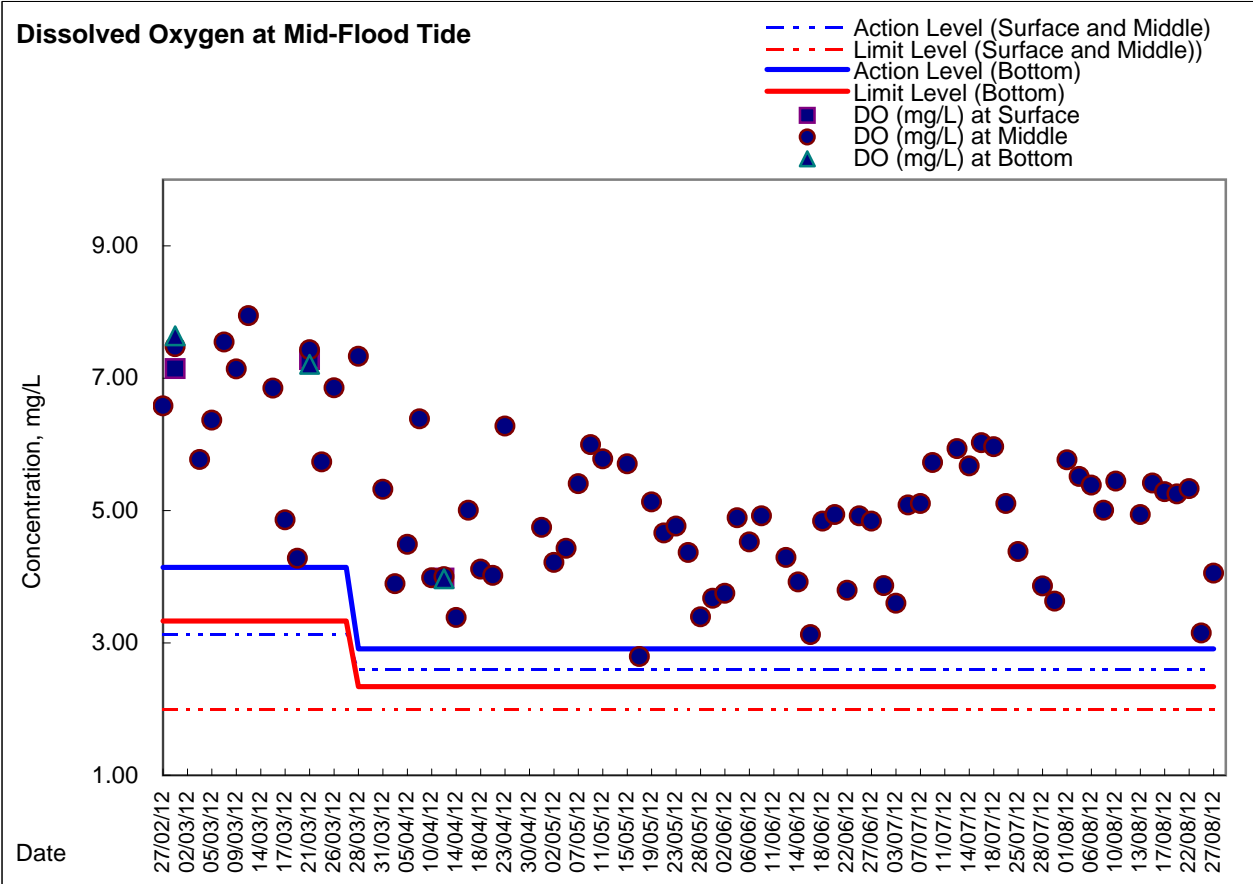
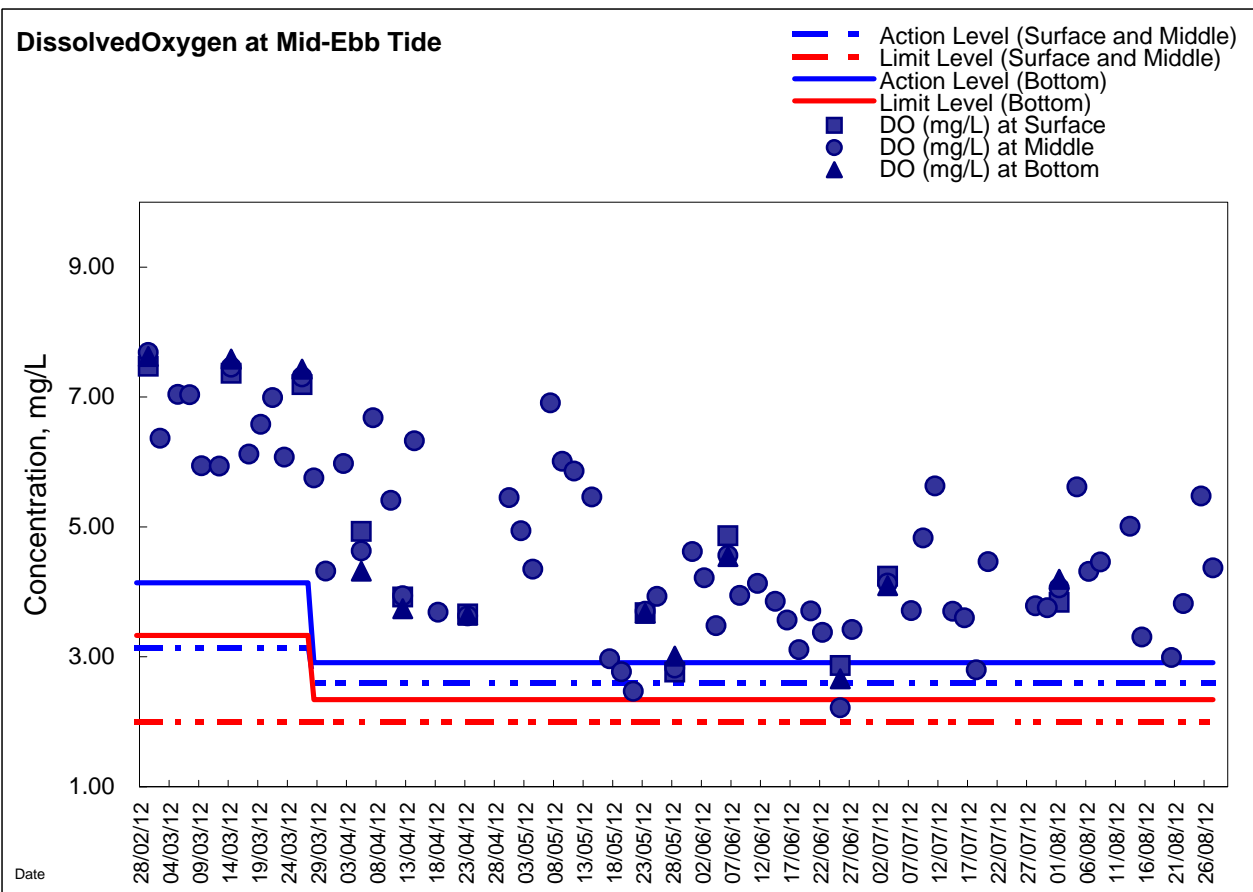
Graphic Presentation of Enhanced Water Monitoring Results (DO) at C6 - Excelsior Hotel

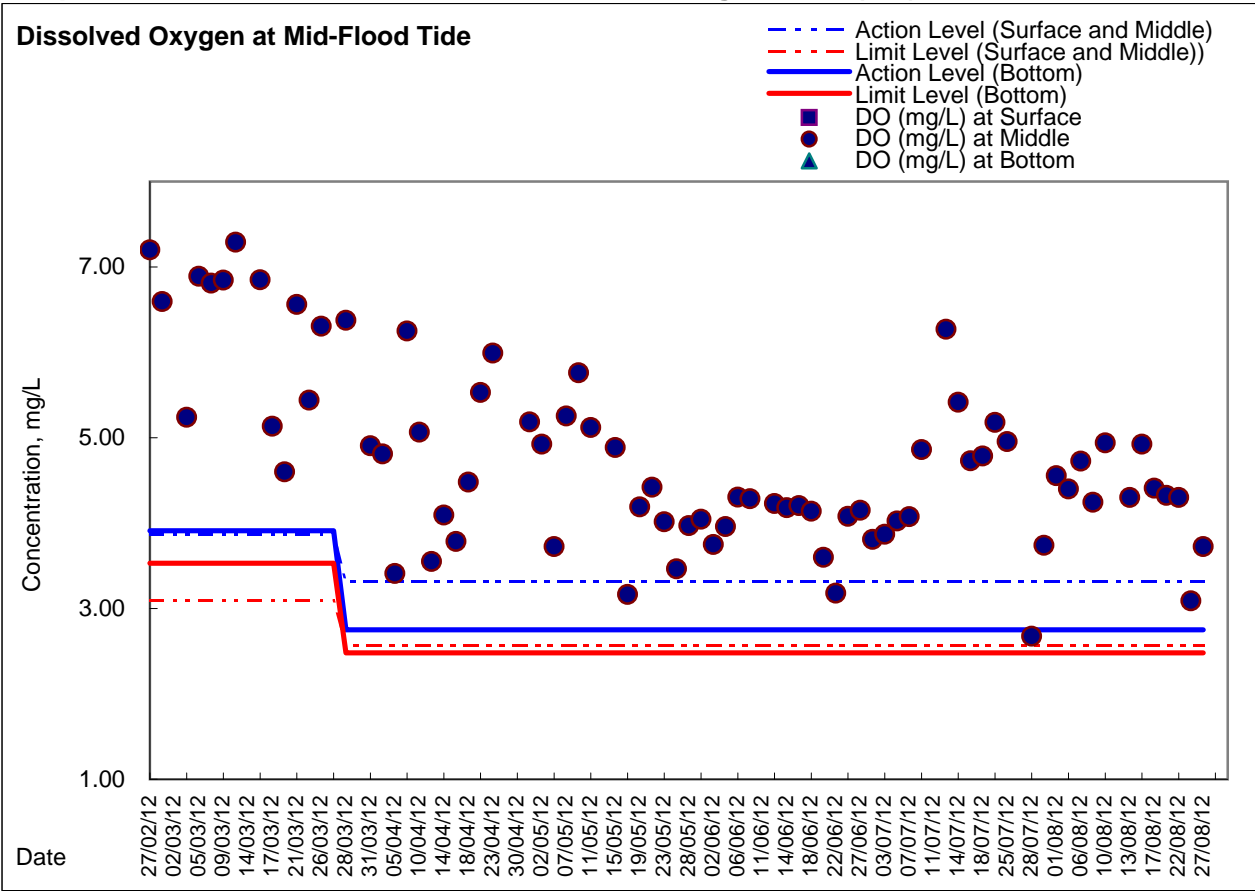
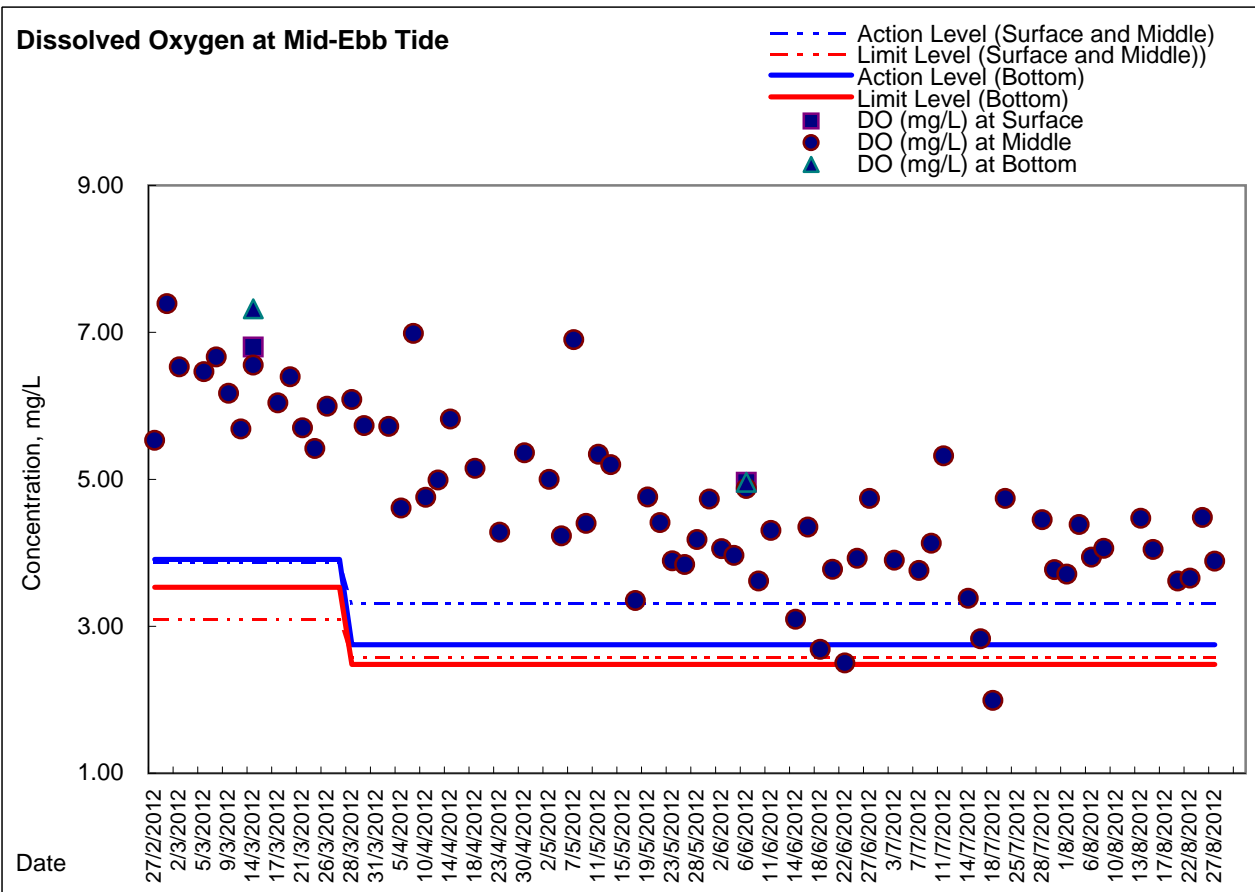
Graphic Presentation of Enhanced Water Monitoring Results (DO) at C7 - Windsor House

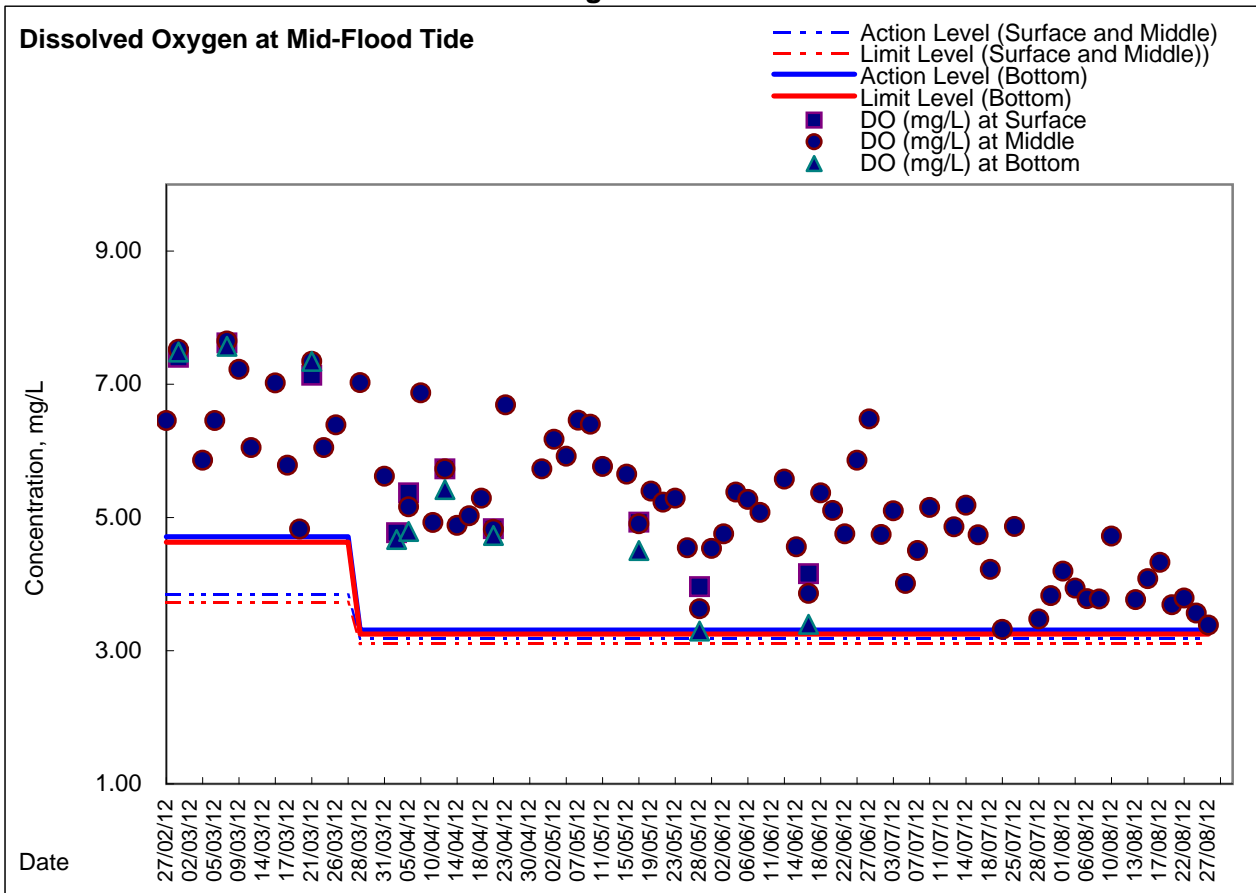
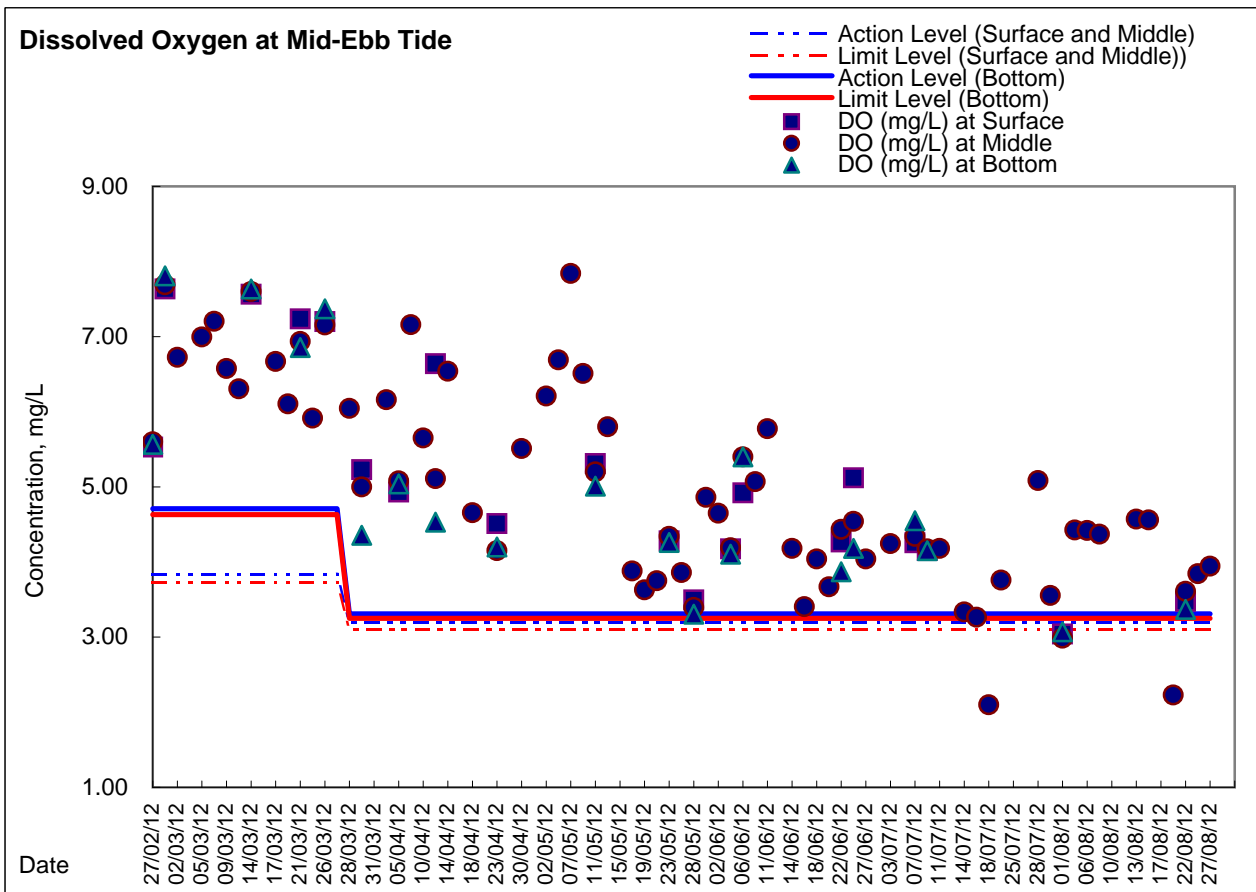
Graphic Presentation of Enhanced Water Monitoring Results (DO) at Ex-WPCWA SW - South-western corners of ex-Public Cargo Works Area

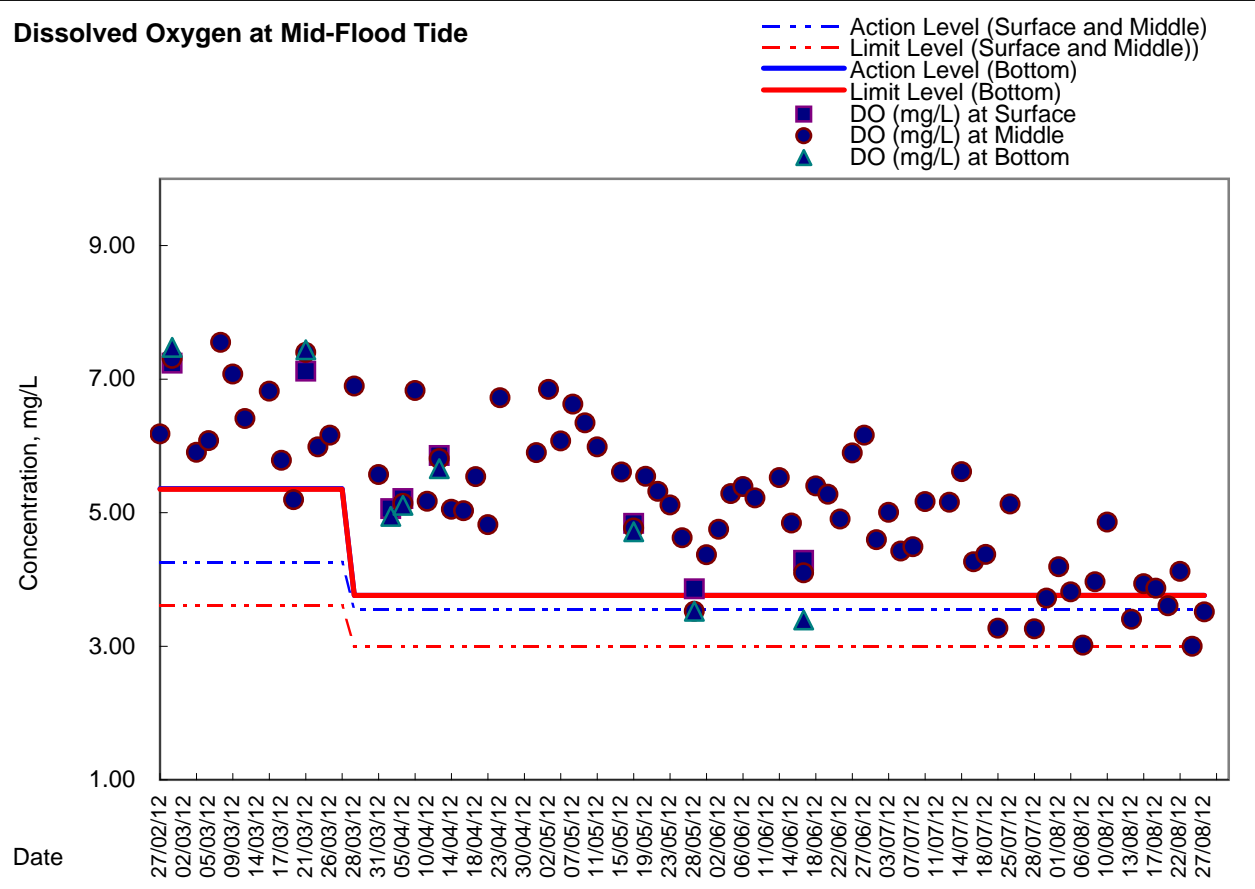
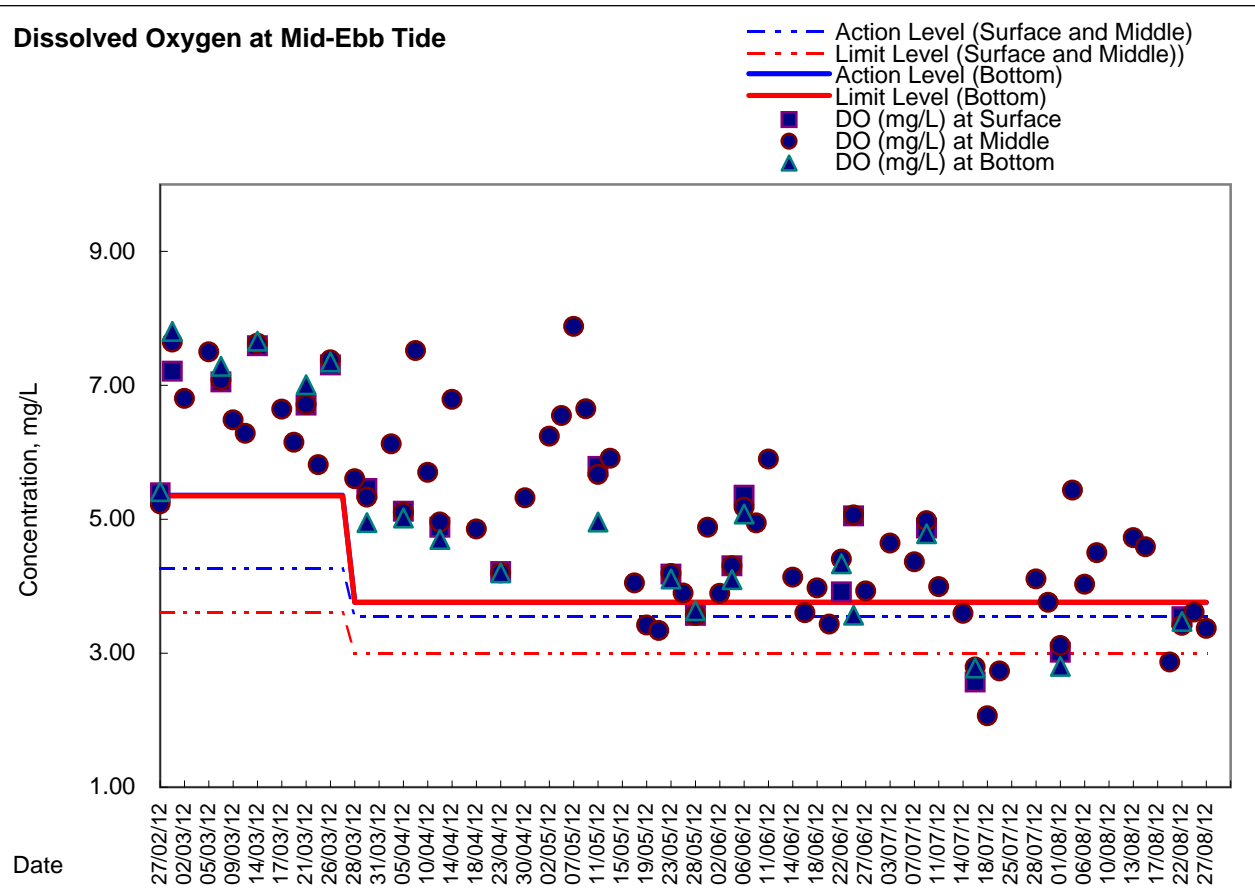
**Graphic Presentation of Enhanced Water Monitoring Results (DO) at Ex-WPCWA SE
- South-eastern corners of ex-Public Cargo Works Area**
