Graphic Presentation of Water Quality Result of WSD19 - Sheung Wan

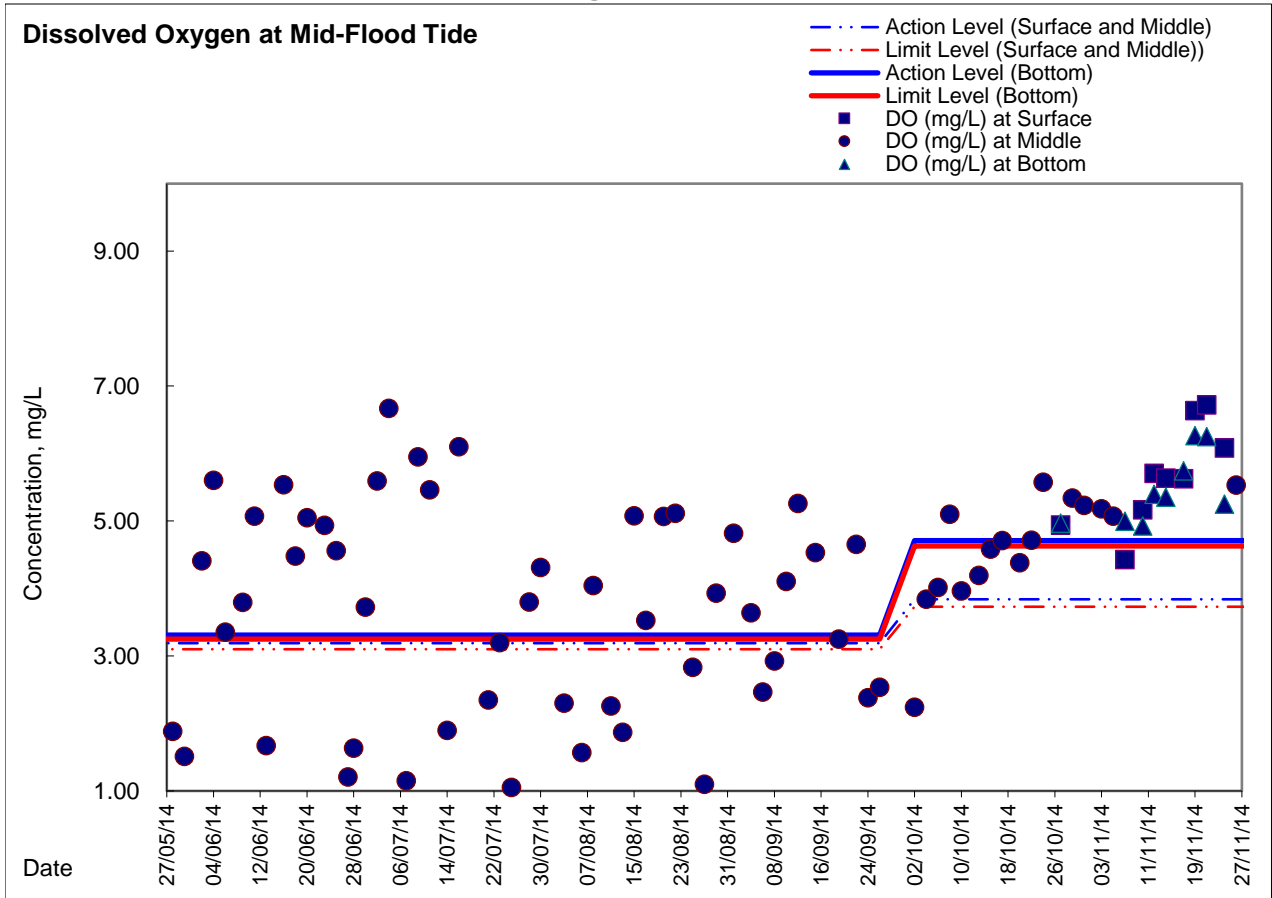
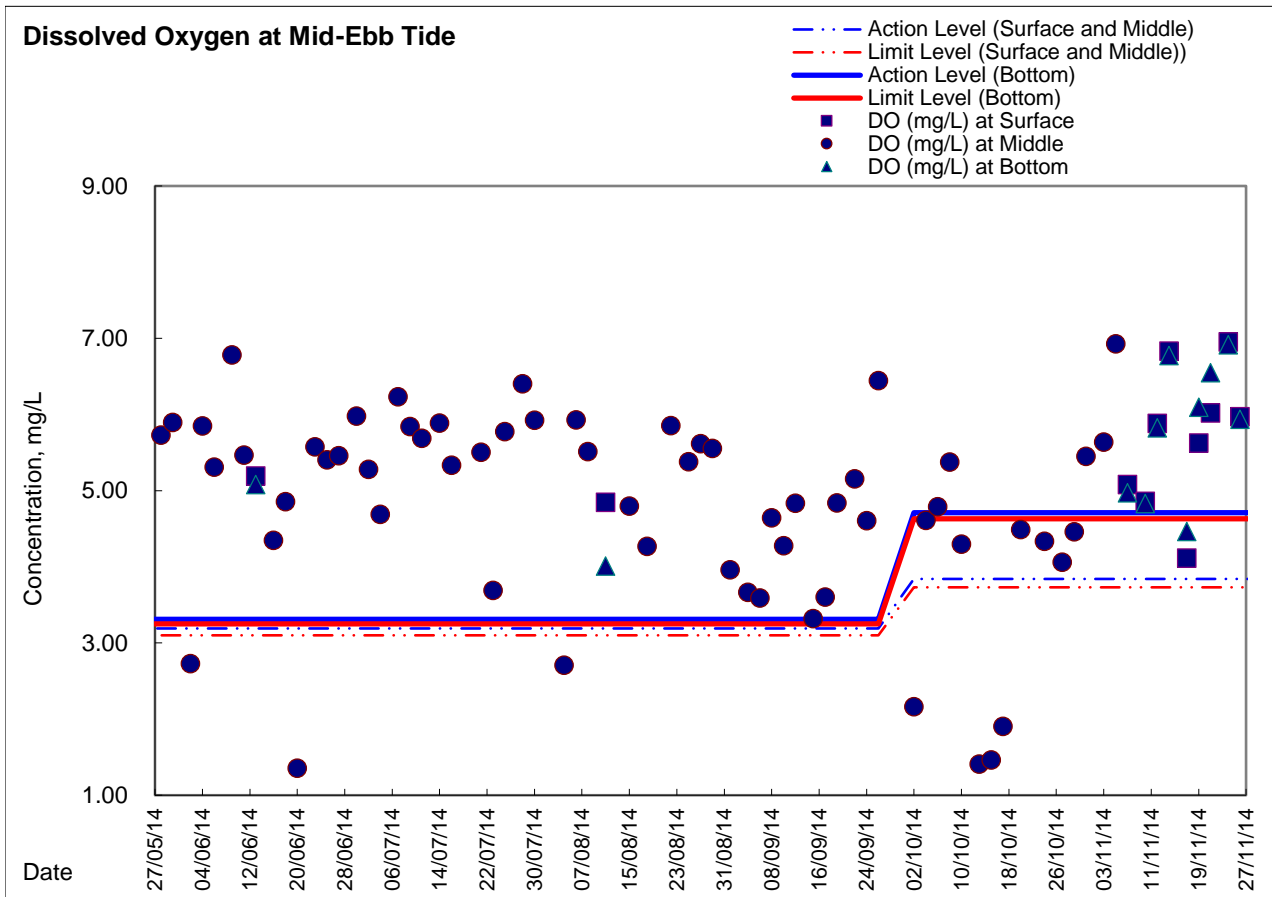
Graphic Presentation of Enhanced Water Monitoring Results (DO) at Ex-WPCWA SW - South-western corners of ex-Public Cargo Works Area

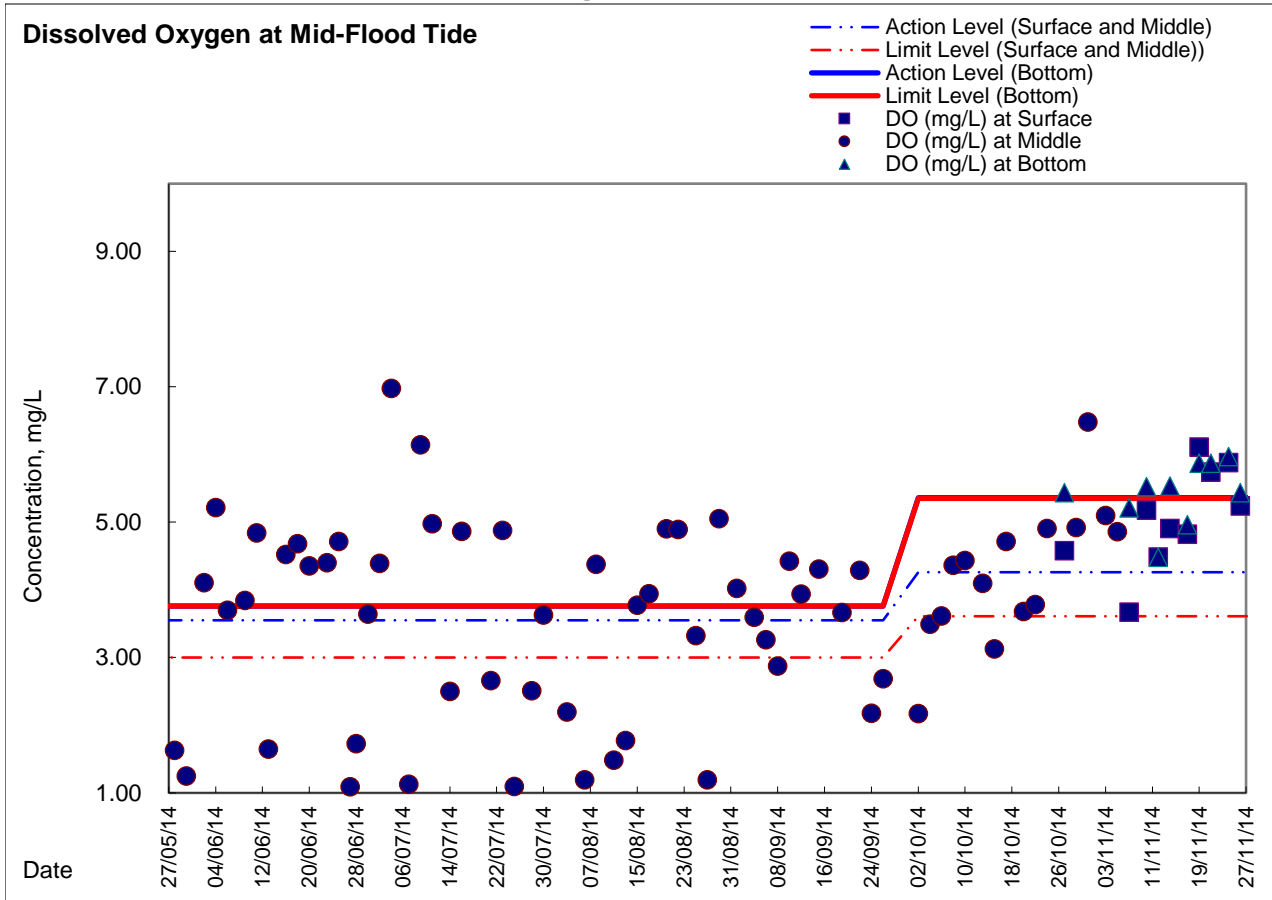
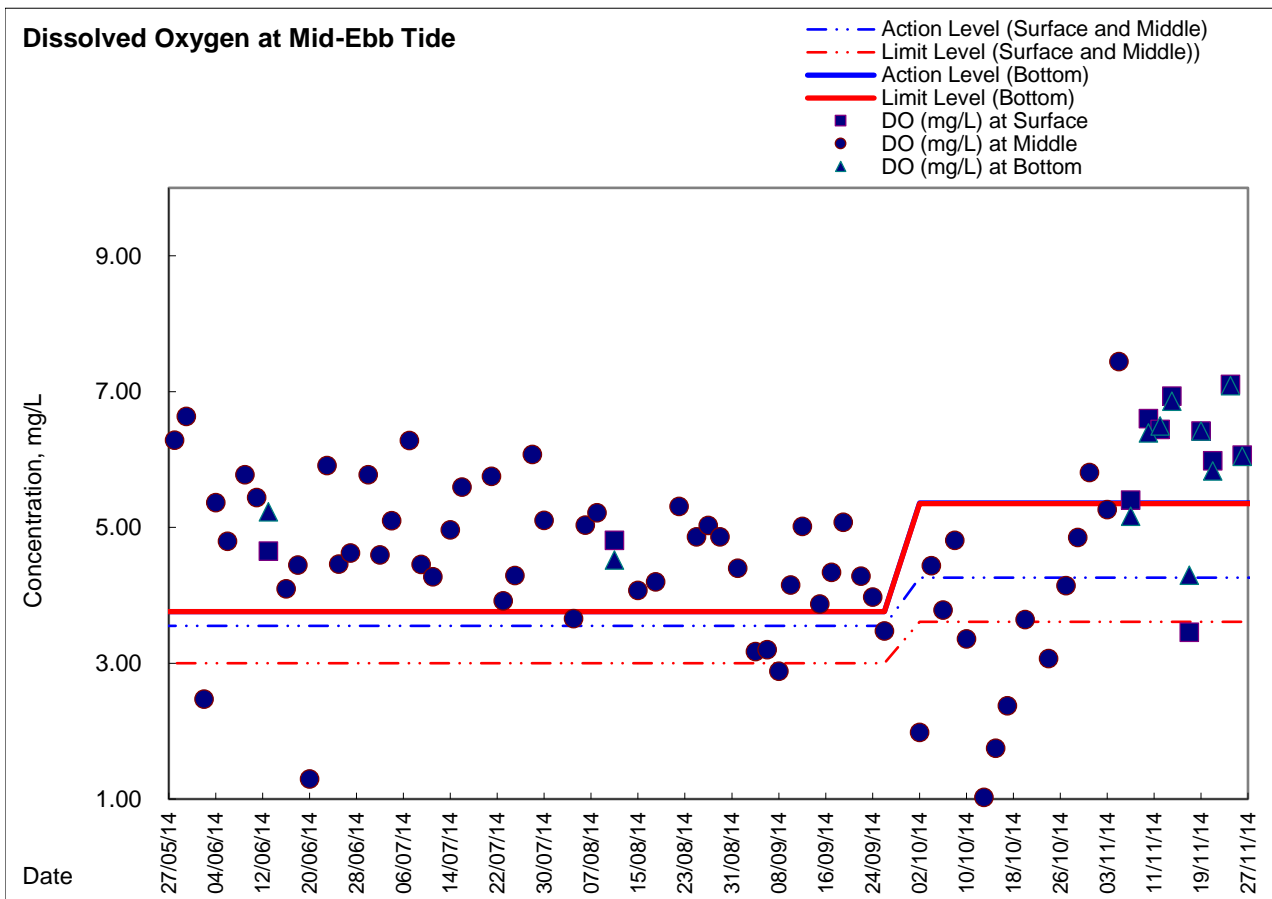
Graphic Presentation of Enhanced Water Monitoring Results (DO) at Ex-WPCWA SE - South-eastern corners of ex-Public Cargo Works Area
