Graphic Presentation of Water Quality Result of WSD19 - Sheung Wan

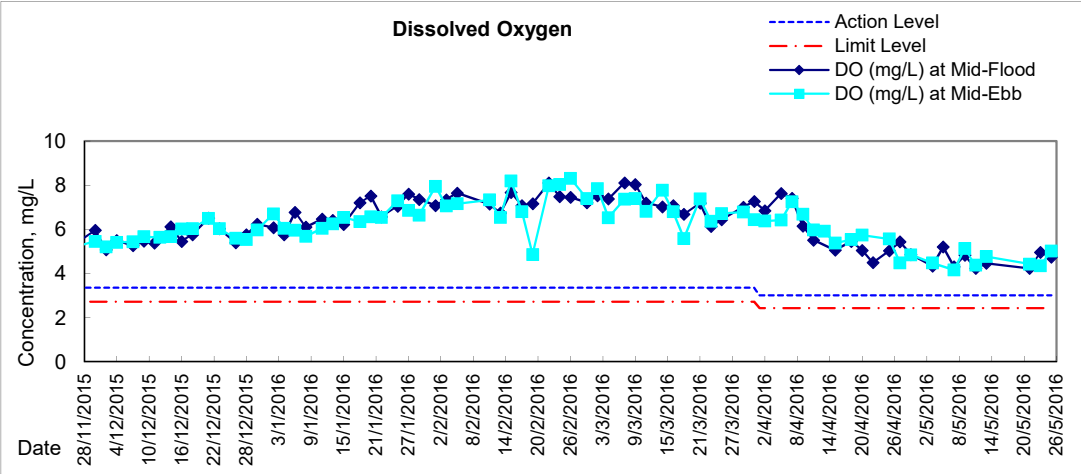
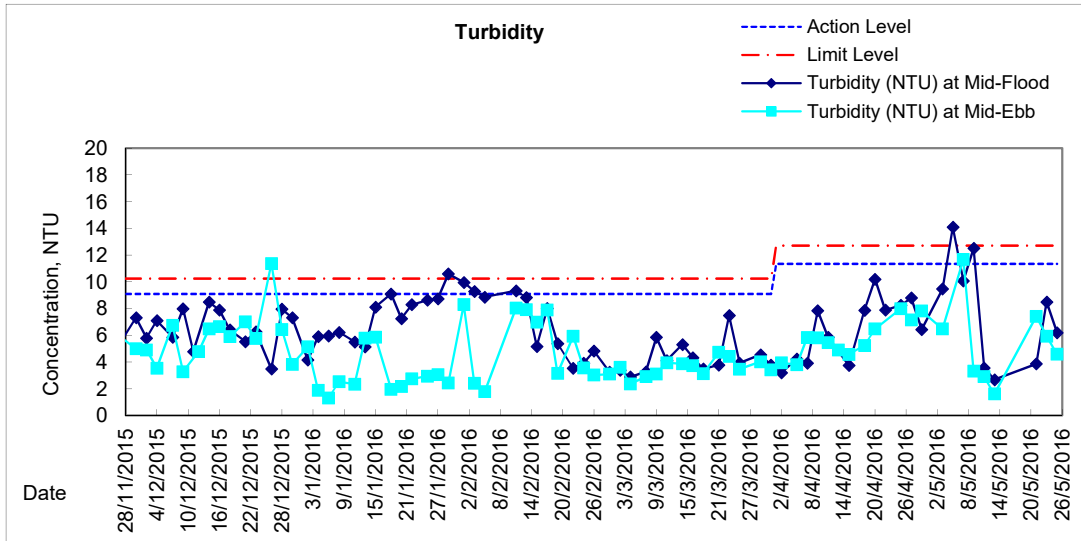
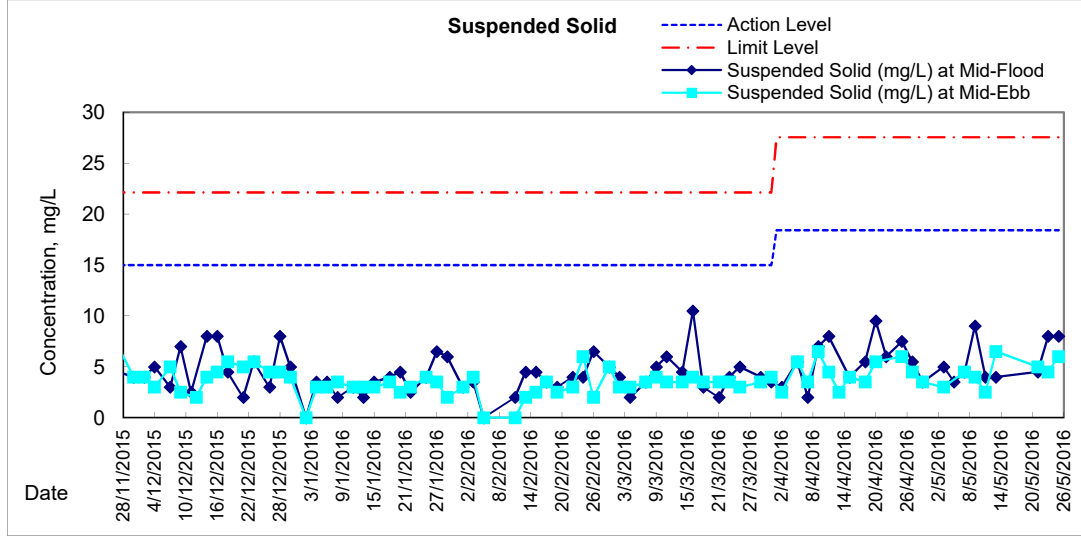
Graphic Presentation of Water Quality Result of C1 - HKCEC

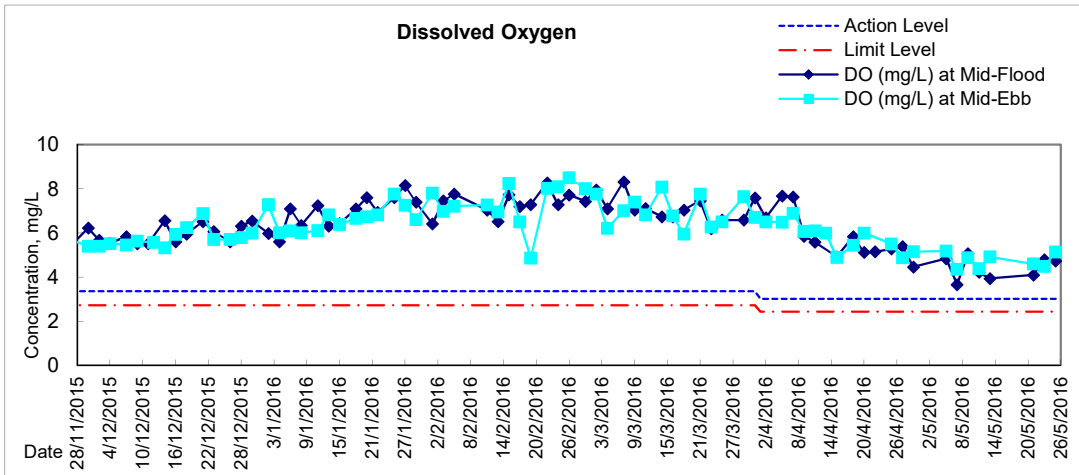
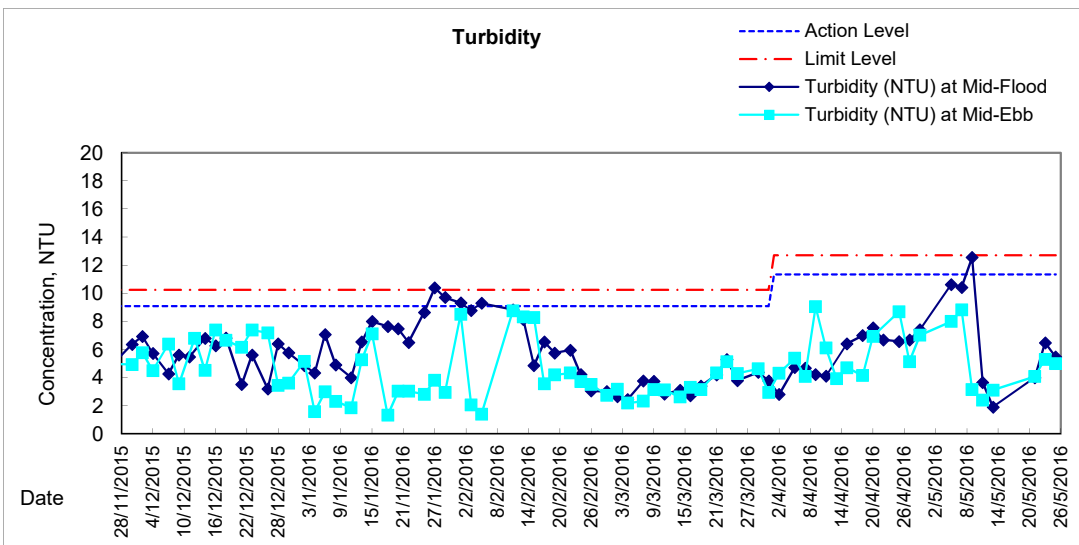
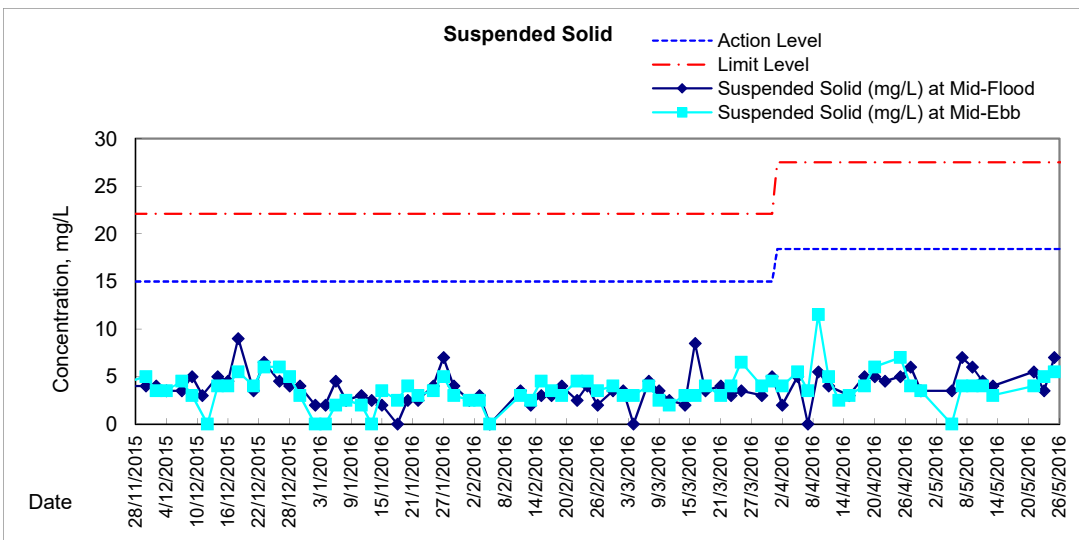
Graphic Presentation of Water Quality Result of P1 - HKCEC Phase I

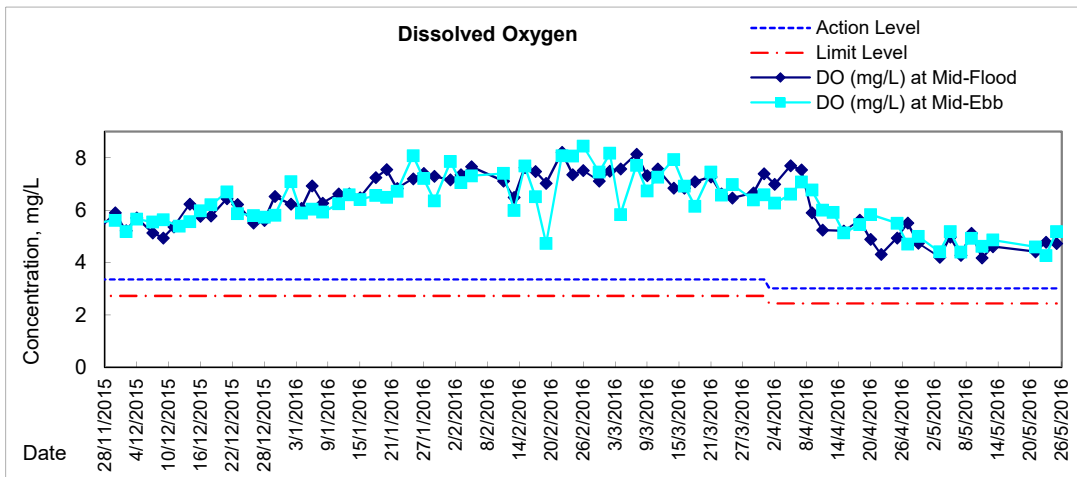
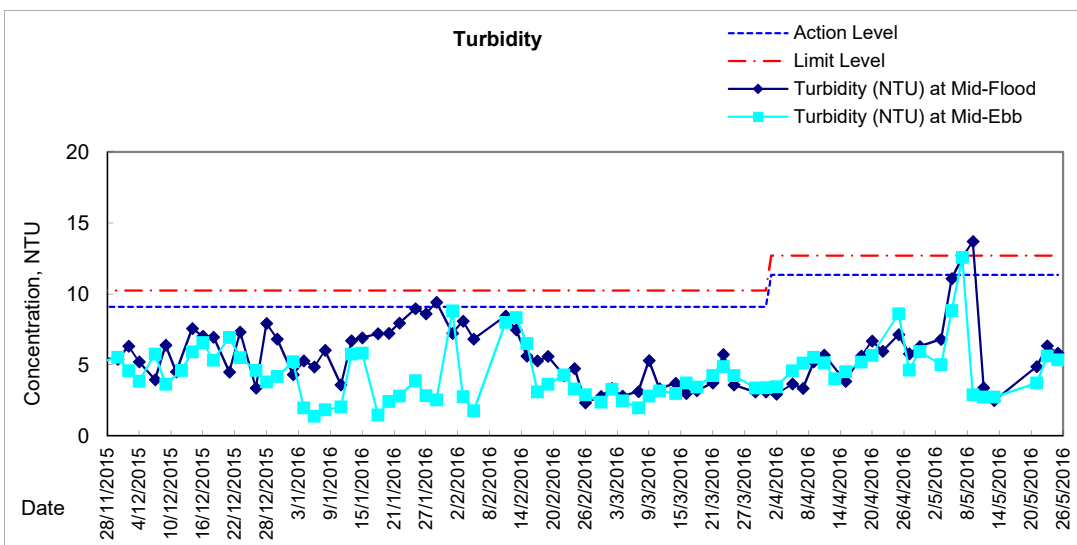
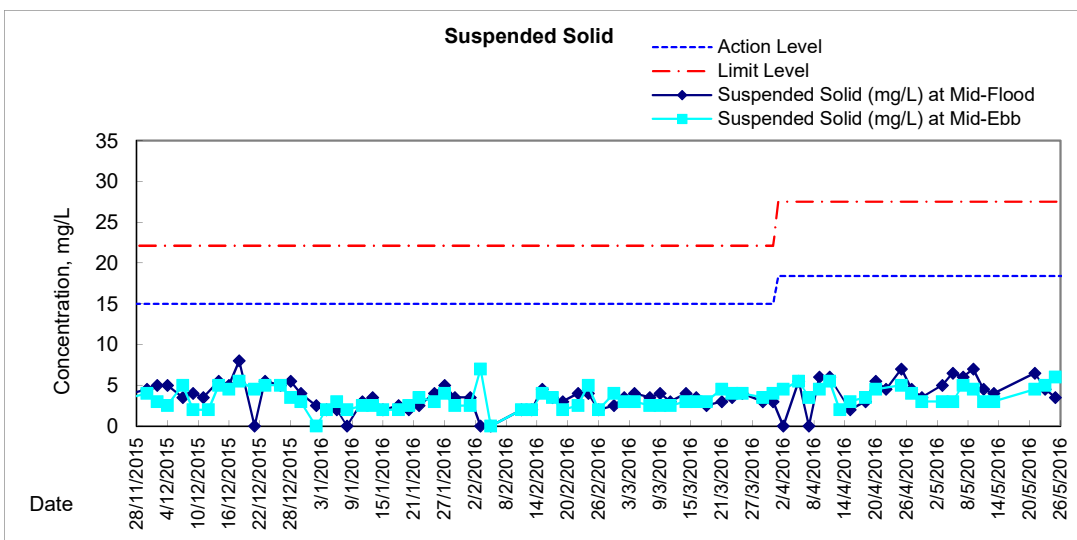
Graphic Presentation of Water Quality Result of P3 - APA

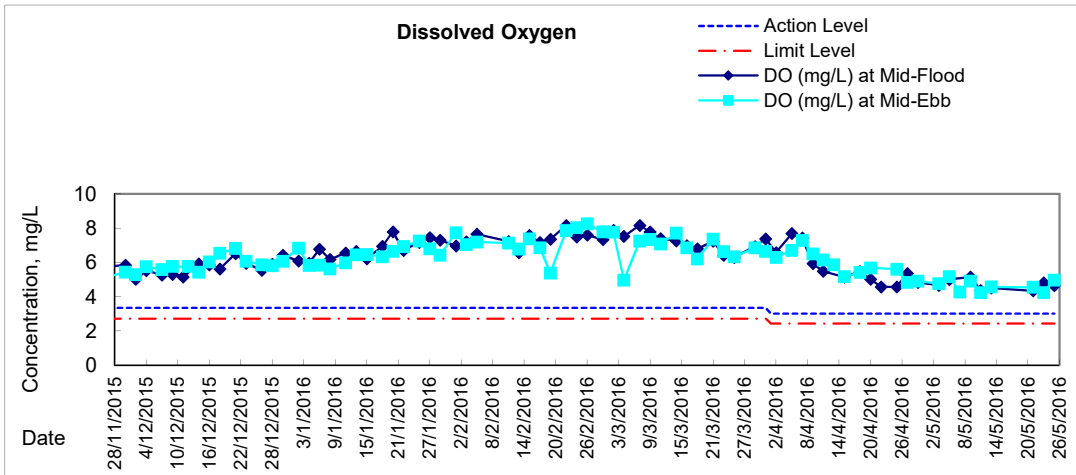
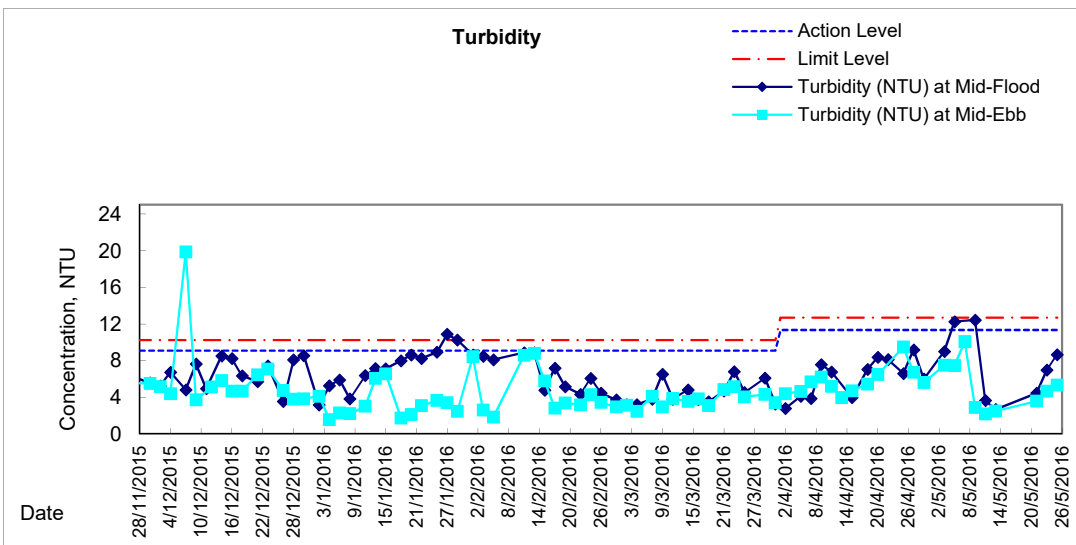
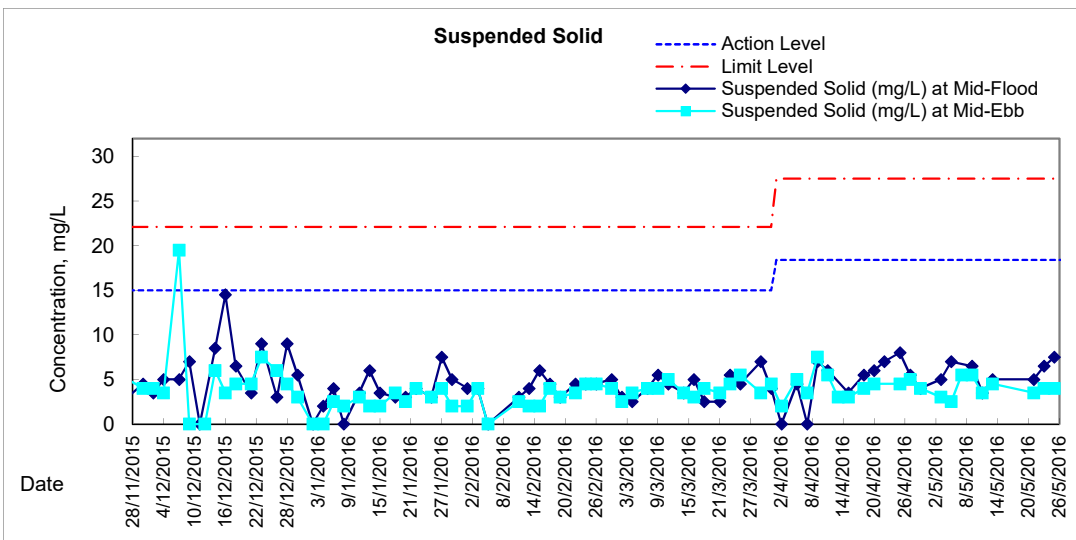
Graphic Presentation of Water Quality Result of P5 - WCT / RT / IT

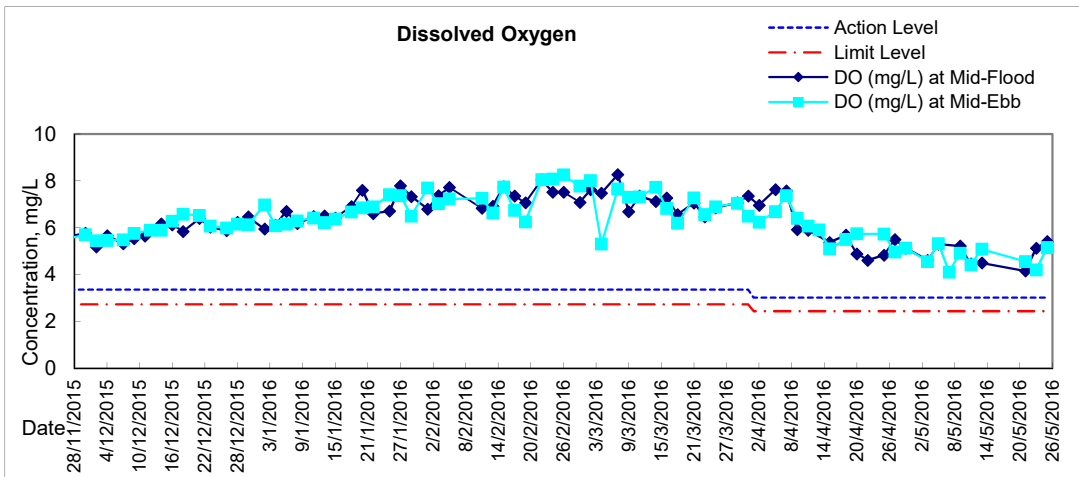
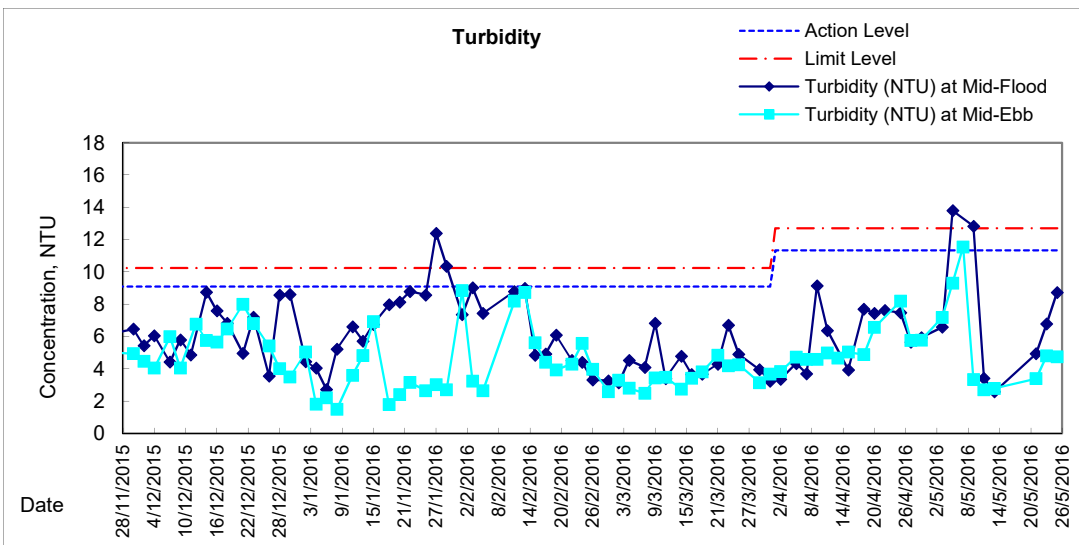
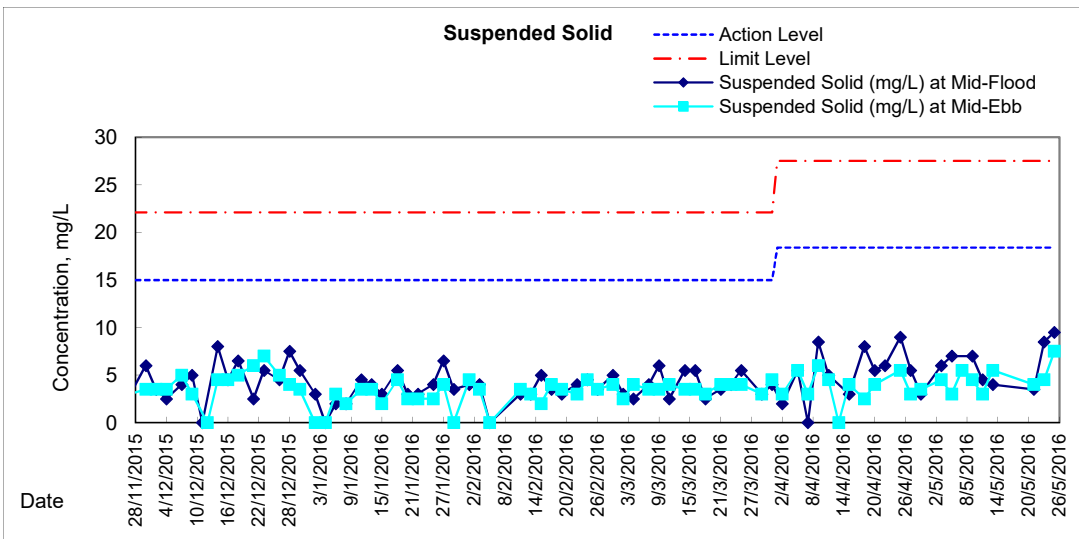
Graphic Presentation of Water Quality Result of P4 - SOC

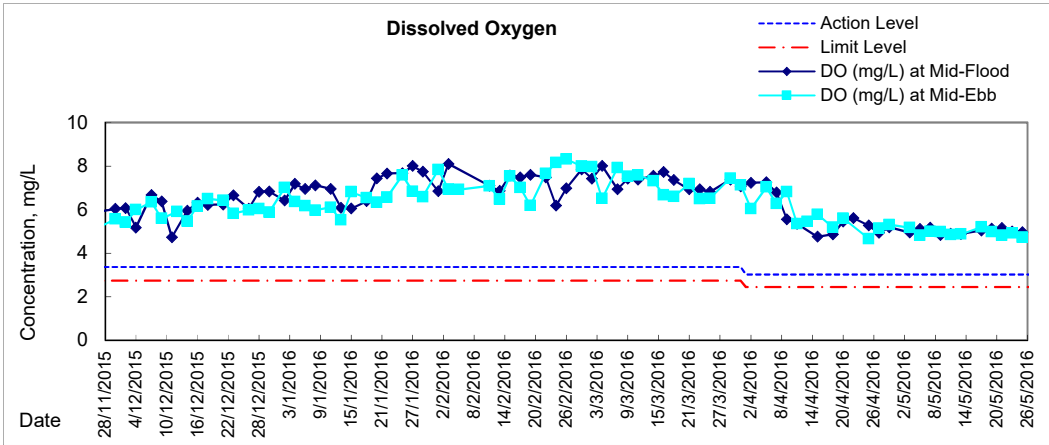
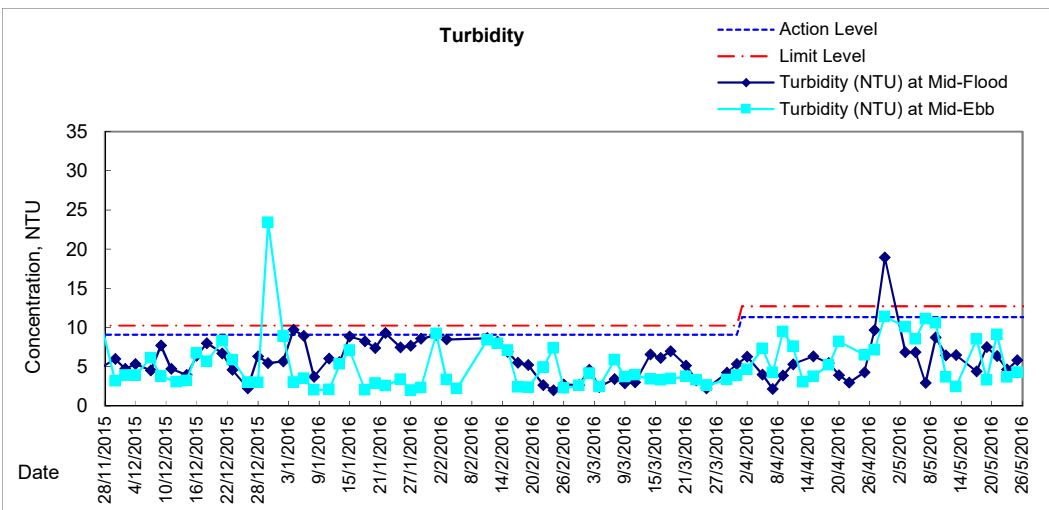
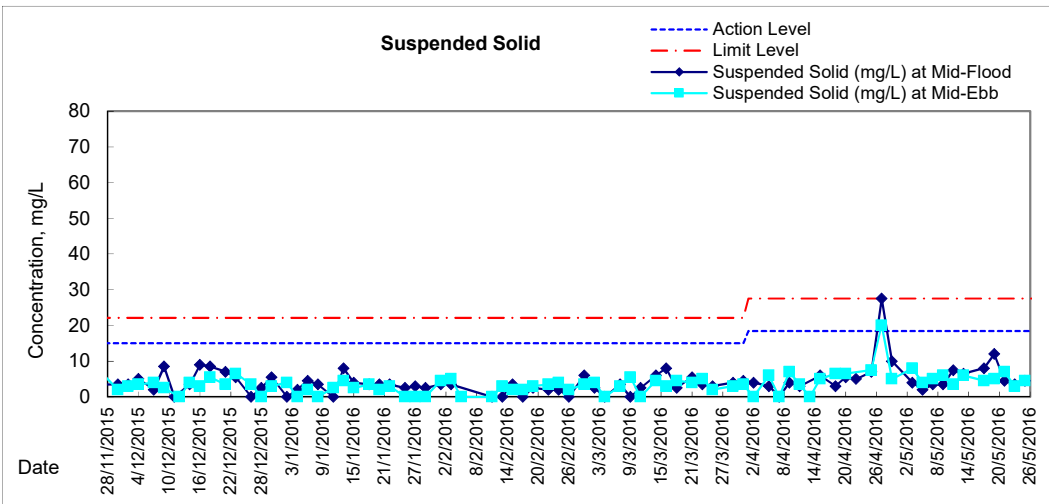
Graphic Presentation of Water Quality Result of C7 - Windsor House

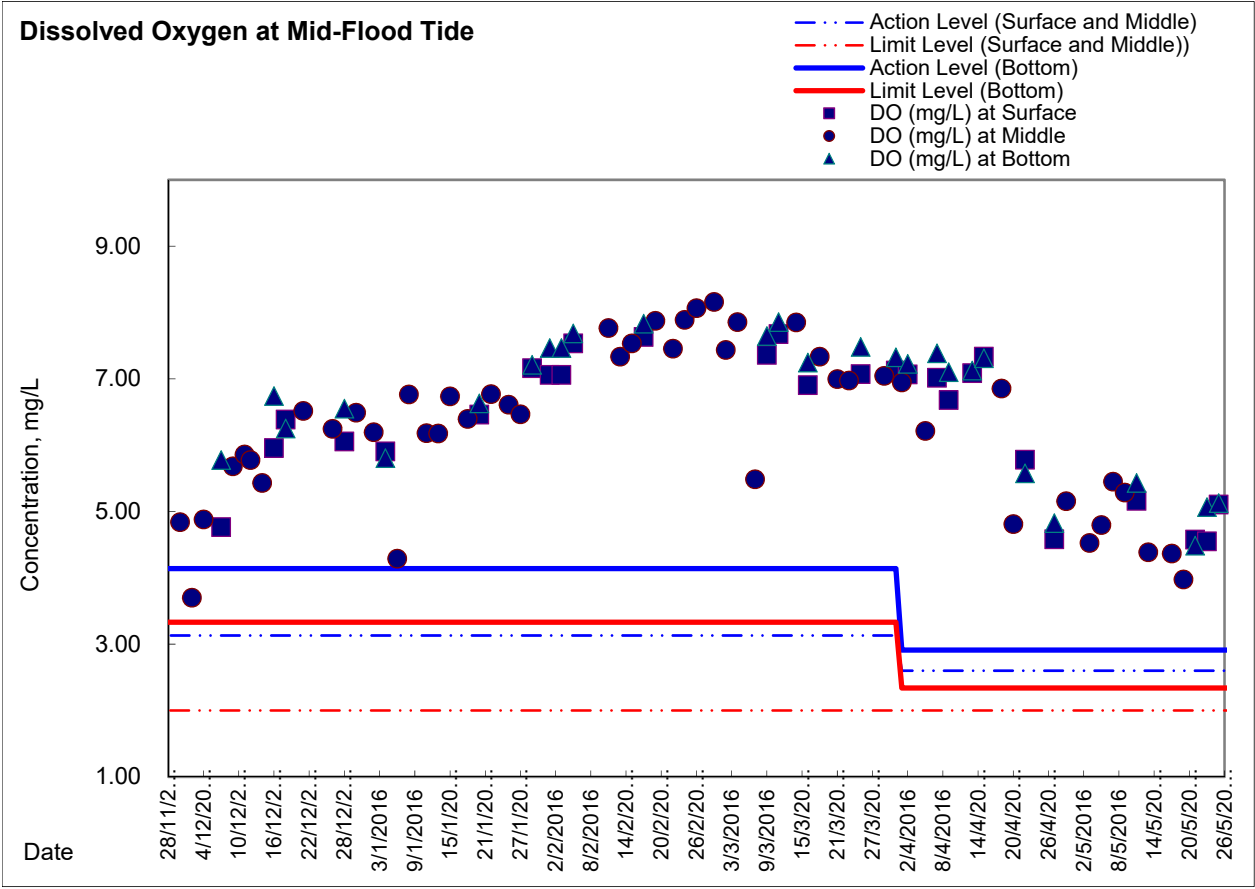
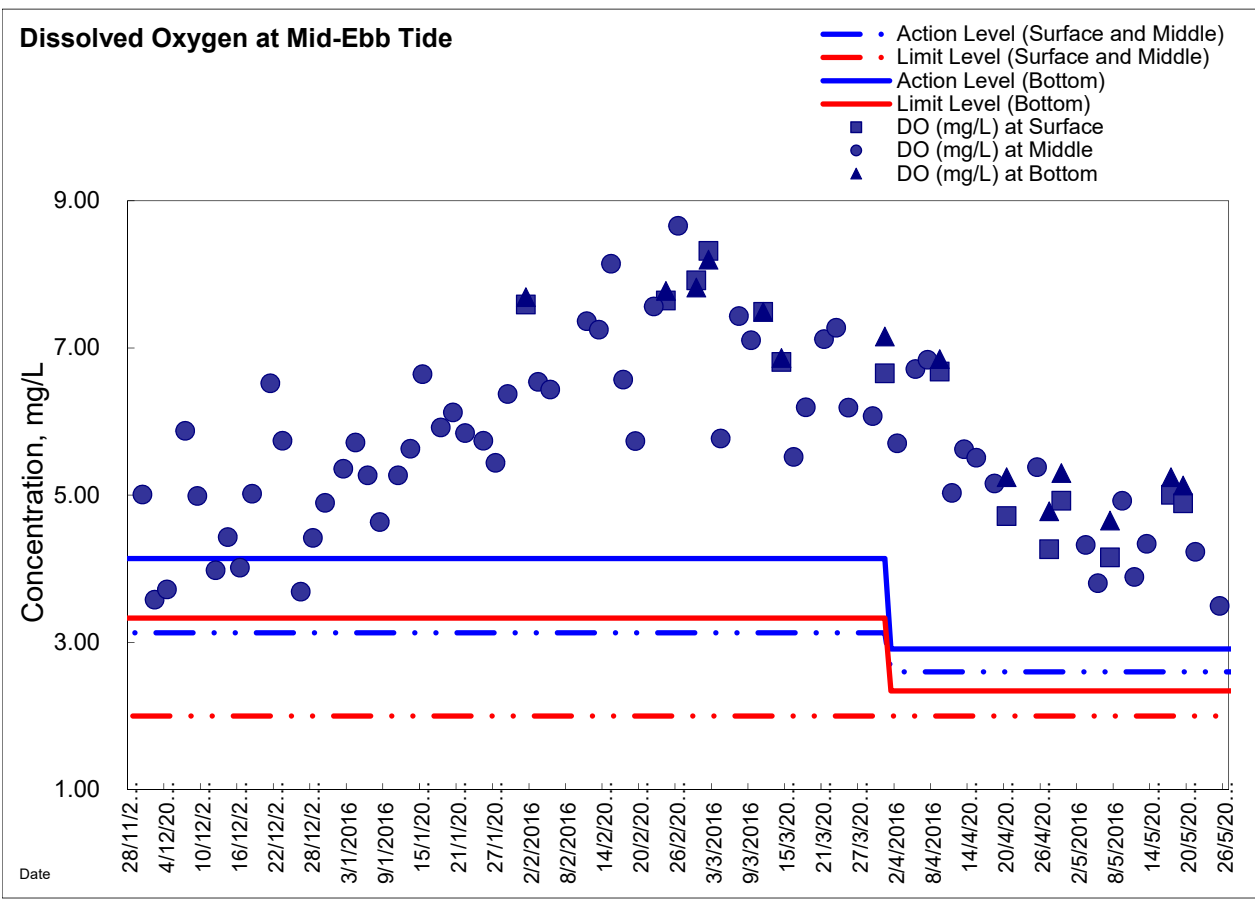
Graphic Presentation of Enhanced Water Monitoring Results (DO) at C6 - Excelsior Hotel

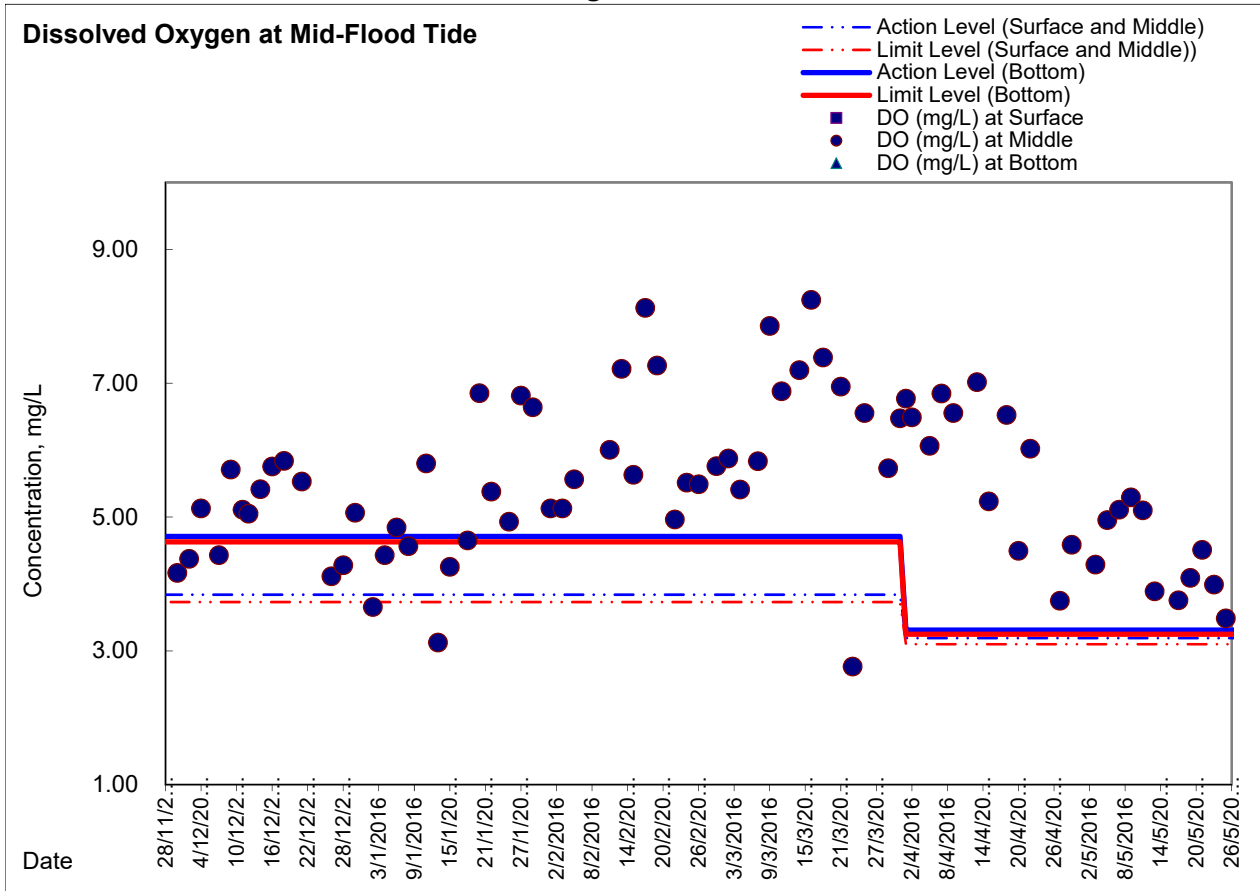
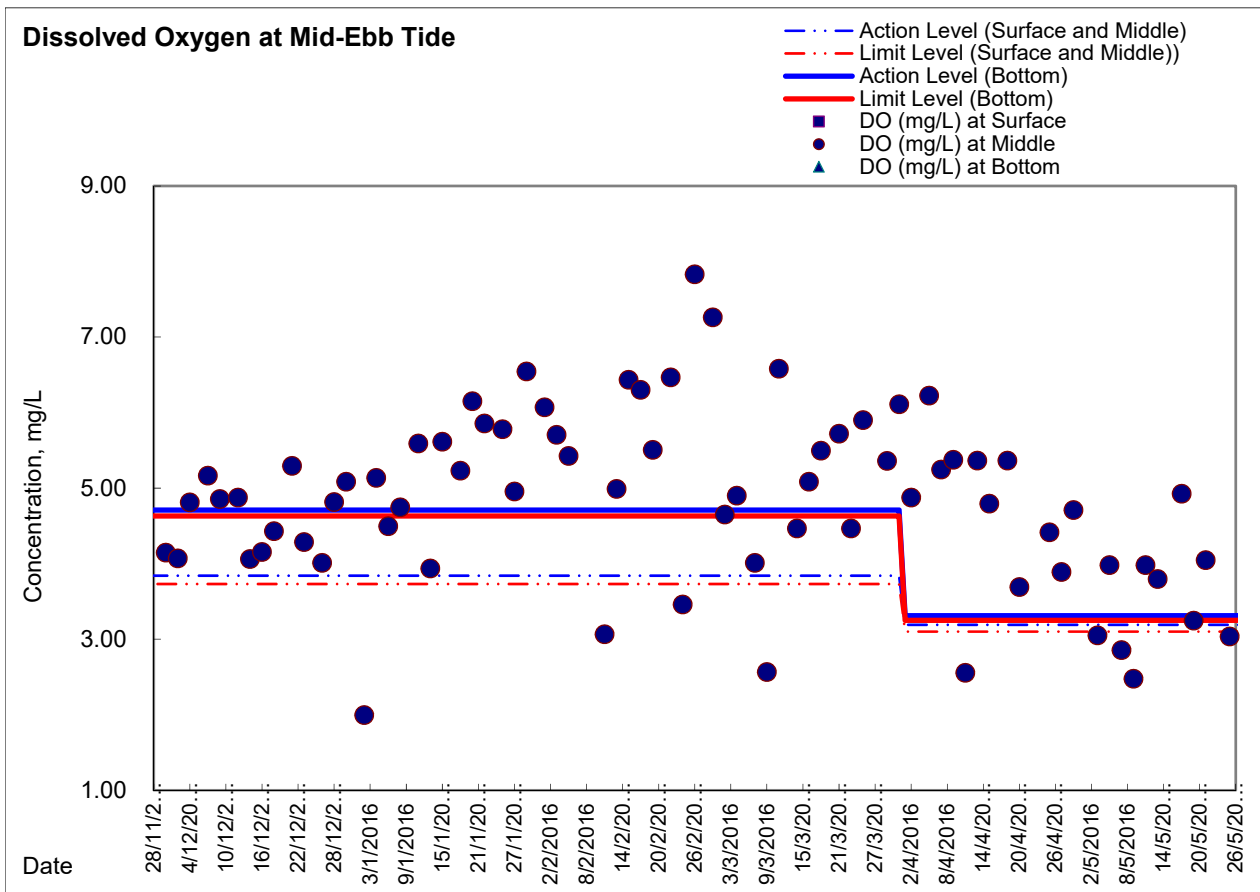
Graphic Presentation of Enhanced Water Monitoring Results (DO) at Ex-WPCWA SW - South-western corners of ex-Public Cargo Works Area

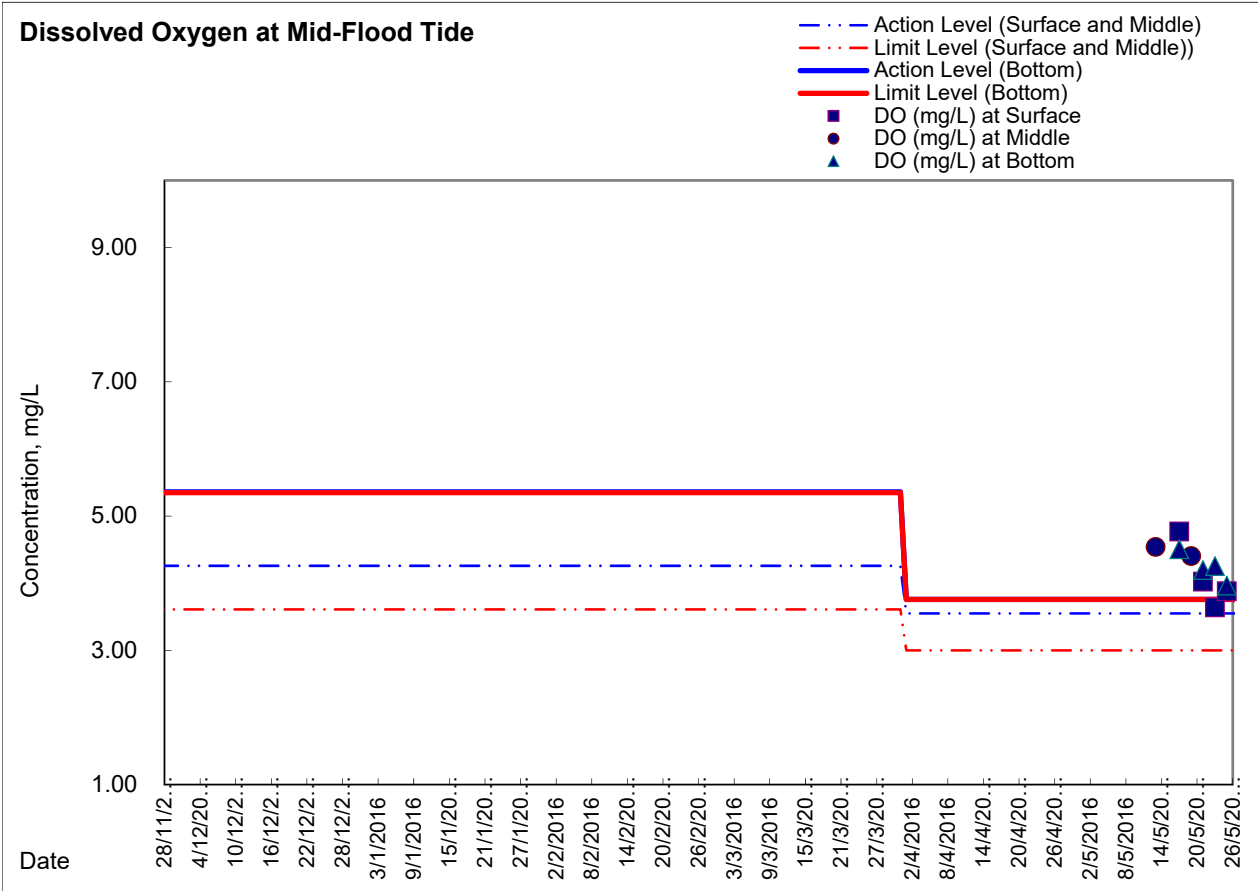
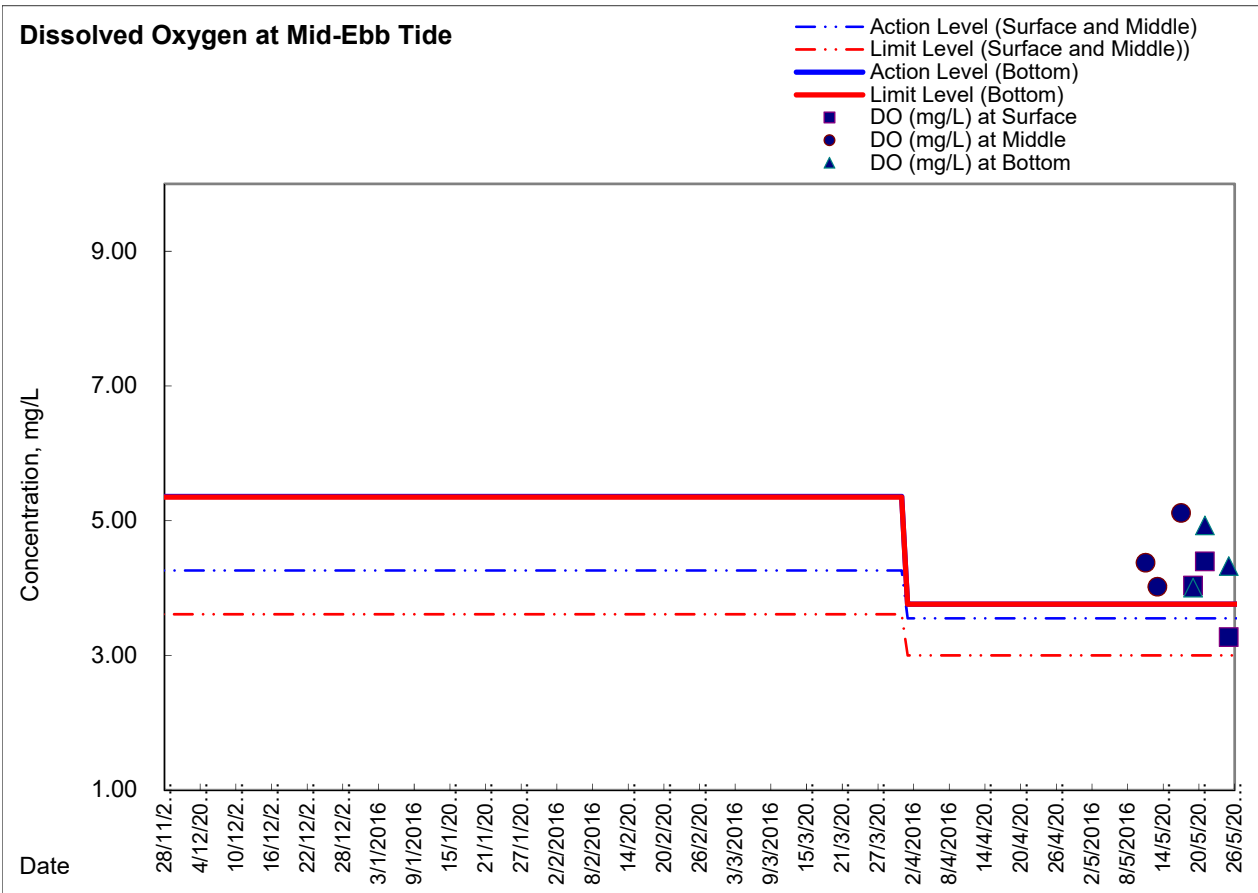
Graphic Presentation of Enhanced Water Monitoring Results (DO) at Ex-WPCWA SE - South-eastern corners of ex-Public Cargo Works Area
