Graphic Presentation of Water Quality Result of C4e - WCT and GEC (Eastern)

Graphic Presentation of Water Quality Result of C4w - WCT and GEC (Western)

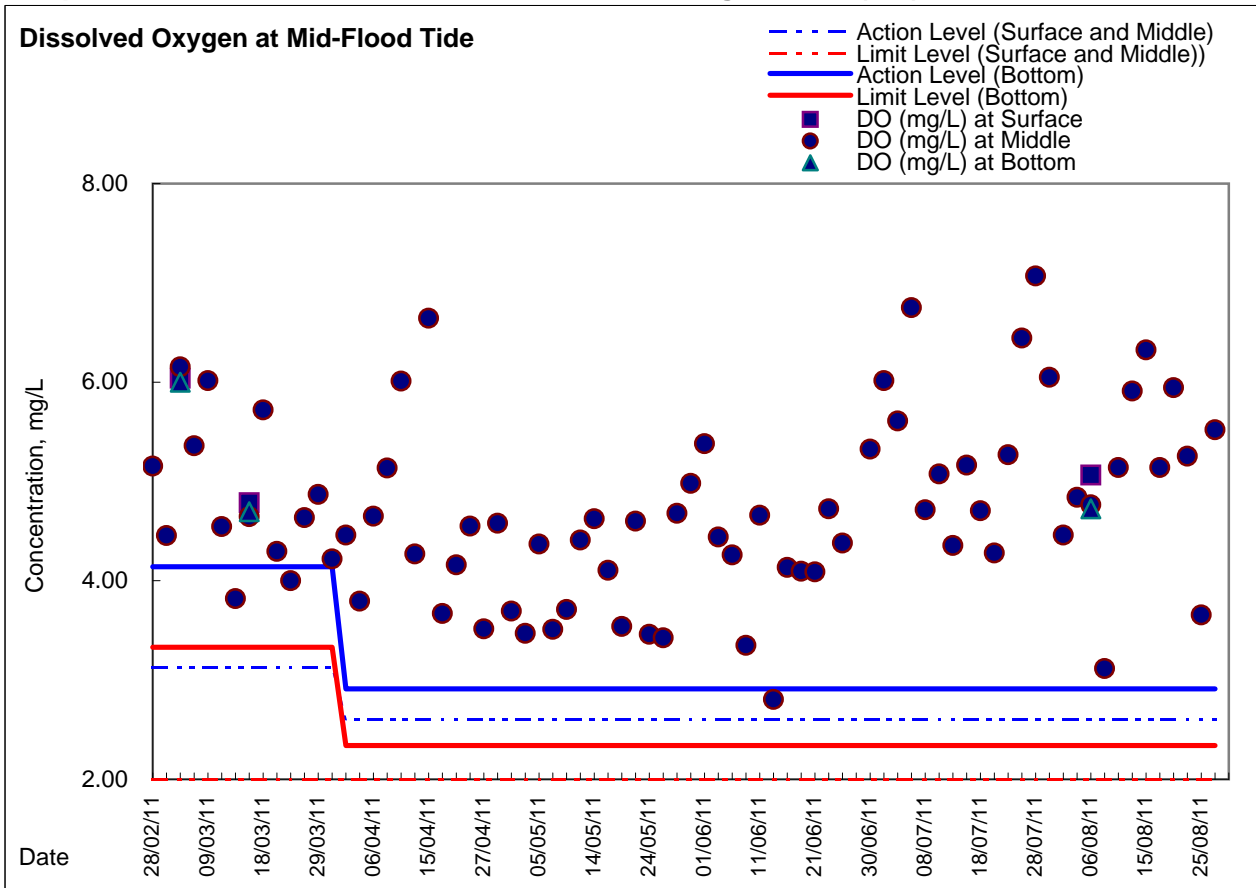
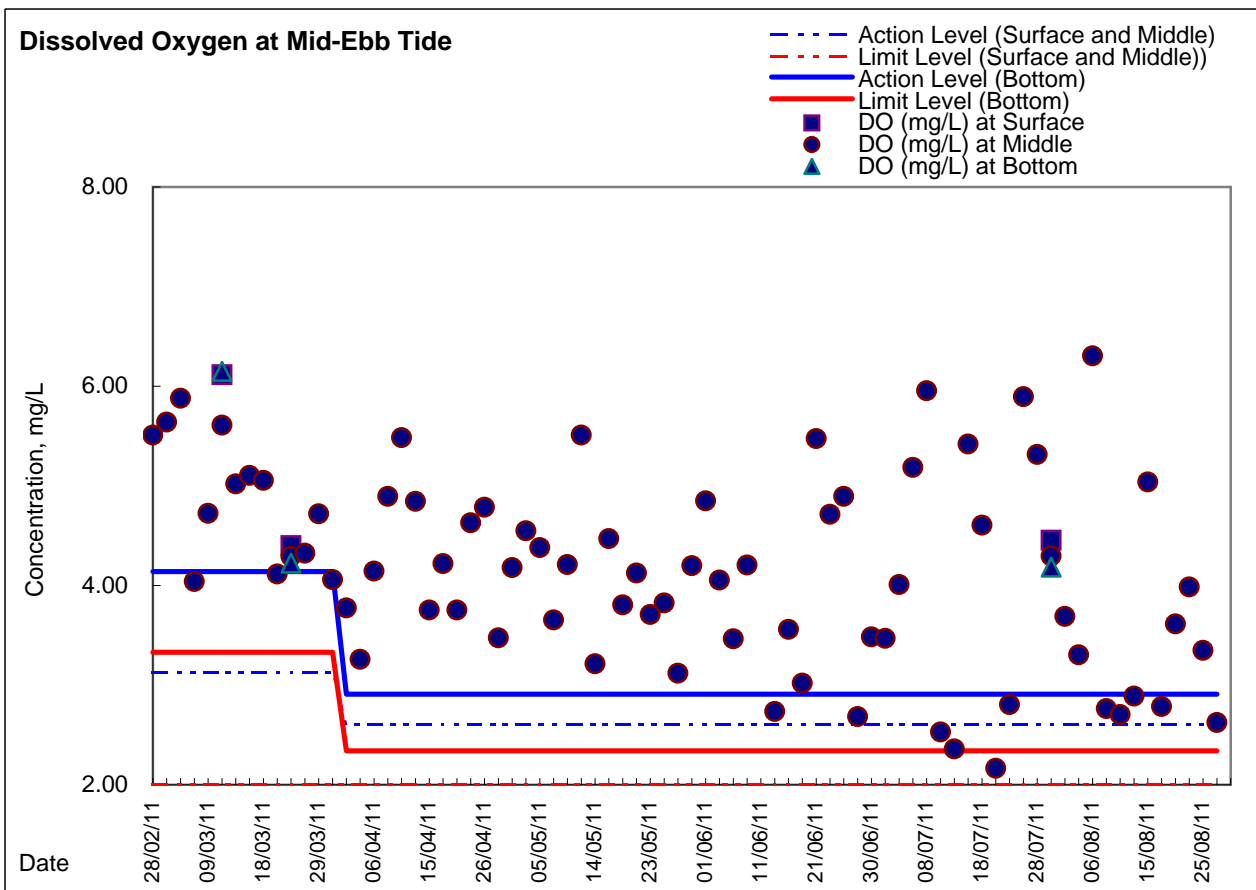
Graphic Presentation of Enhanced Water Monitoring Results (DO) at C6 - Excelsior Hotel

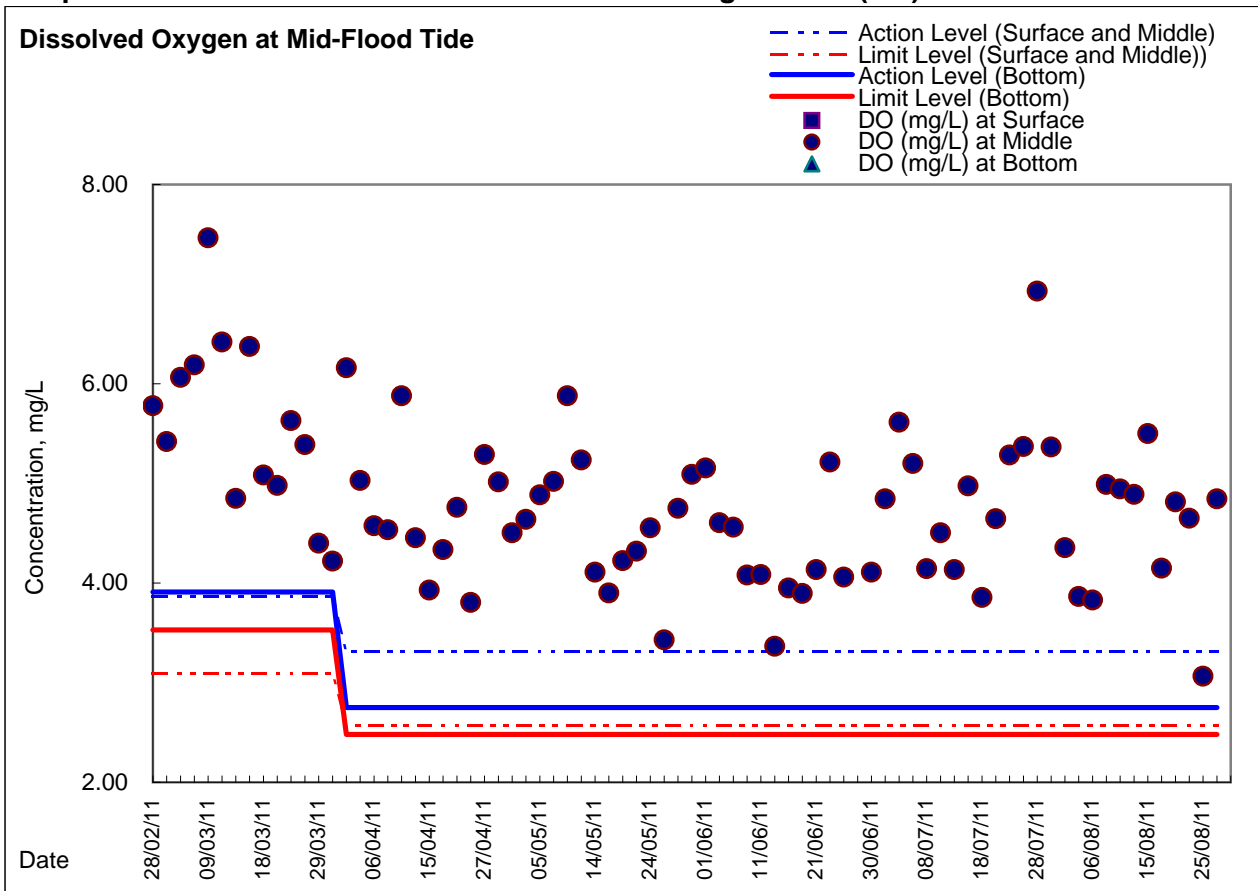
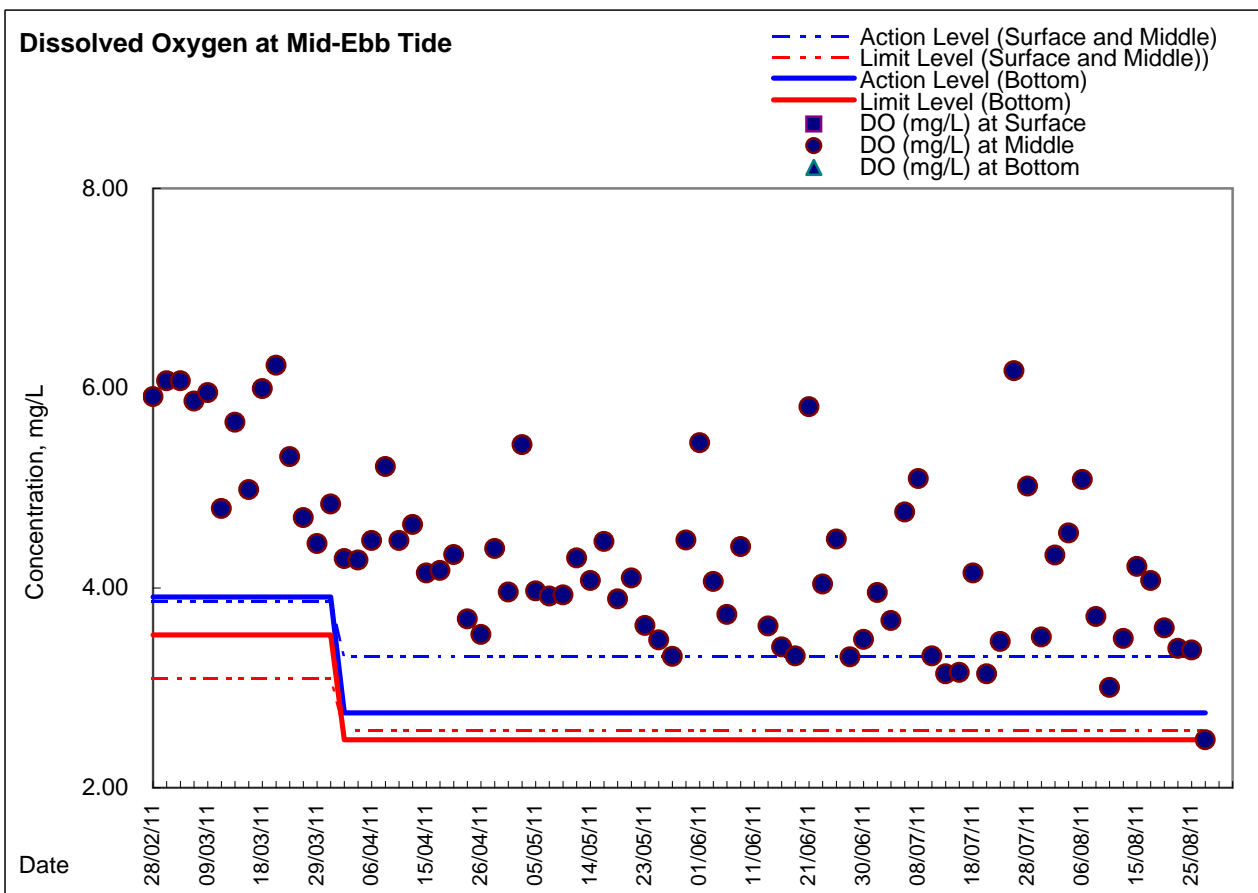
Graphic Presentation of Enhanced Water Monitoring Results (DO) at C7 - Windsor House

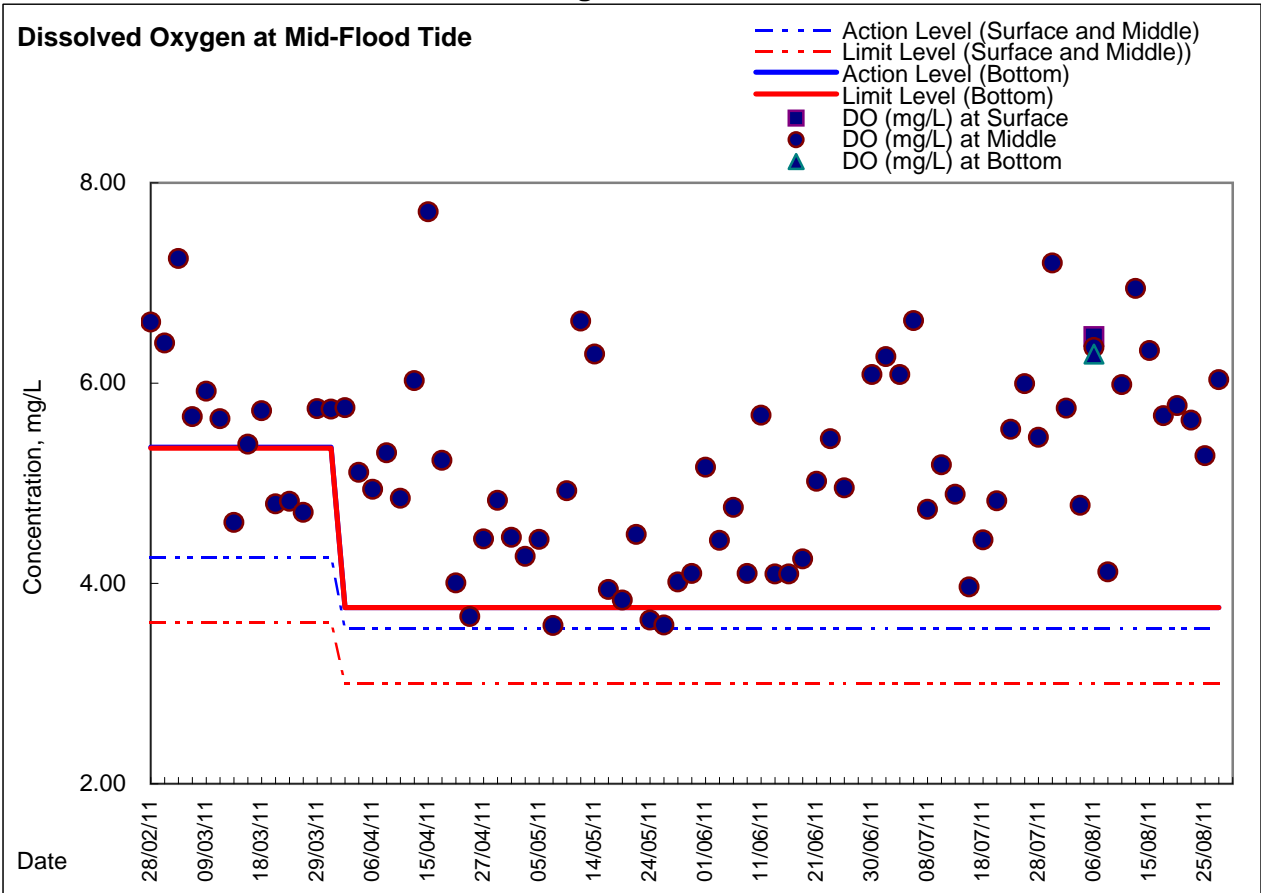
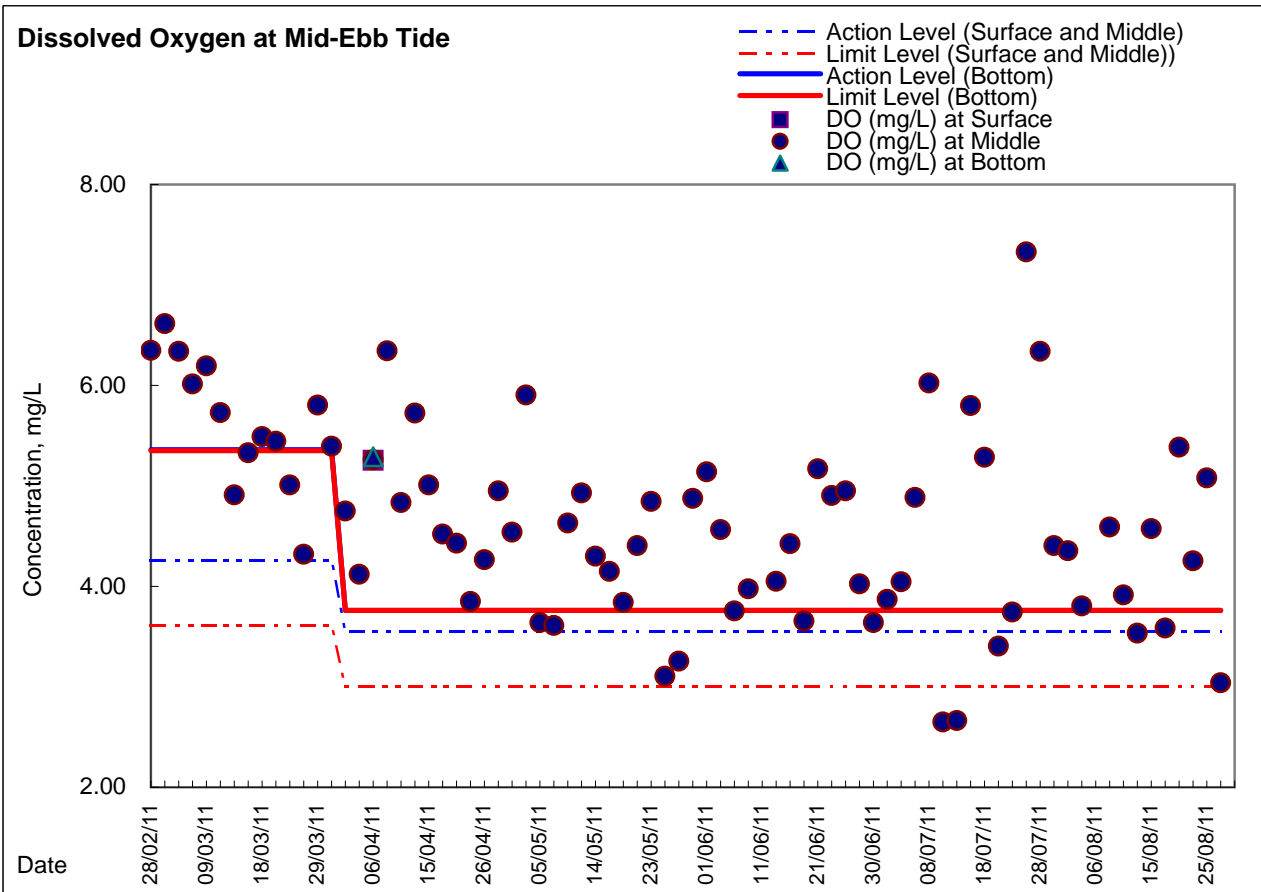
Graphic Presentation of Enhanced Water Monitoring Results (DO) at Ex-WPCWA SE - South-eastern corners of ex-Public Cargo Works Area

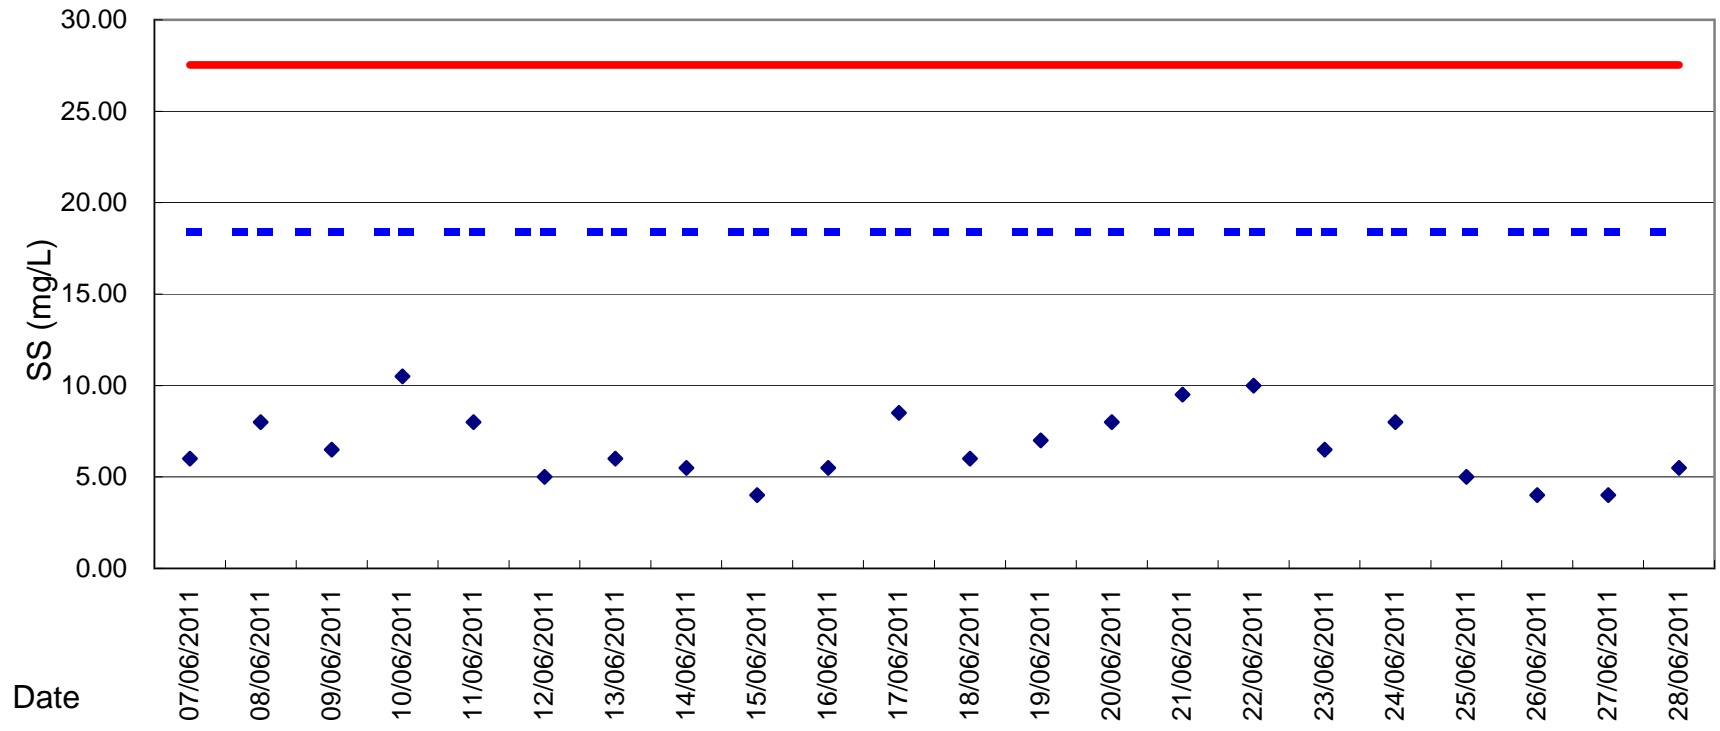
Daily SS Moniotring at C7 - Windsor House

- ◆ SS level (mg/L)
- - - Action Level
- Limit Level

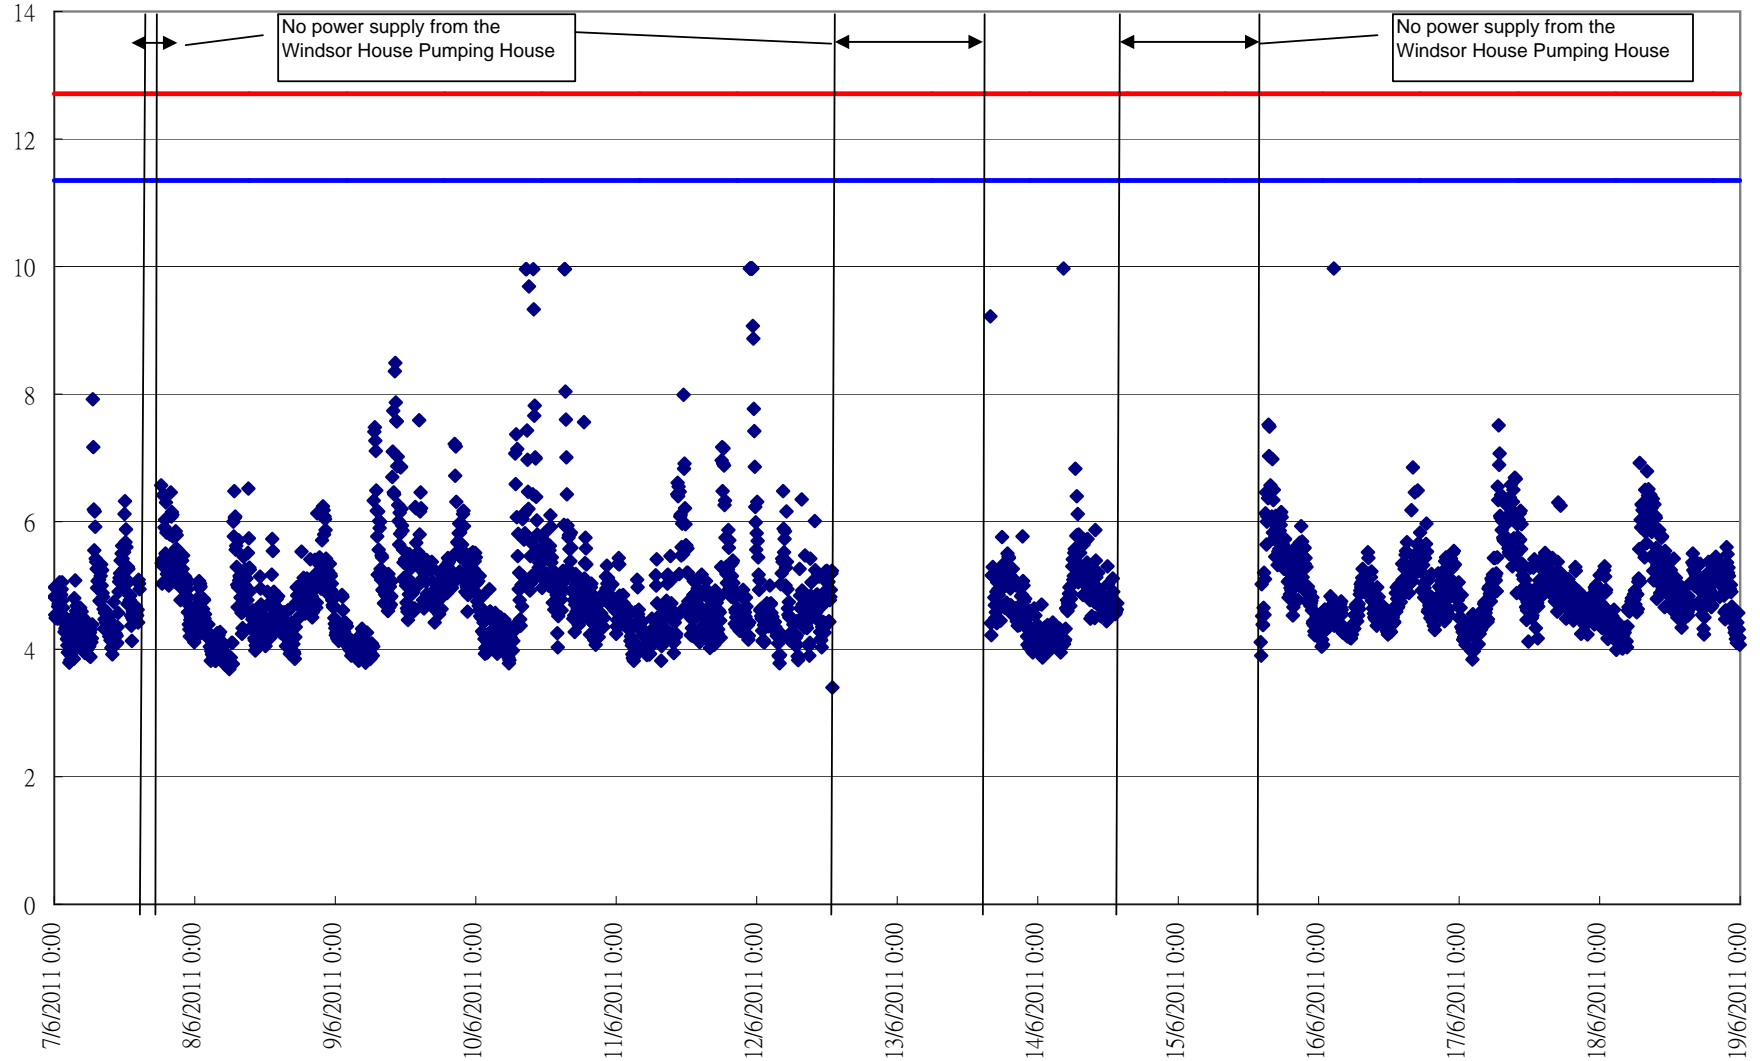
24hr Turbidity at C7 (NTU)

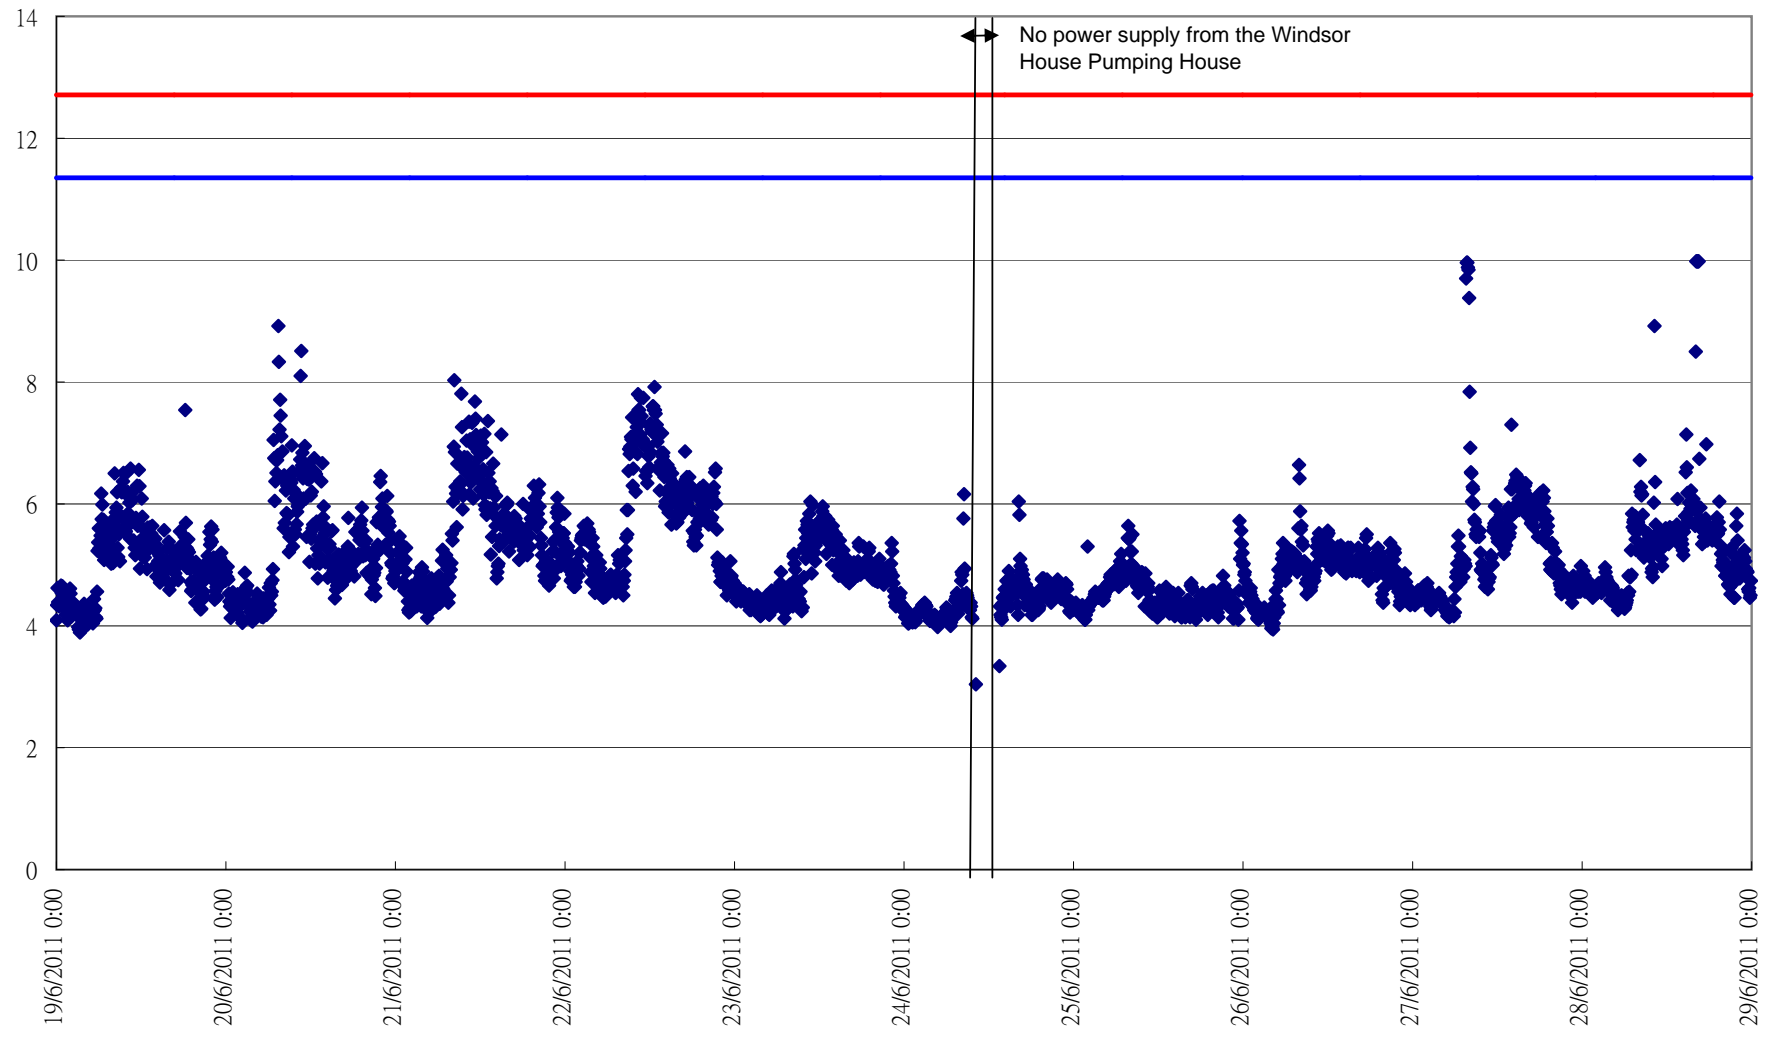
24hr Turbidity at C7 (NTU)
