Graphic Presentation of Real Time Noise Monitoring Result (RTN2a- Hong Kong Electric Centre)

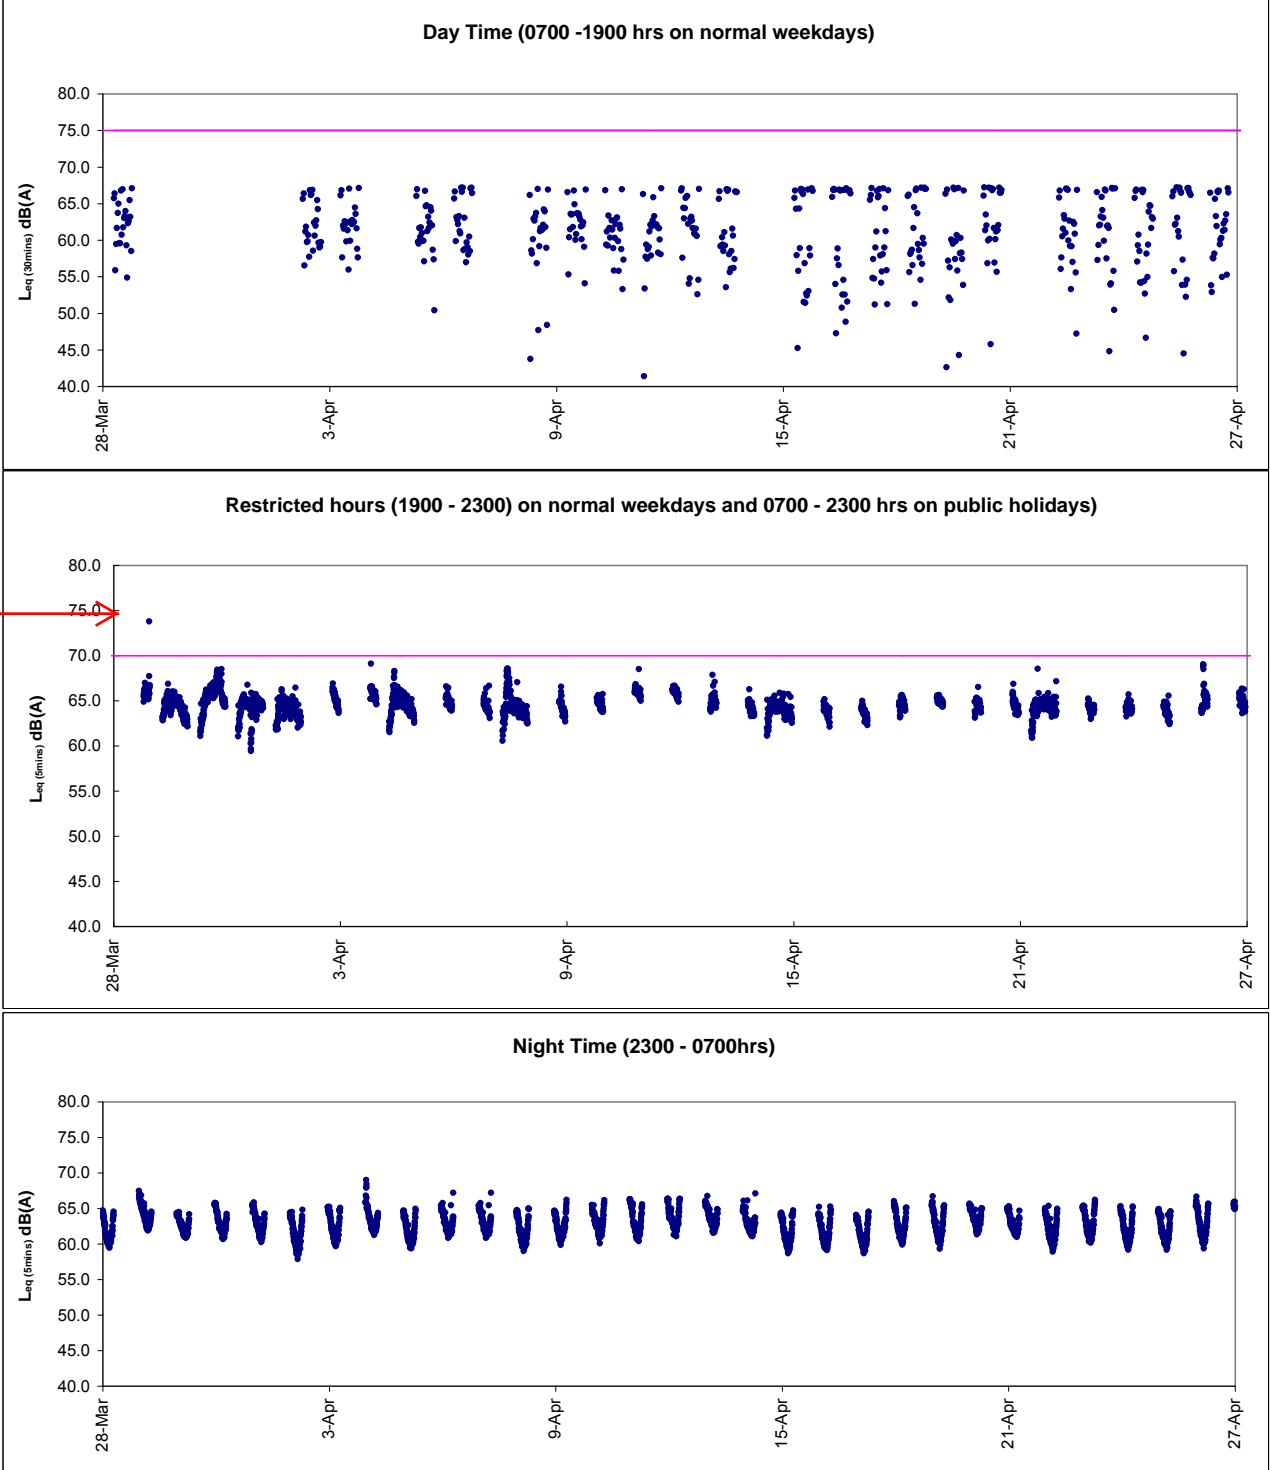
Graphic Presentation of Real Time Noise Monitoring Result (RTN2a- Hong Kong Electric Centre)

After checking with contractor HY/2009/19, no noisy construction activities were conducted during the recorded period and the exceedance was non-continuous. Exceedances were considered to be contributed by nearby IEC traffic

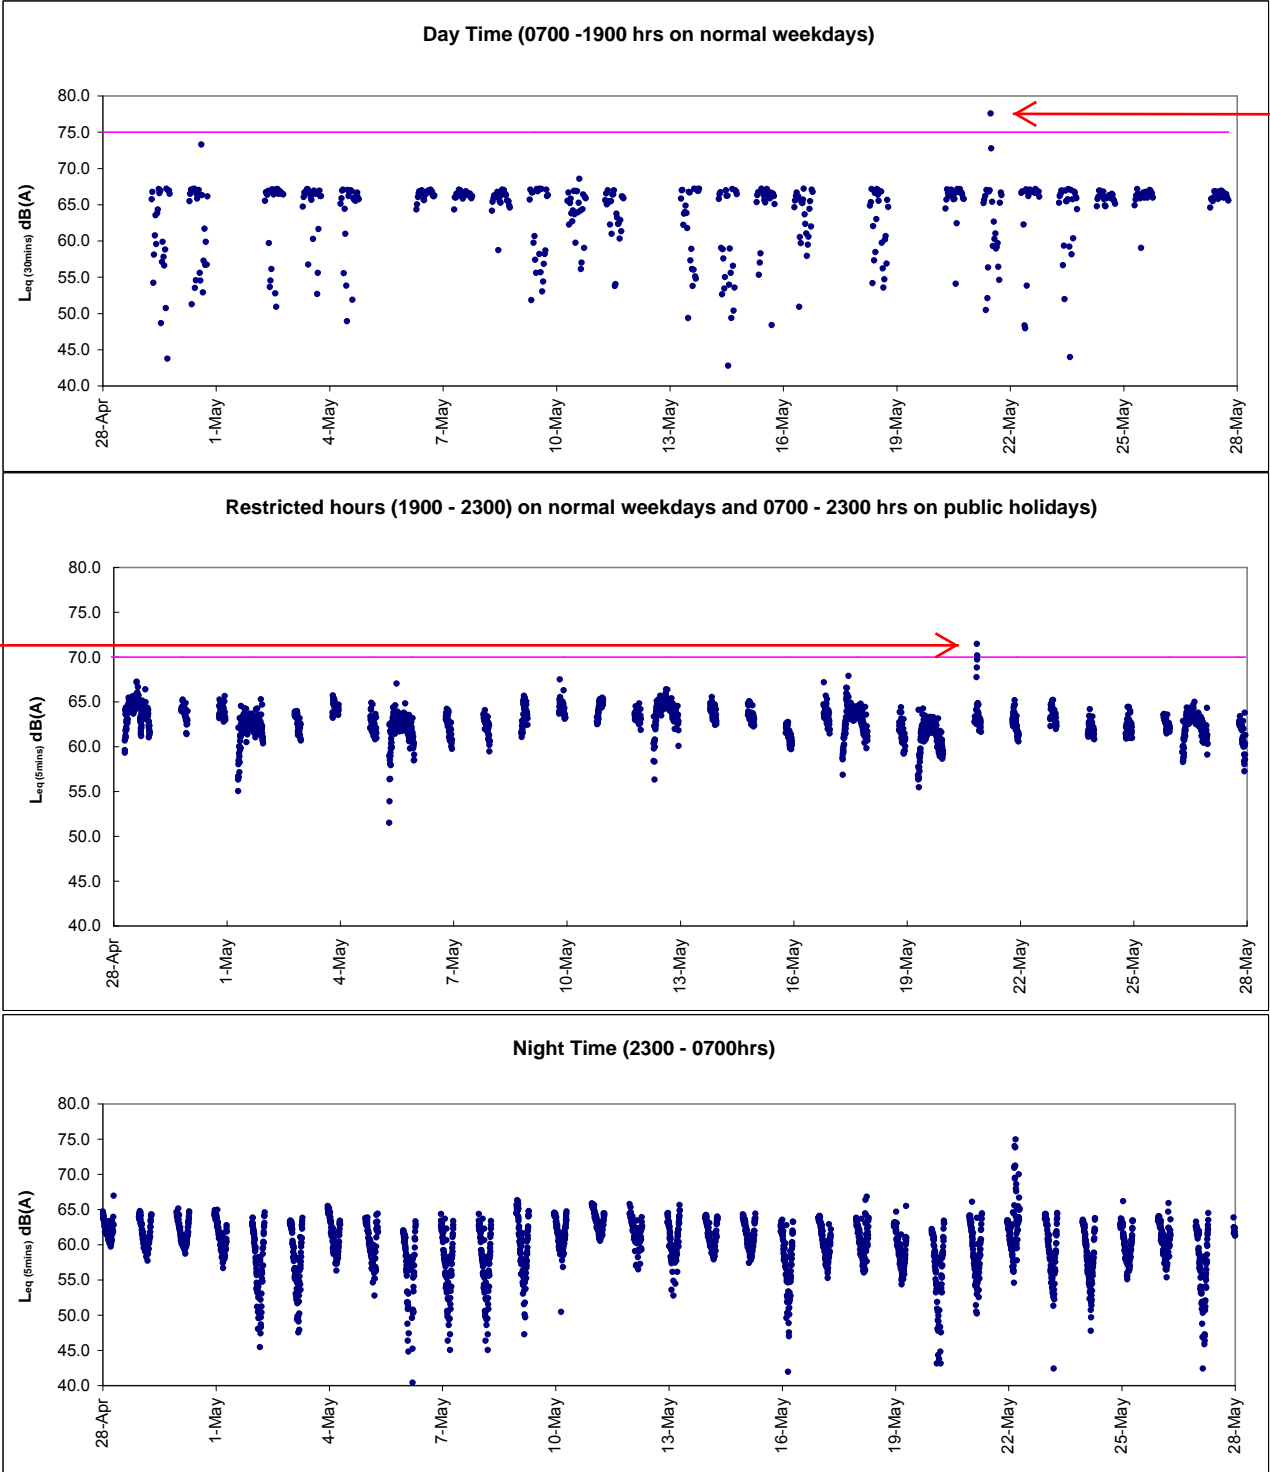
Graphic Presentation of Real Time Noise Monitoring Result (RTN2a- Hong Kong Electric Centre)

After checking with contractor HY/2009/19, no construction works were conducted at the concerned location during the recorded period. As such, the exceedances were considered to be contributed by nearby IEC traffic

After checking with contractor HY/2009/19, no noisy construction works were conducted at the concerned location during the recorded period and the exceedance was non-continuous. As such, the exceedances were considered to be contributed by nearby IEC traffic
