Graphic Presentation of Real Time Noise Monitoring Result (RTN2a- Hong Kong Electric Centre)

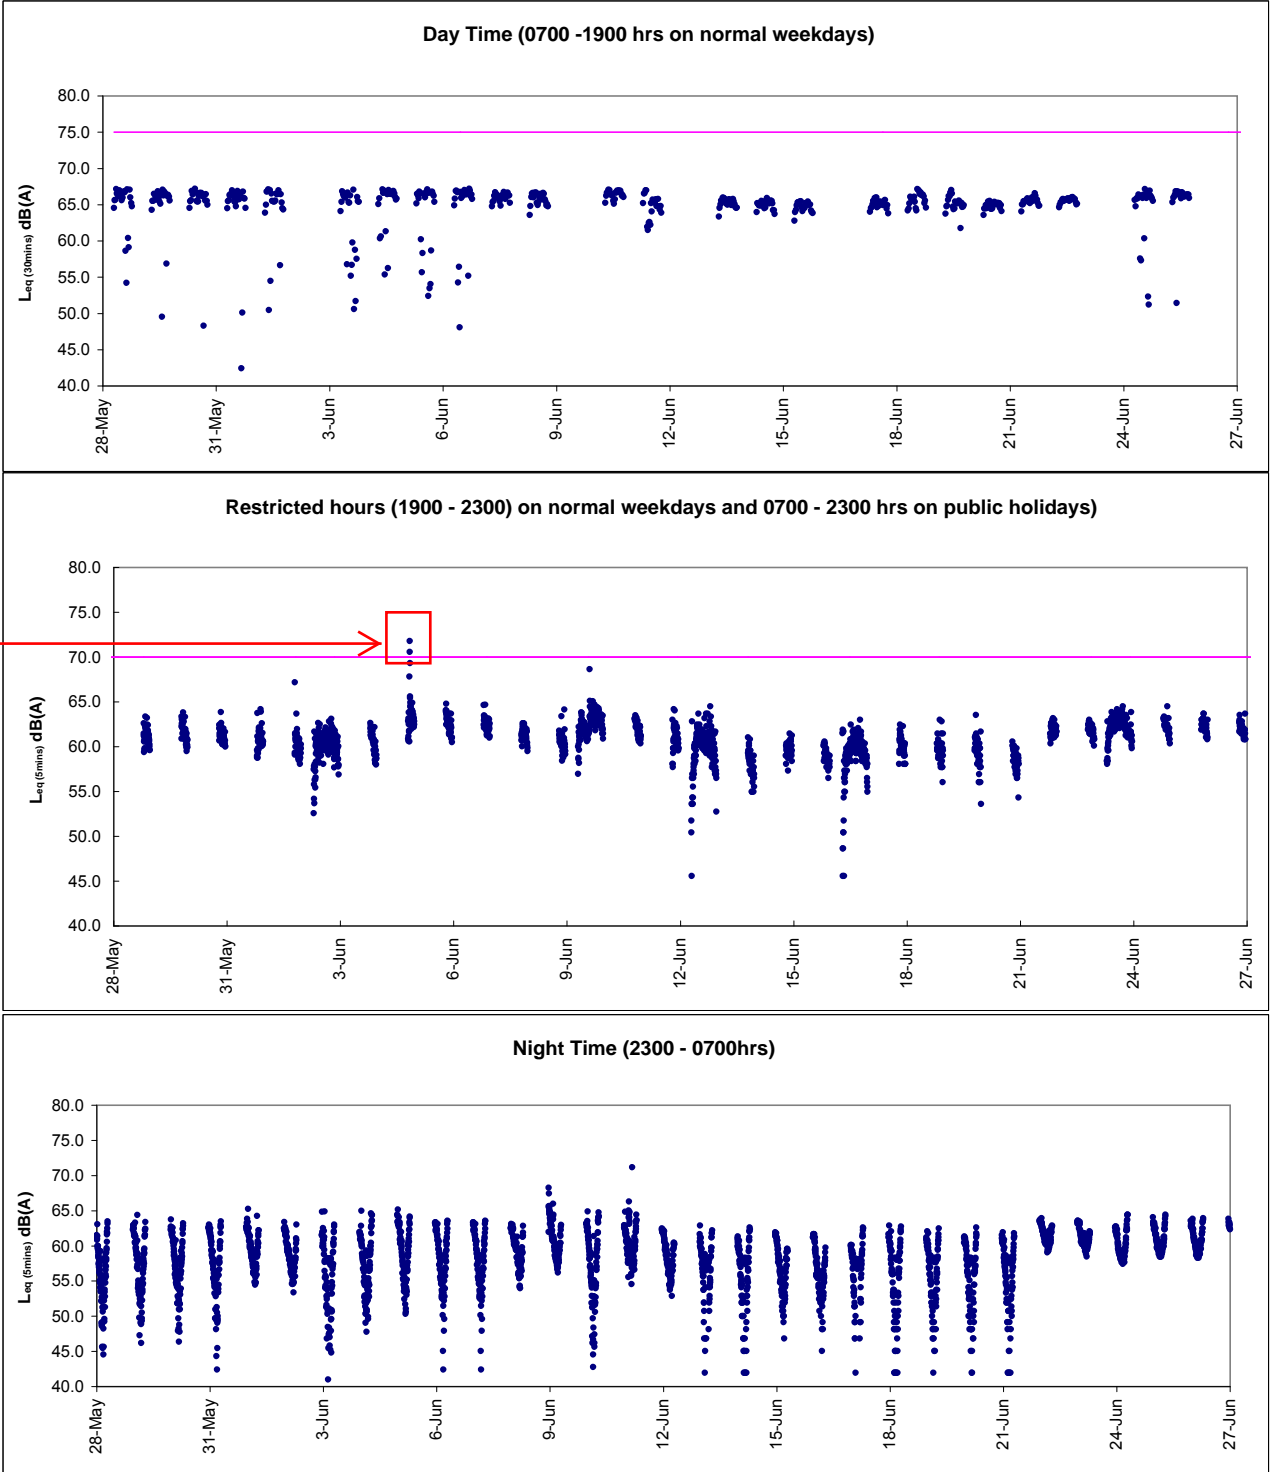
After checking with contractor HY/2009/19, no construction works was conducted during the recorded period. As such, the exceedances were considered as non- project related and contributed by nearby IEC traffic

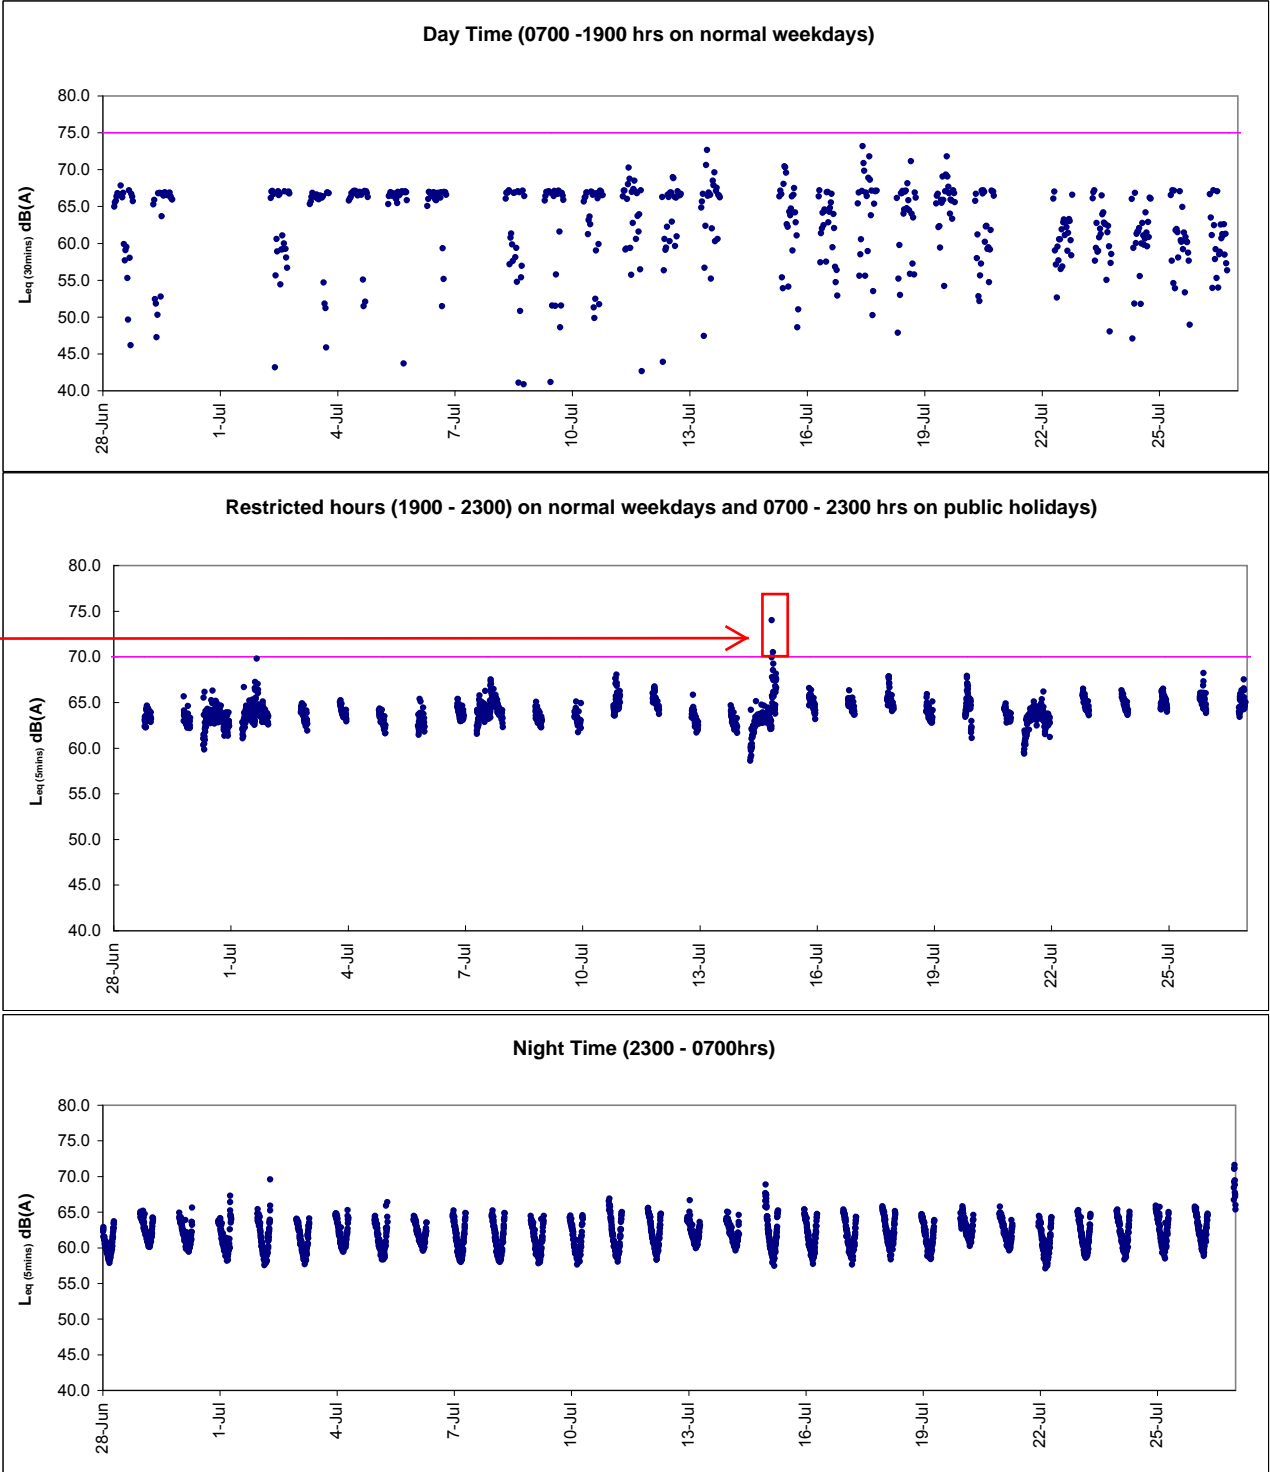
Graphic Presentation of Real Time Noise Monitoring Result (RTN2a- Hong Kong Electric Centre)

After checking with contractor HY/2009/19, no construction works were conducted at the concerned location during the recorded period. As such, the exceedances were considered to be contributed by nearby IEC traffic

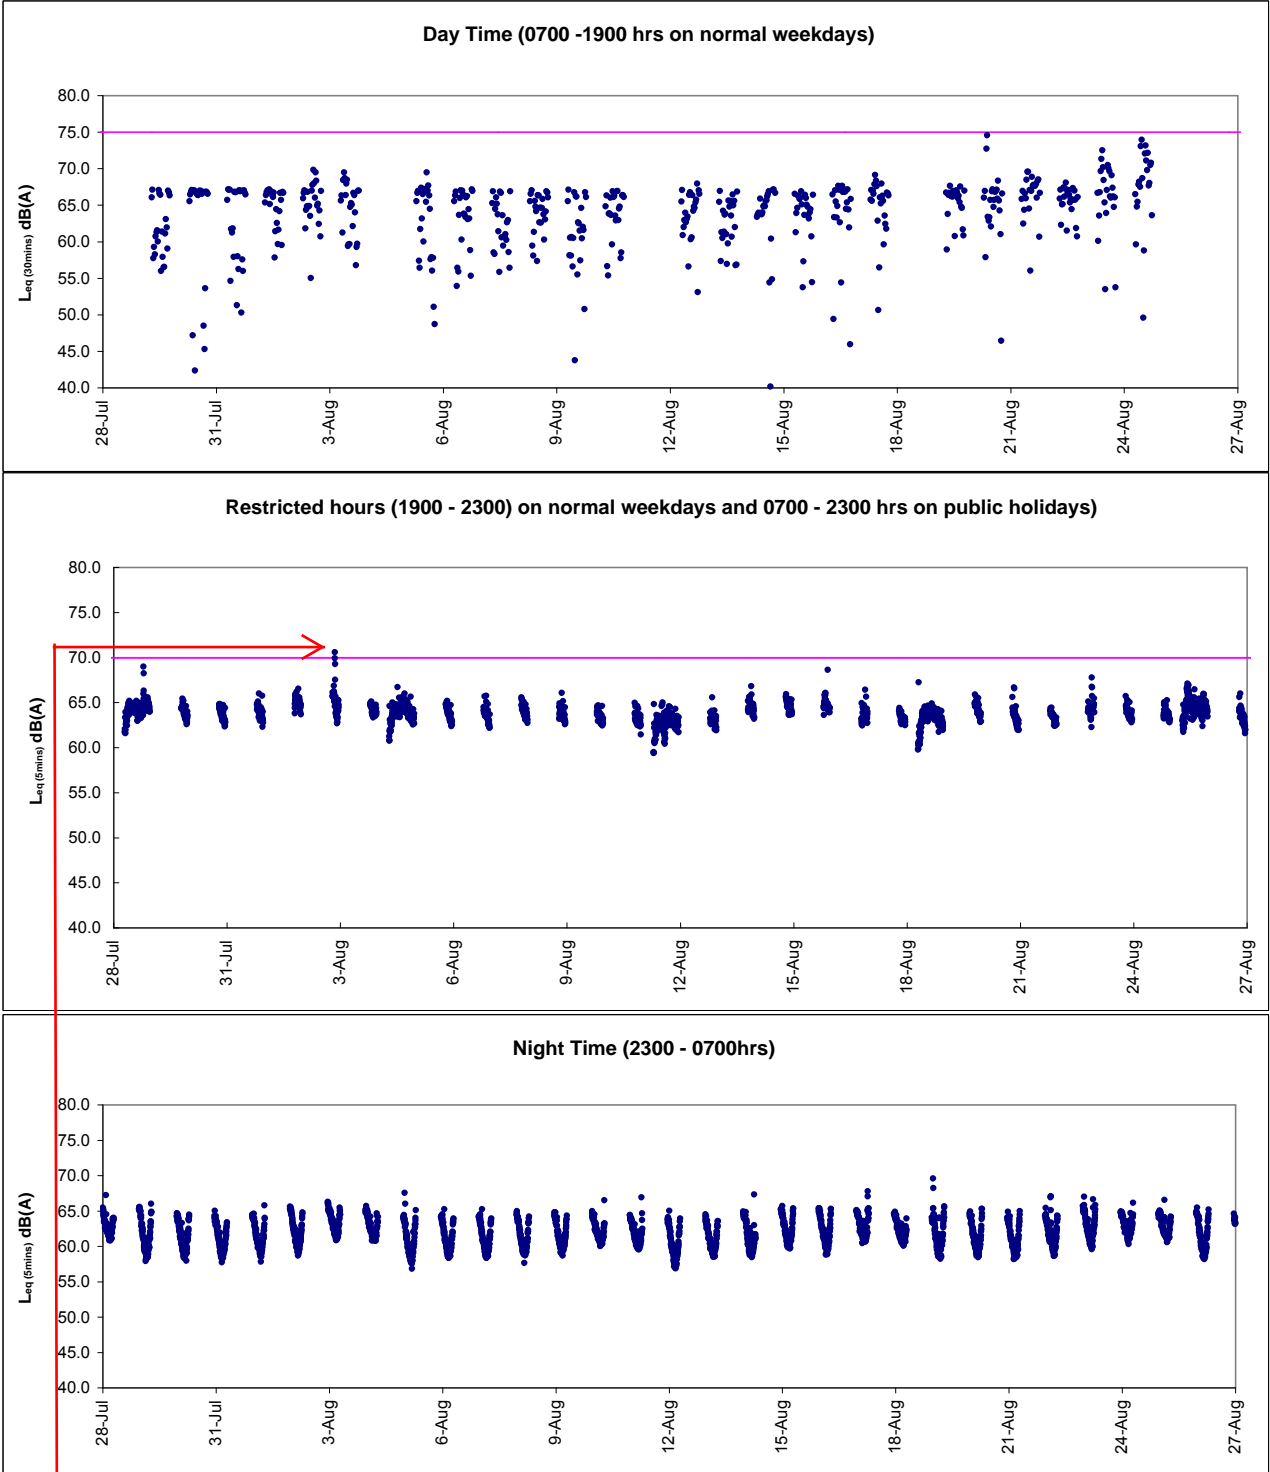
Graphic Presentation of Real Time Noise Monitoring Result (RTN2a- Hong Kong Electric Centre)

After checking with contractor HY/2009/19, no major noisy construction works were conducted at the concerned location during the recorded period and the exceedance was non-continuous. As such, the exceedances were considered to be contributed by nearby IEC traffic
