Graphic Presentation of Real Time Noise Monitoring Result (RTN2a- Hong Kong Electric Centre)

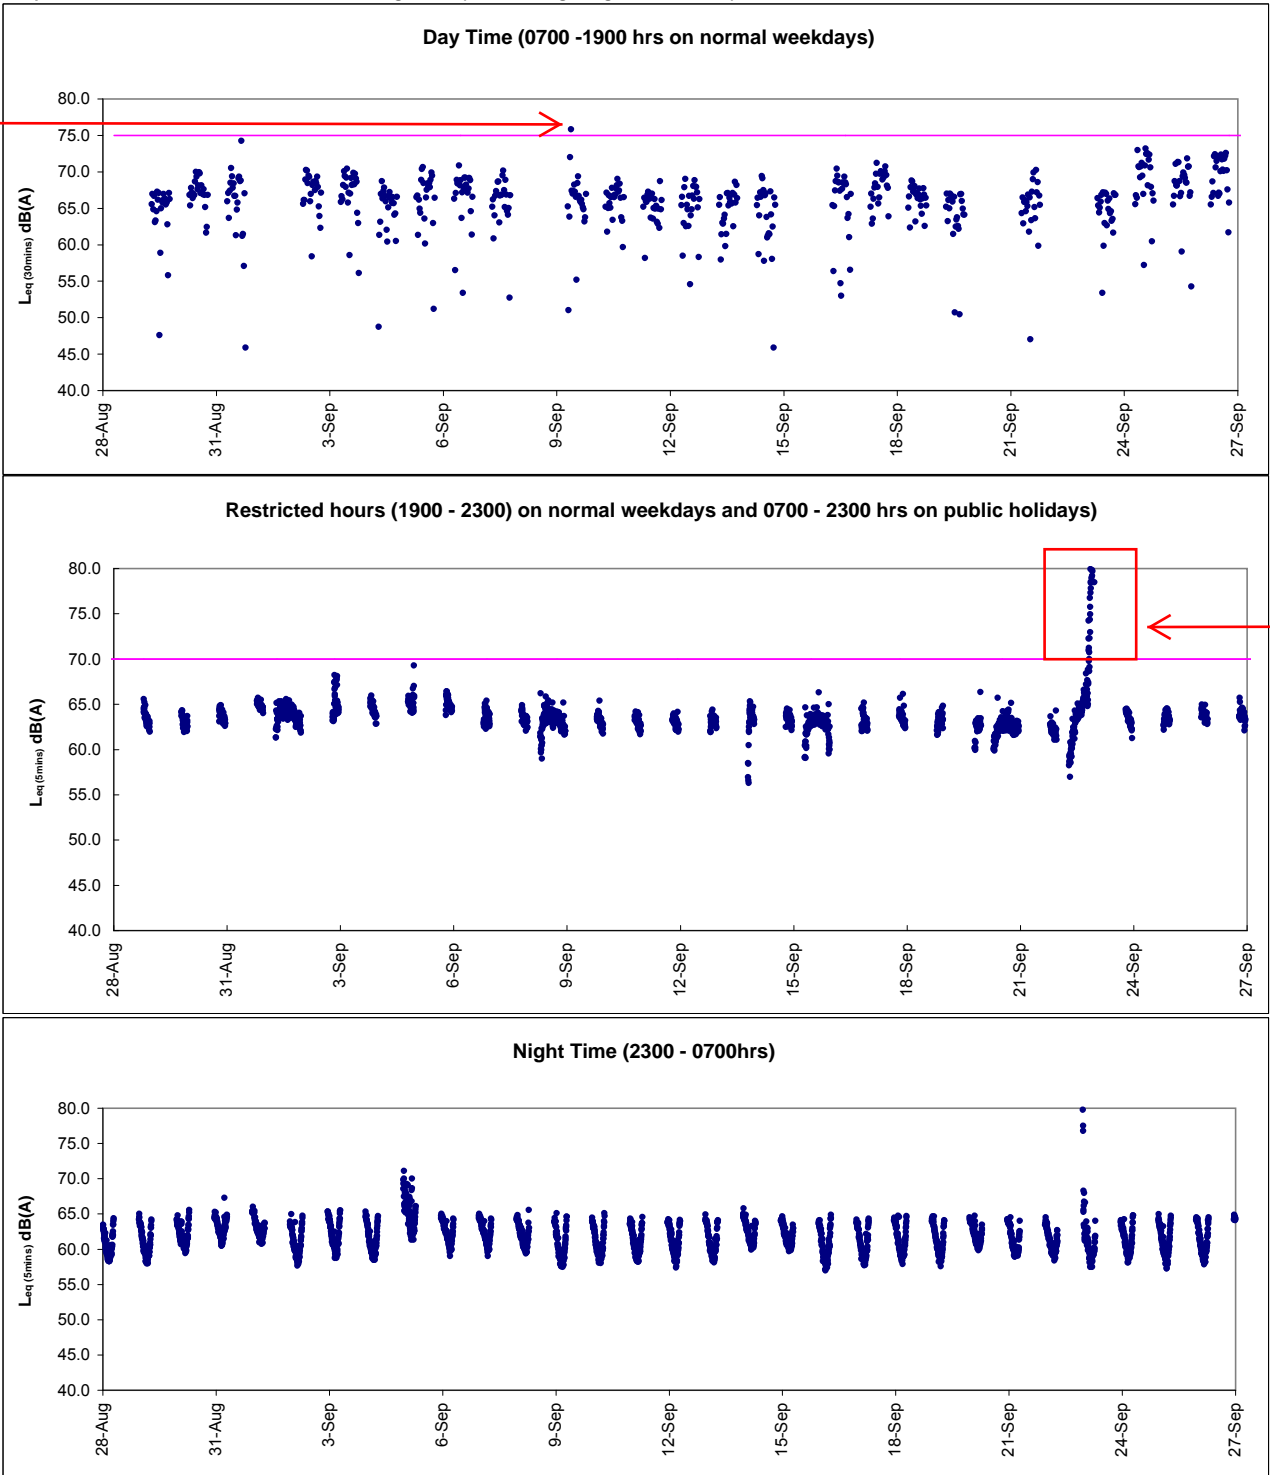
After checking with contractor HY/2009/19, no major noisy construction works were conducted at the concerned location during the recorded period and the exceedance was non-continuous. As such, the exceedances were considered to be contributed by nearby IEC traffic

After checking with contractor HY/2009/19, no construction work was conducted at the concerned location during the recorded period. The continuous exceedances were considered to be contributed by adverse weather condition during hoisting of Gale warning signal.

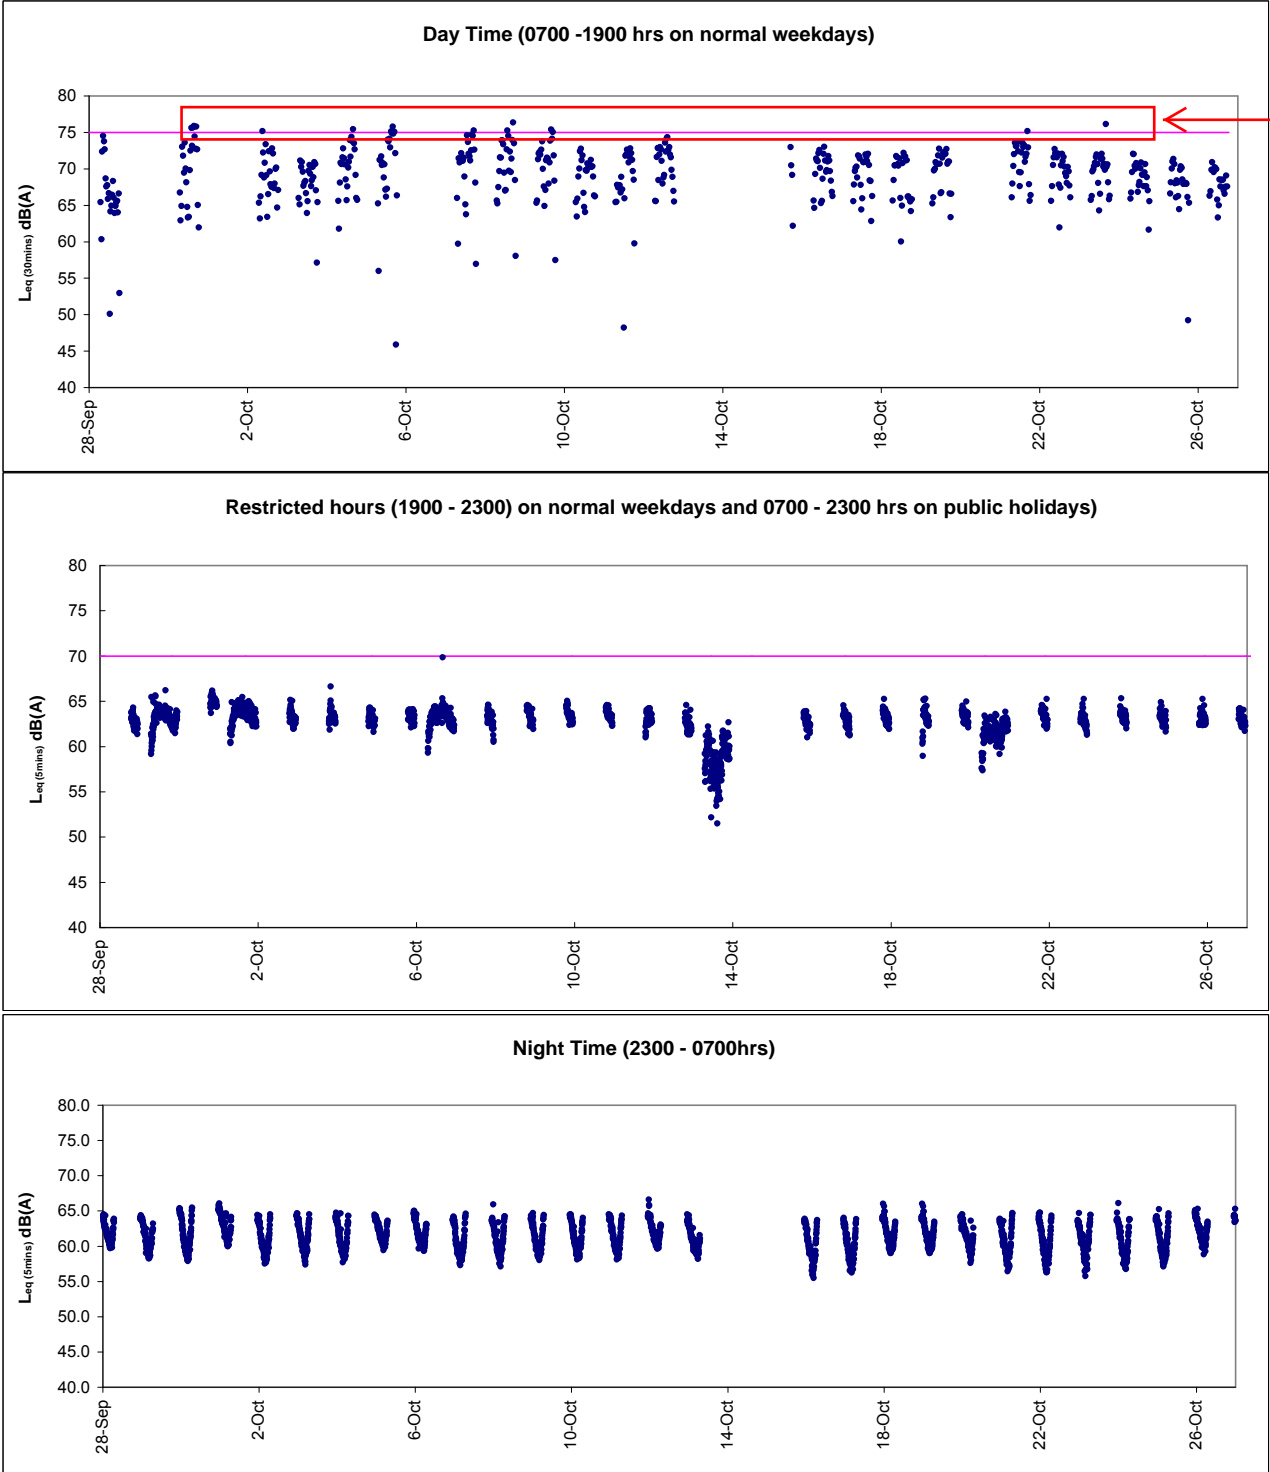
Graphic Presentation of Real Time Noise Monitoring Result (RTN2a- Hong Kong Electric Centre)

After checking with contractor HY/2009/19, no major noisy construction works were conducted at the concerned location during the recorded period. On-going Breaking works and piling works was observed undertaken at adjacent non-CWB Project construction sites. As such, the exceedances were considered to be contributed by non-CWB Project works.

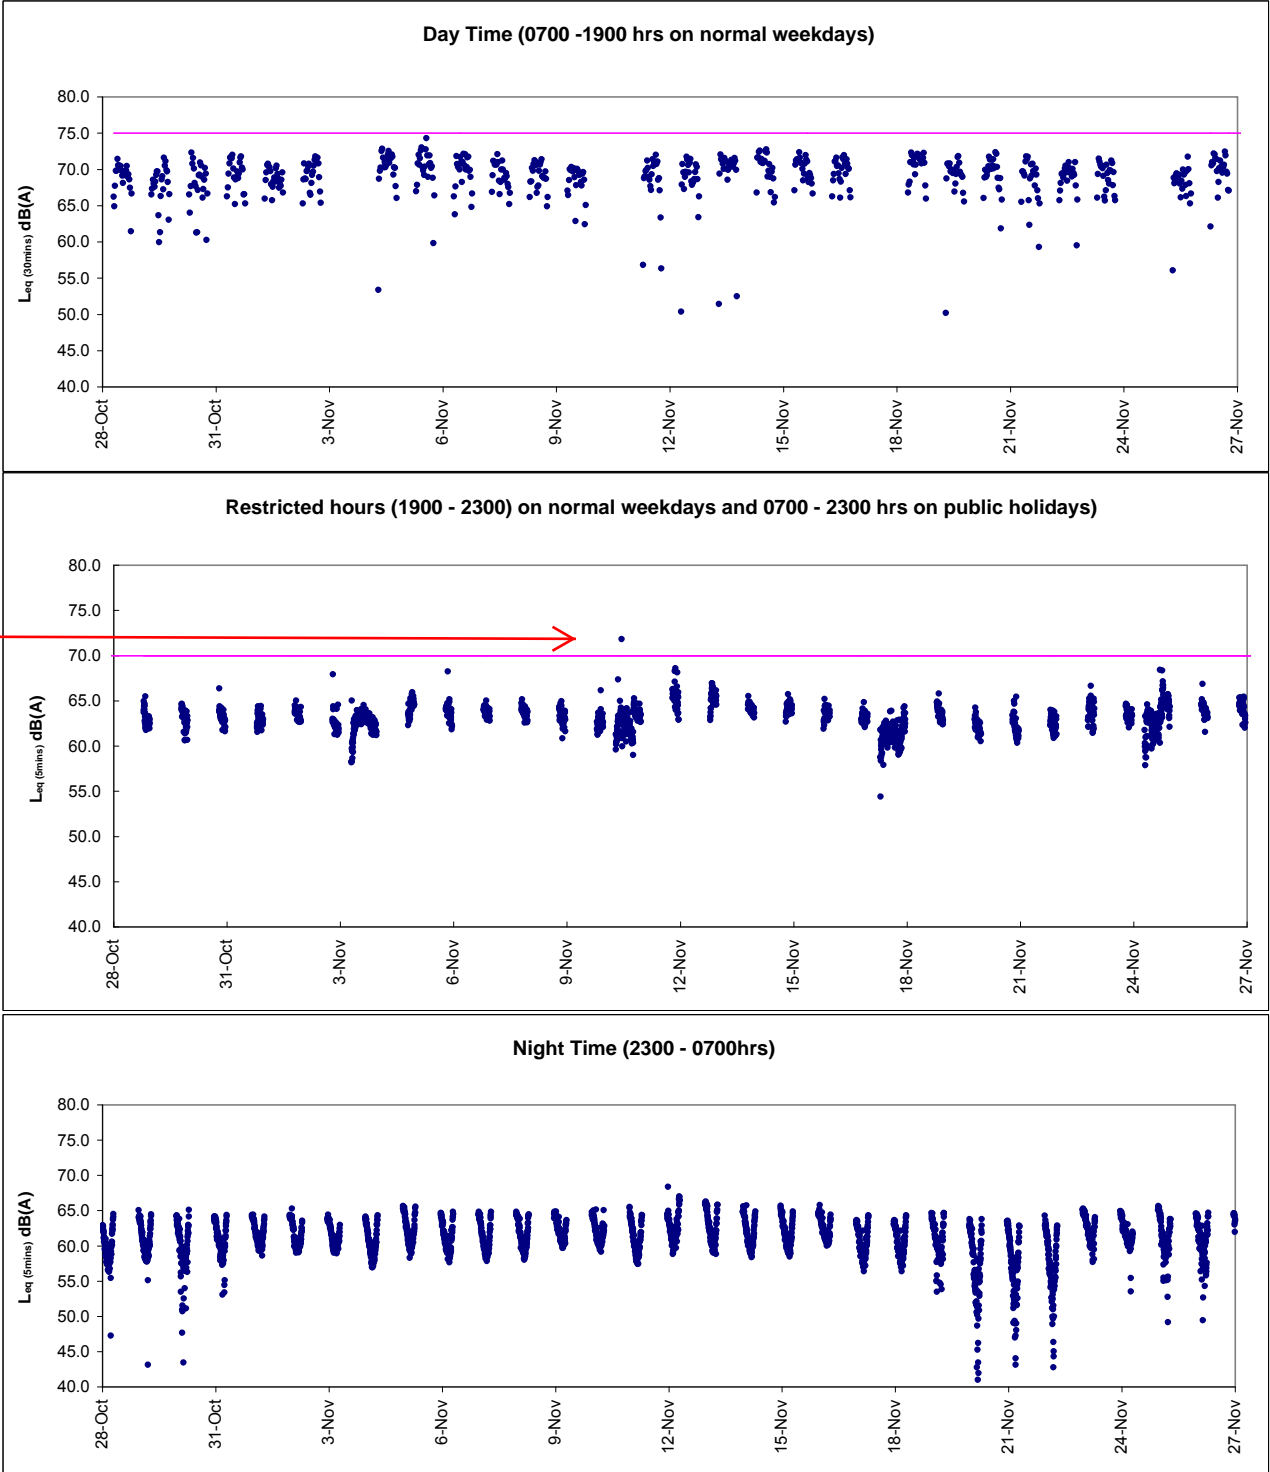
Graphic Presentation of Real Time Noise Monitoring Result (RTN2a- Hong Kong Electric Centre)

After checking with contractor HY/2009/19, no construction works were conducted at the concerned location during the recorded period . As such, the exceedances were considered to be contributed by nearby IEC traffic
