Graphic Presentation of Real Time Noise Monitoring Result (RTN2a- Hong Kong Electric Centre)

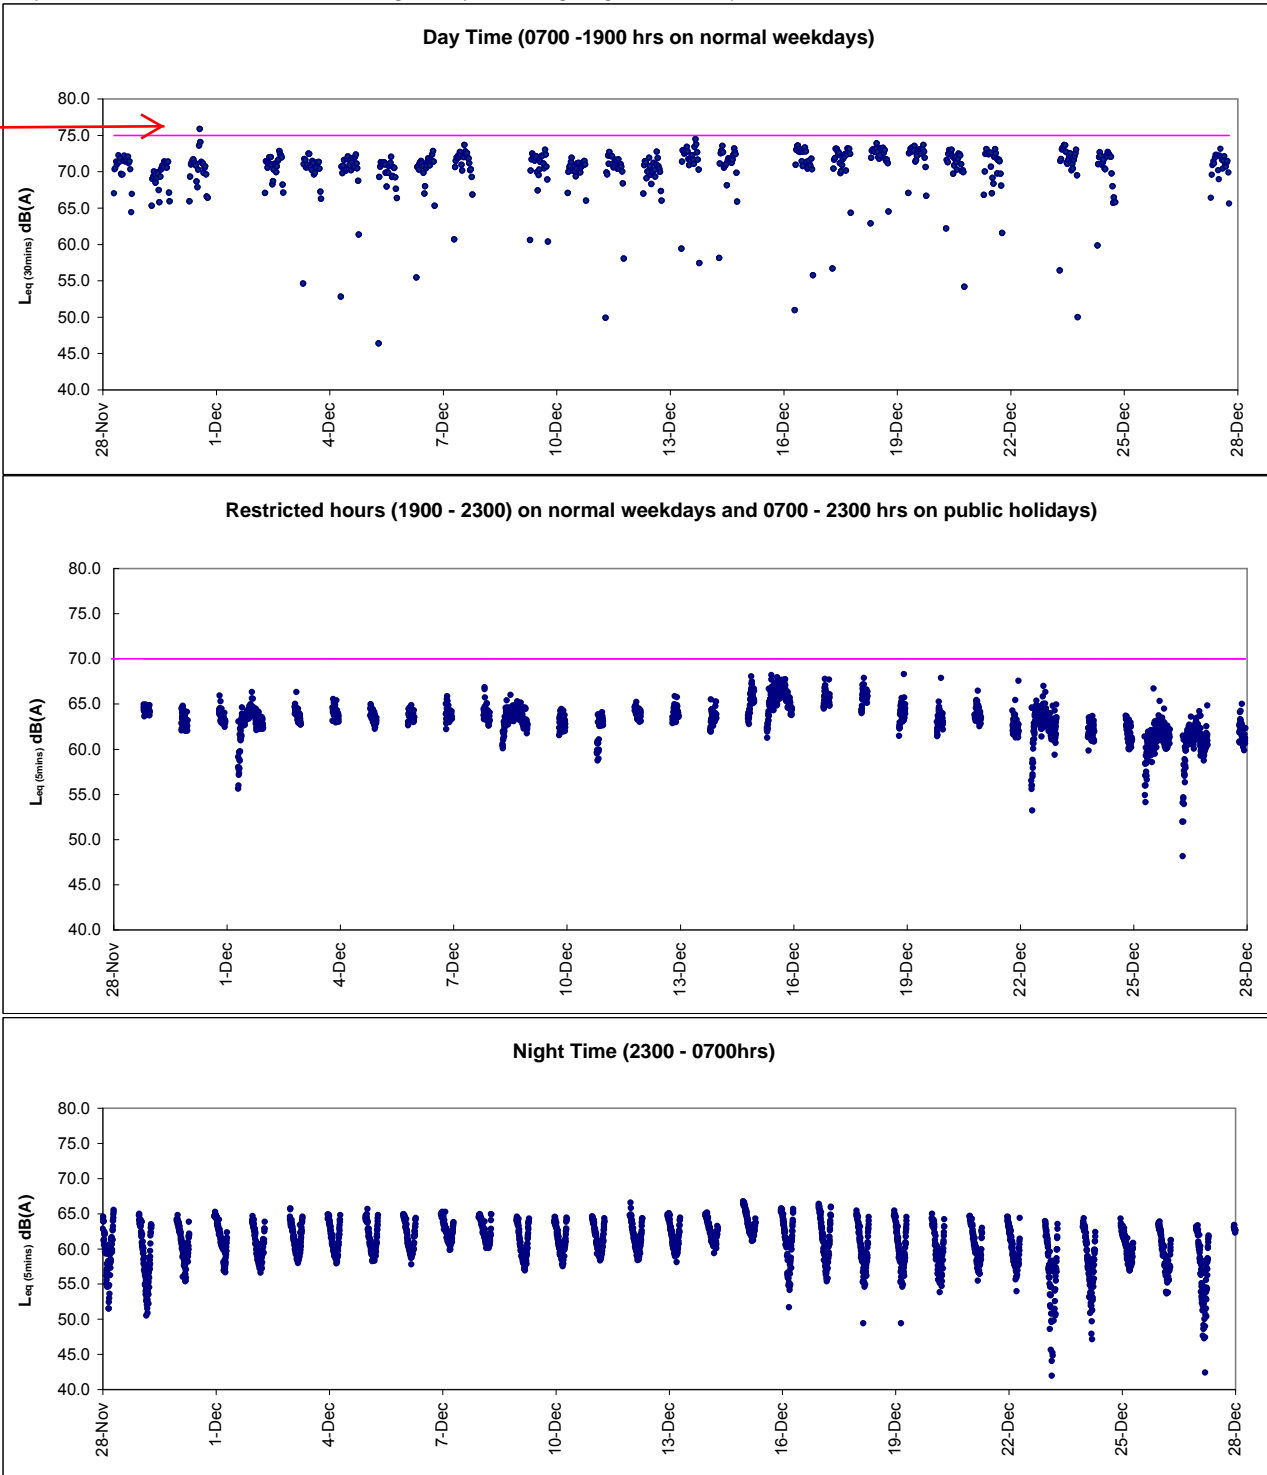
After checking with contractor HY/2009/19, no major noisy construction works were conducted at the concerned location during the recorded period and contractor mitigation measures including erection of temporary noise barrier was confirmed in place. As the exceedance is non-continuous, the exceedances were considered to be contributed by nearby IEC traffic and nearby non- CWB Projects.

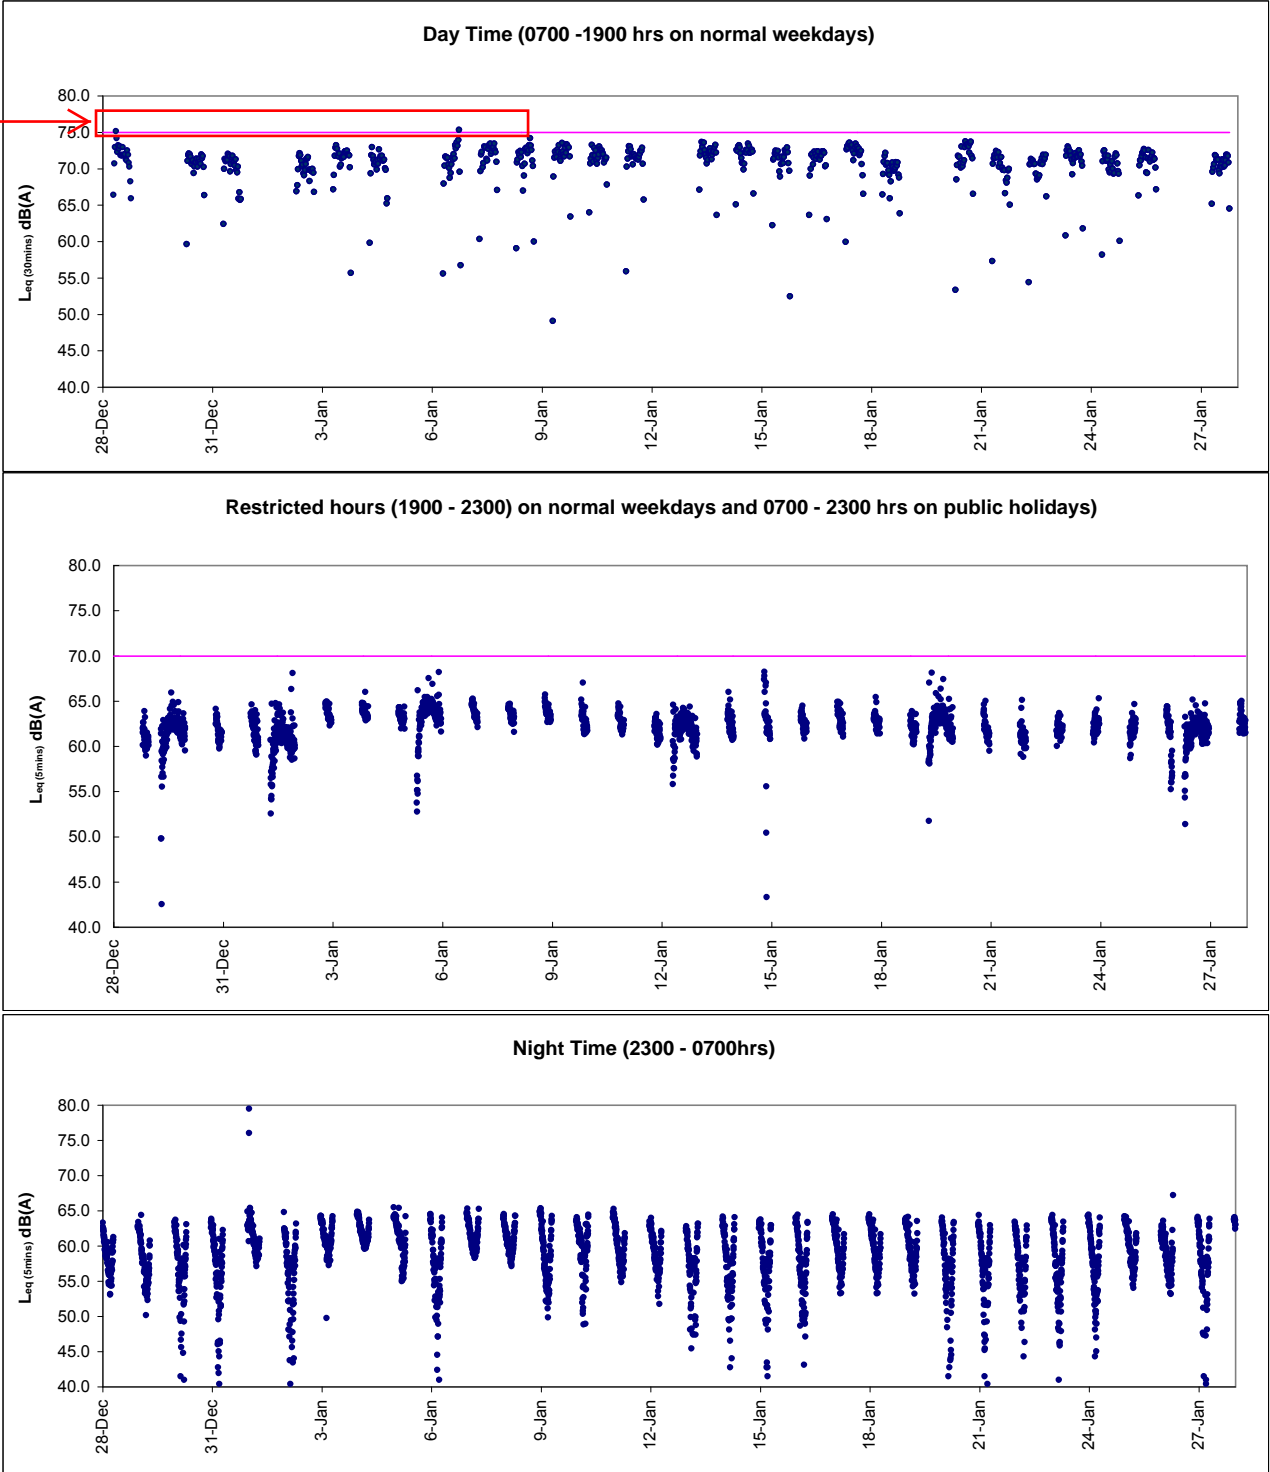
Graphic Presentation of Real Time Noise Monitoring Result (RTN2a- Hong Kong Electric Centre)

After checking with contractor HY/2009/19, no major noisy construction works were conducted at the concerned location during the recorded period. As the exceedance is non-continuous, the exceedances were considered to be contributed by nearby IEC traffic and nearby non- CWB Projects.

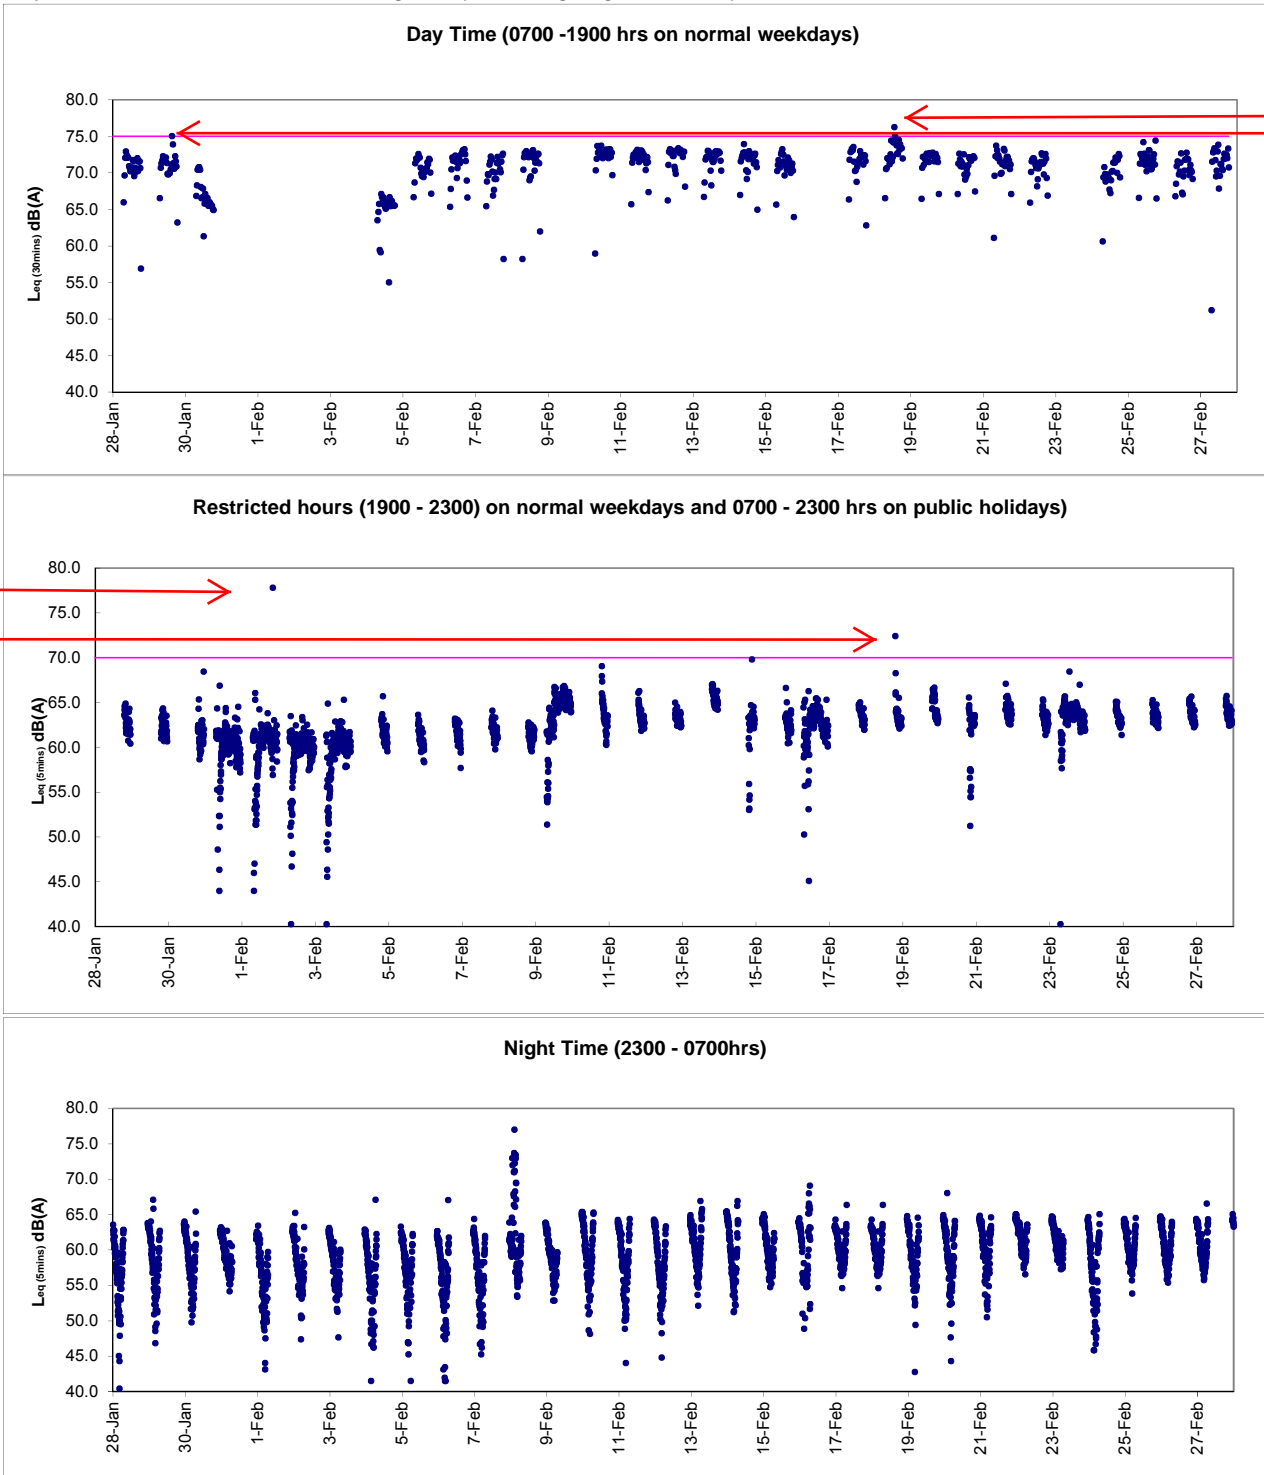
Graphic Presentation of Real Time Noise Monitoring Result (RTN2a- Hong Kong Electric Centre)

After checking with contractor HY/2009/19, no construction activities were conducted at the concerned location during the recorded period. The exceedances were considered to be contributed by nearby IEC traffic.

After checking with contractor HY/2009/19, no major noisy construction activities were conducted at the concerned location during the recorded period. The exceedances were non-continuous and were considered to be contributed by nearby IEC traffic.
