Graphic Presentation of Real Time Noise Monitoring Result (RTN2a- Hong Kong Electric Centre)

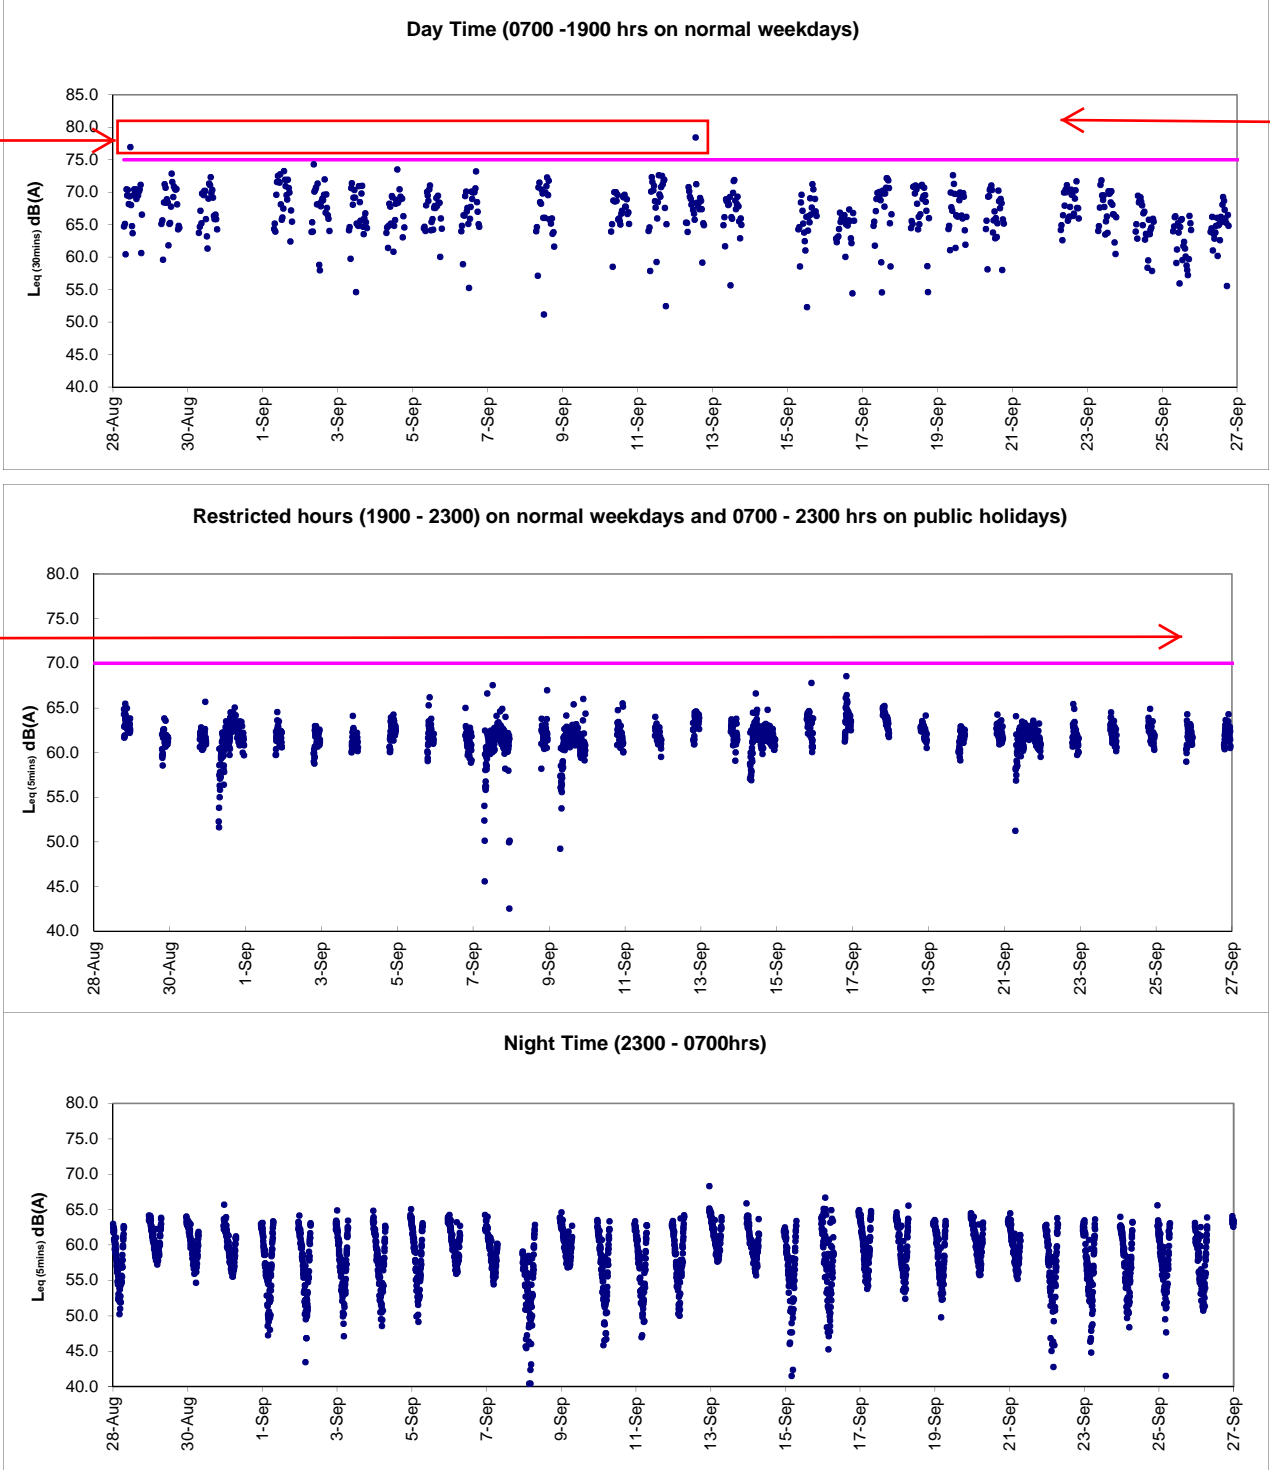
After checking with contractor HY/2009/19, despite bored piling works and socket piling were conducted, contractor mitigation measures including erection of temporary noise barrier and noise blanket were in place. In view of the exceedances are non-continuous, the exceedances are considered to be non-Project related and contributed by the IEC traffic and adjacent non-CWB piling site.

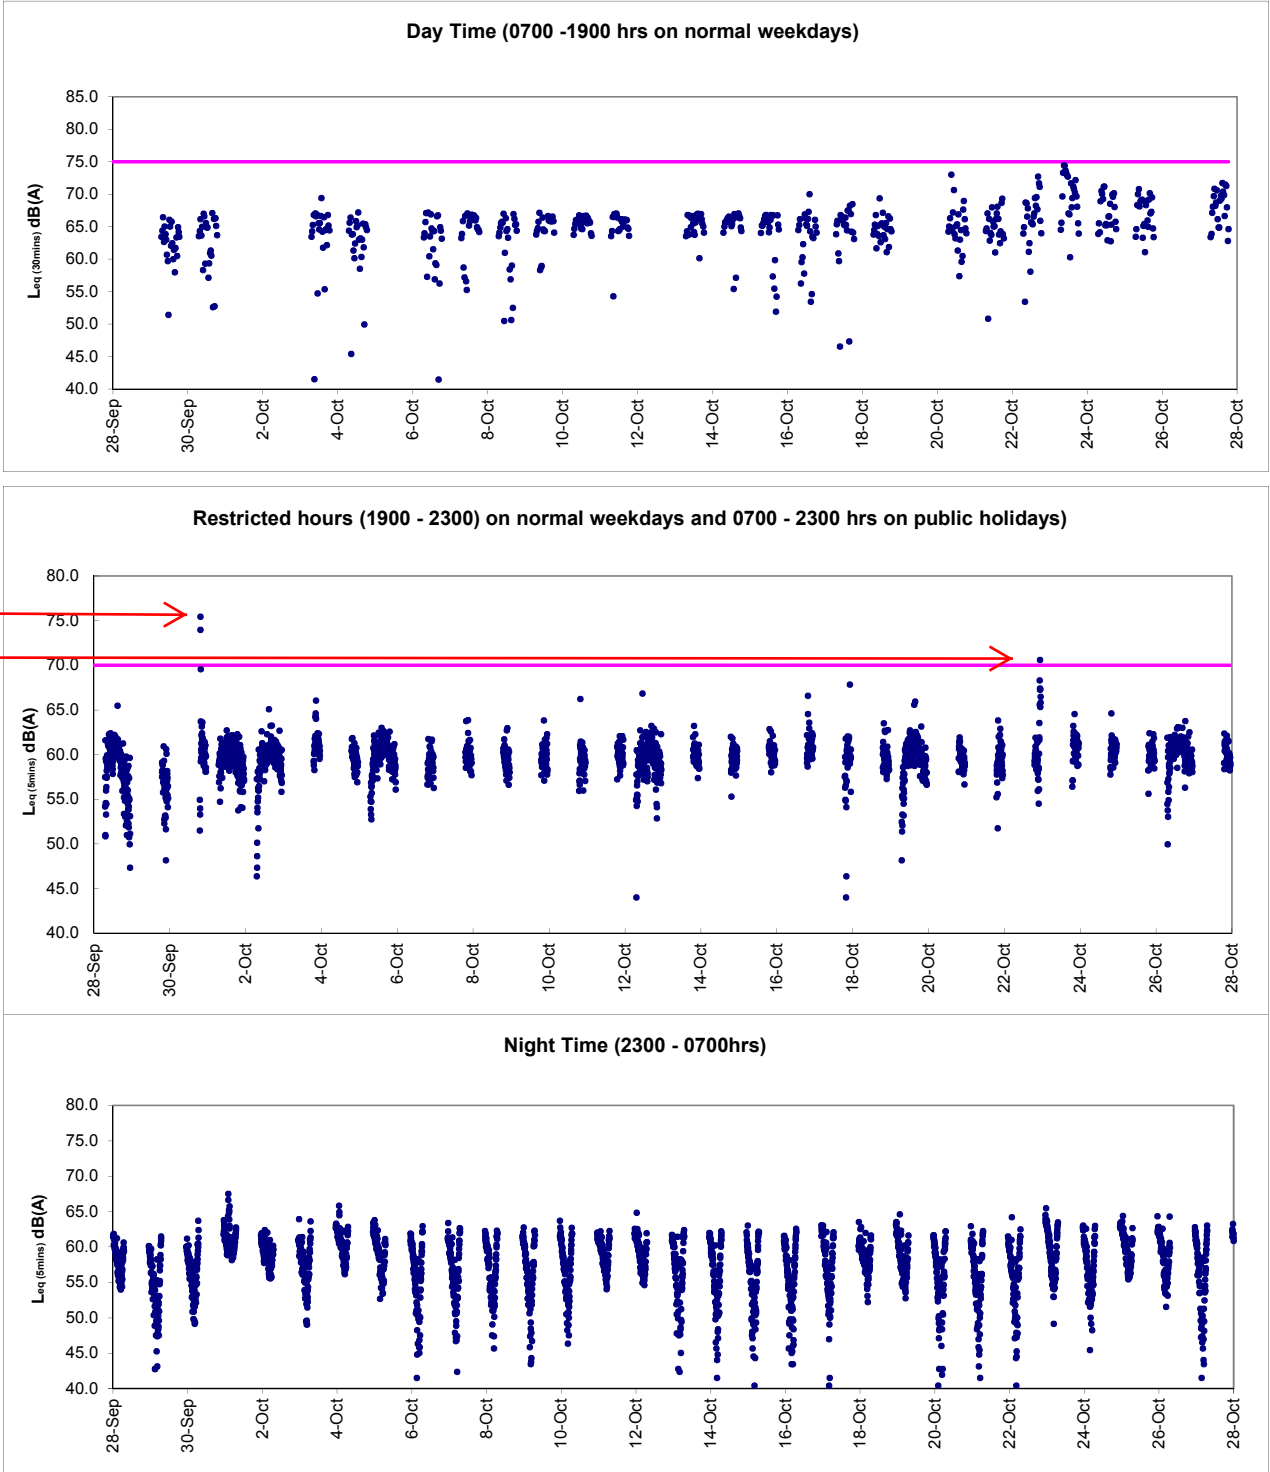
Graphic Presentation of Real Time Noise Monitoring Result (RTN2a- Hong Kong Electric Centre)

After checking with contractor HY/2009/19, no construction works was conducted during the recorded period. In view of the exceedance was non-continuous, the exceedance was considered to be non-Project related and contributed by the nearby IEC traffic

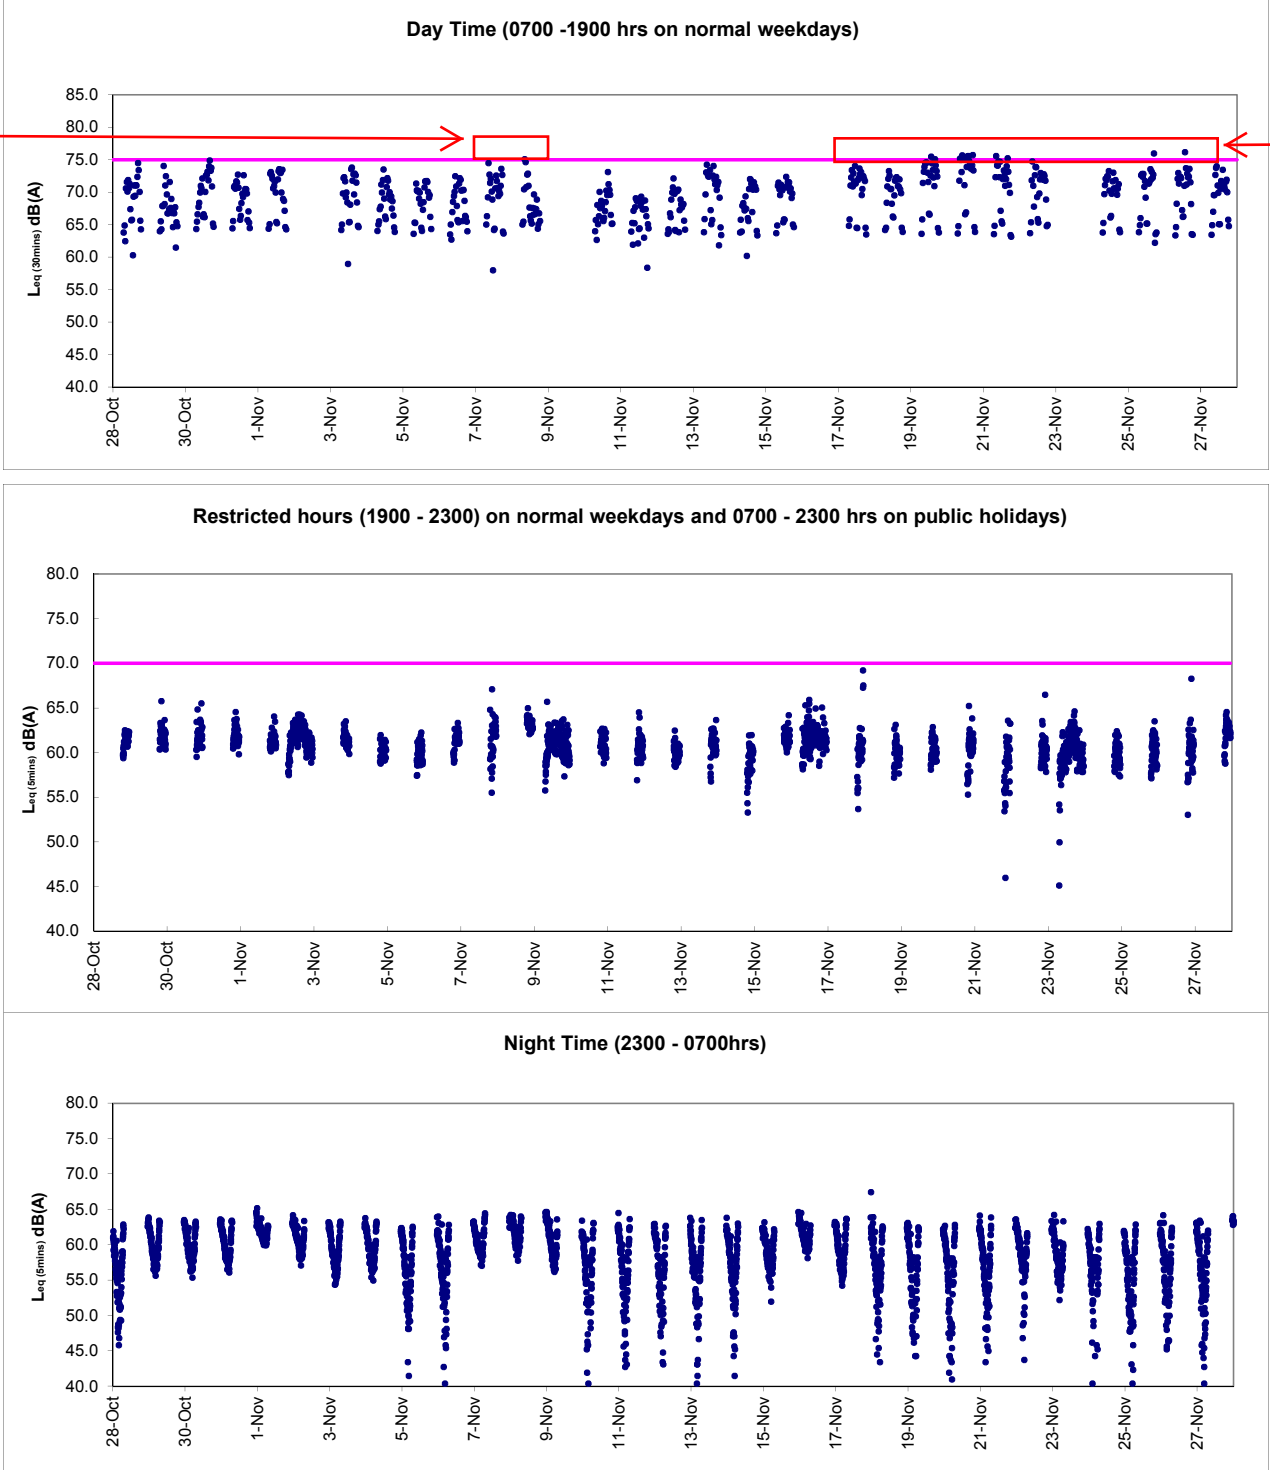
Graphic Presentation of Real Time Noise Monitoring Result (RTN2a- Hong Kong Electric Centre)

After checking with contractor HY/2009/19, sheet piling and socket H-piling were conducted during the recorded period, contractor mitigation measures including provision of temporary noise barrier was implemented. In view of the exceedance was non-continuous, the exceedances are considered to be non-Project related and contributed by nearby the IEC
