Graphic Presentation of Real Time Noise Monitoring Result (RTN2a- Hong Kong Electric Centre)

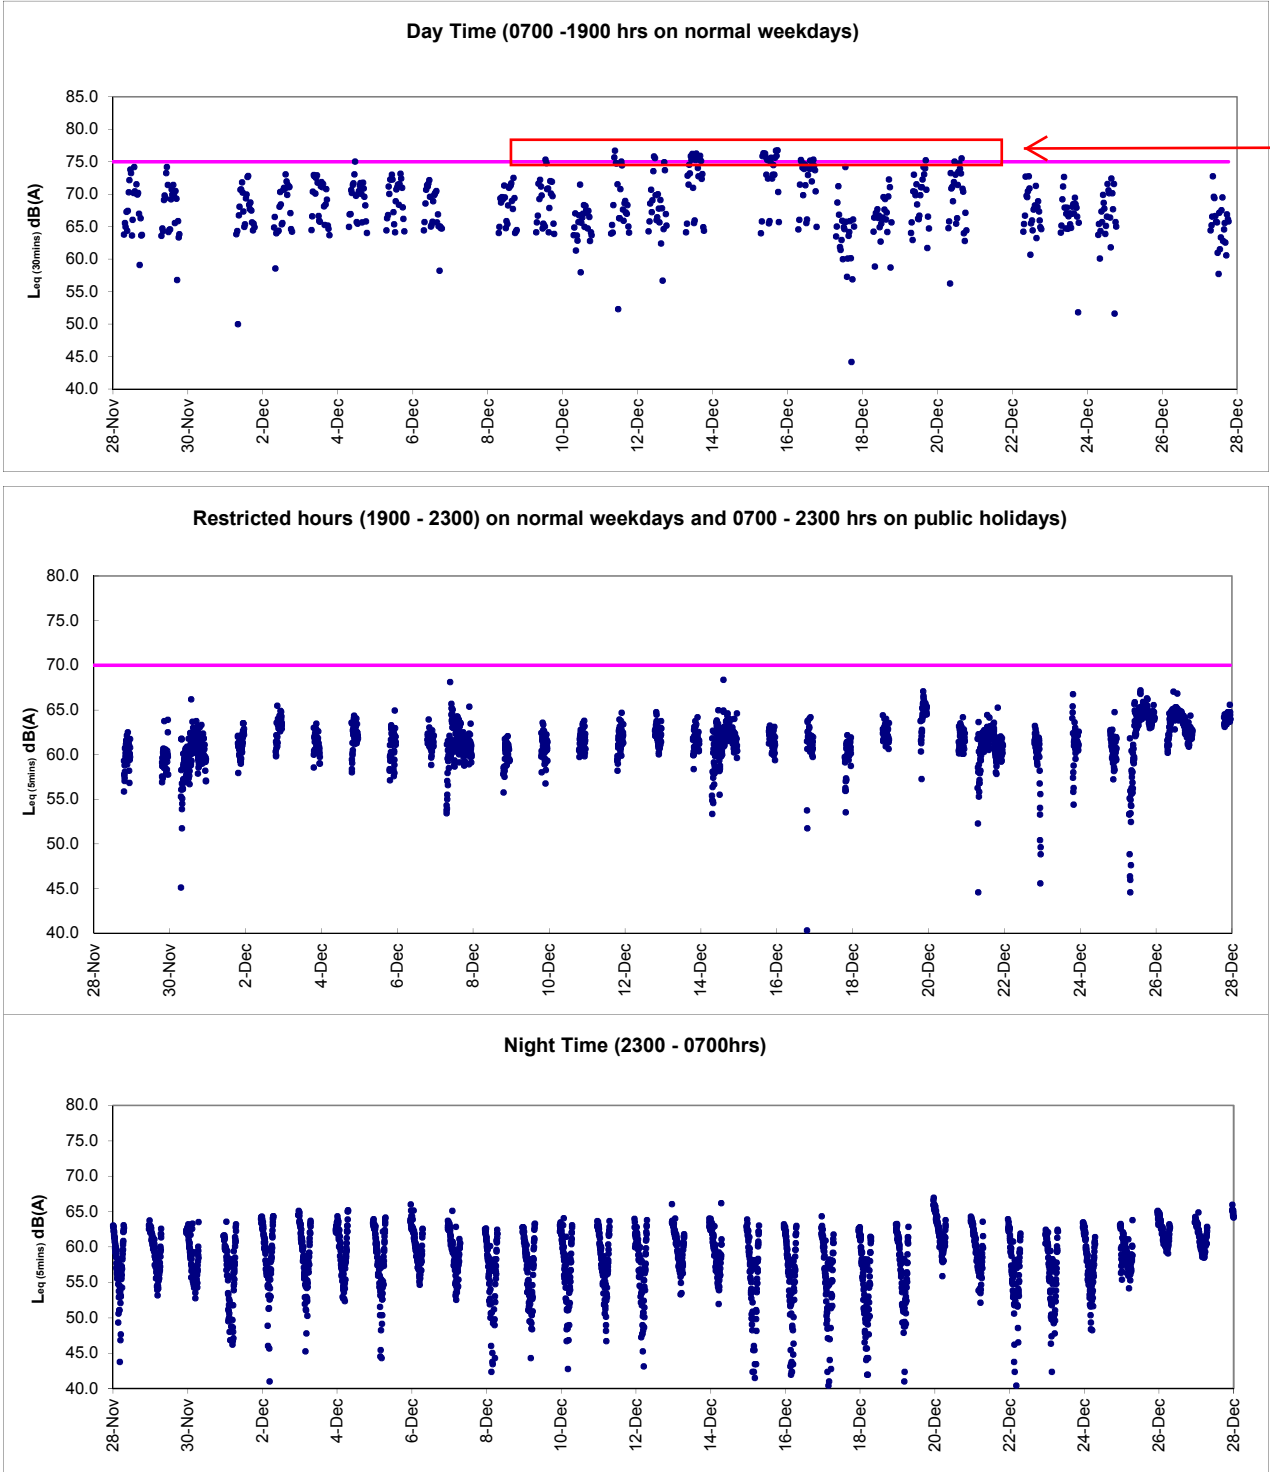
After checking with contractor HY/2009/19, socket H-piling was conducted during the recorded period, contractor mitigation measures including provision of temporary noise barrier were implemented while chilling system pipe work installation works (hammering and welding works) was conducting at the roof top of Hong Kong Electric Centre during the recorded period. As such, the exceedances were considered to be non-Project related and contributed by the pipe work installation works at Hong Kong Electric Centre.

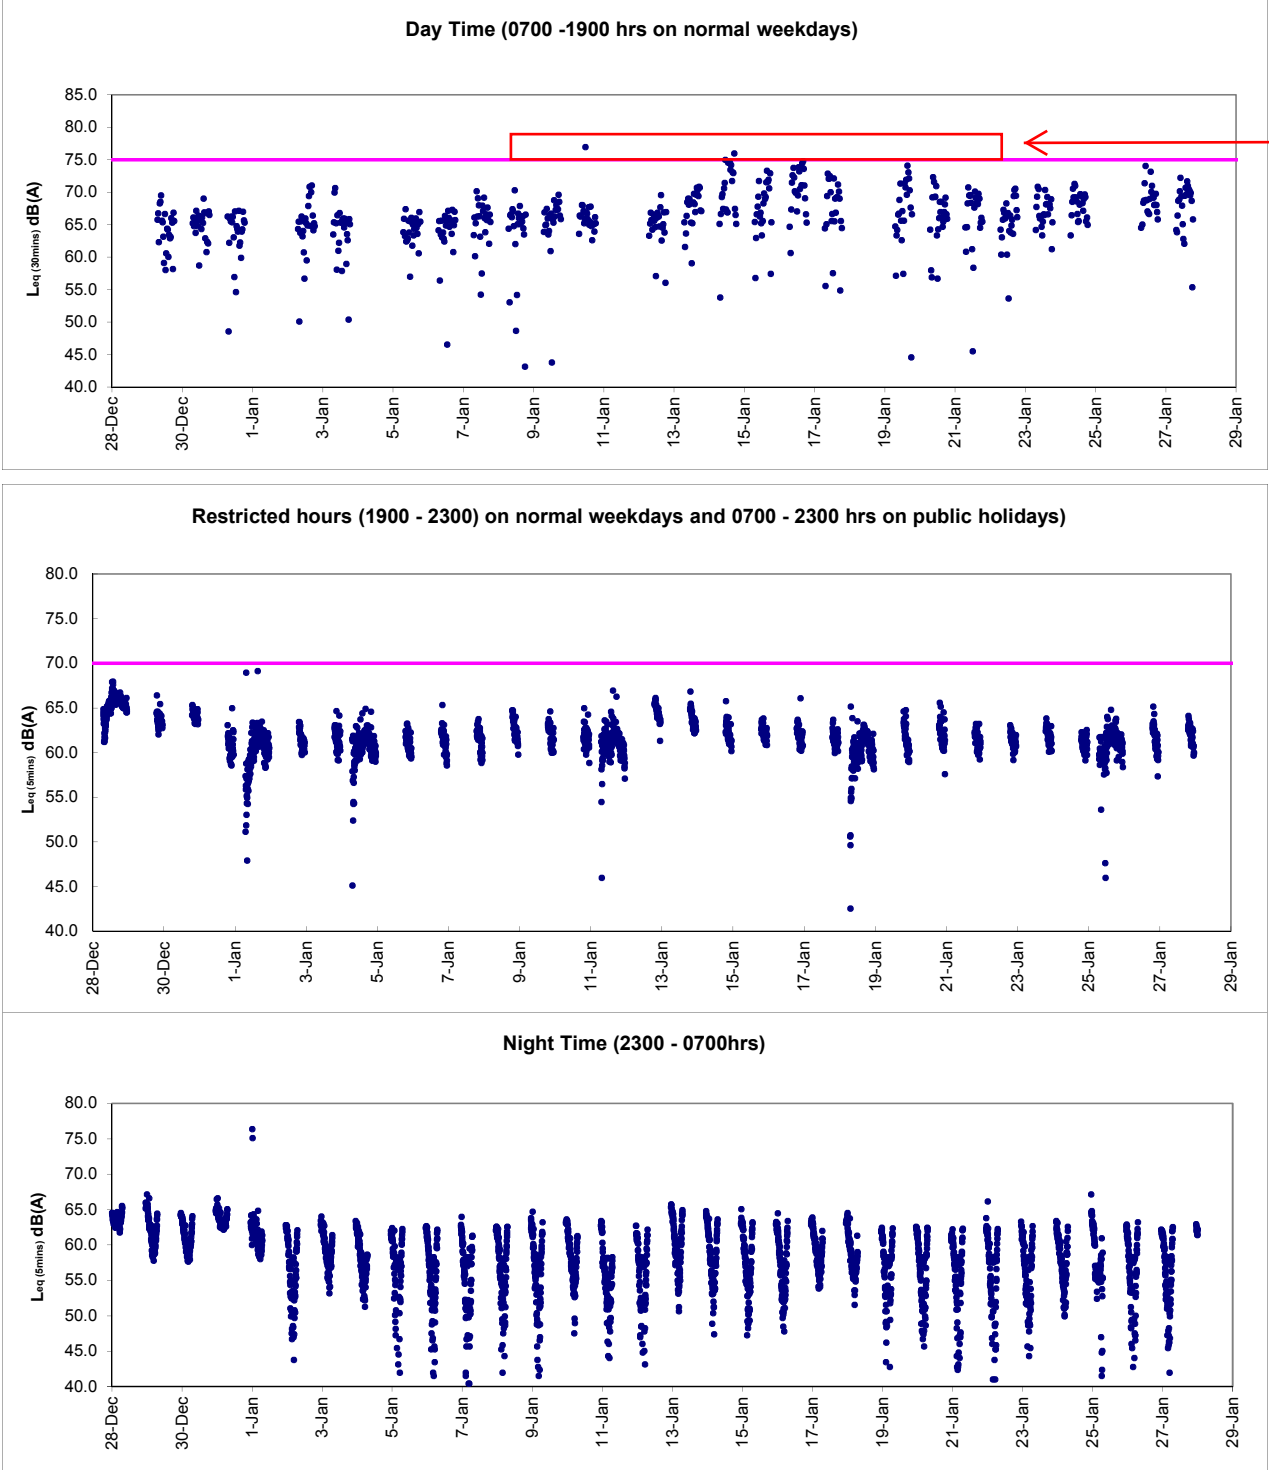
Graphic Presentation of Real Time Noise Monitoring Result (RTN2a- Hong Kong Electric Centre)

After checking with contractor HY/2009/19, bored piling was conducted during the recorded period, contractor mitigation measures including provision of temporary noise barrier were implemented. In view of the exceedances are non-continuous, the exceedances were considered to be non-Project related and contributed by nearby IEC traffic.

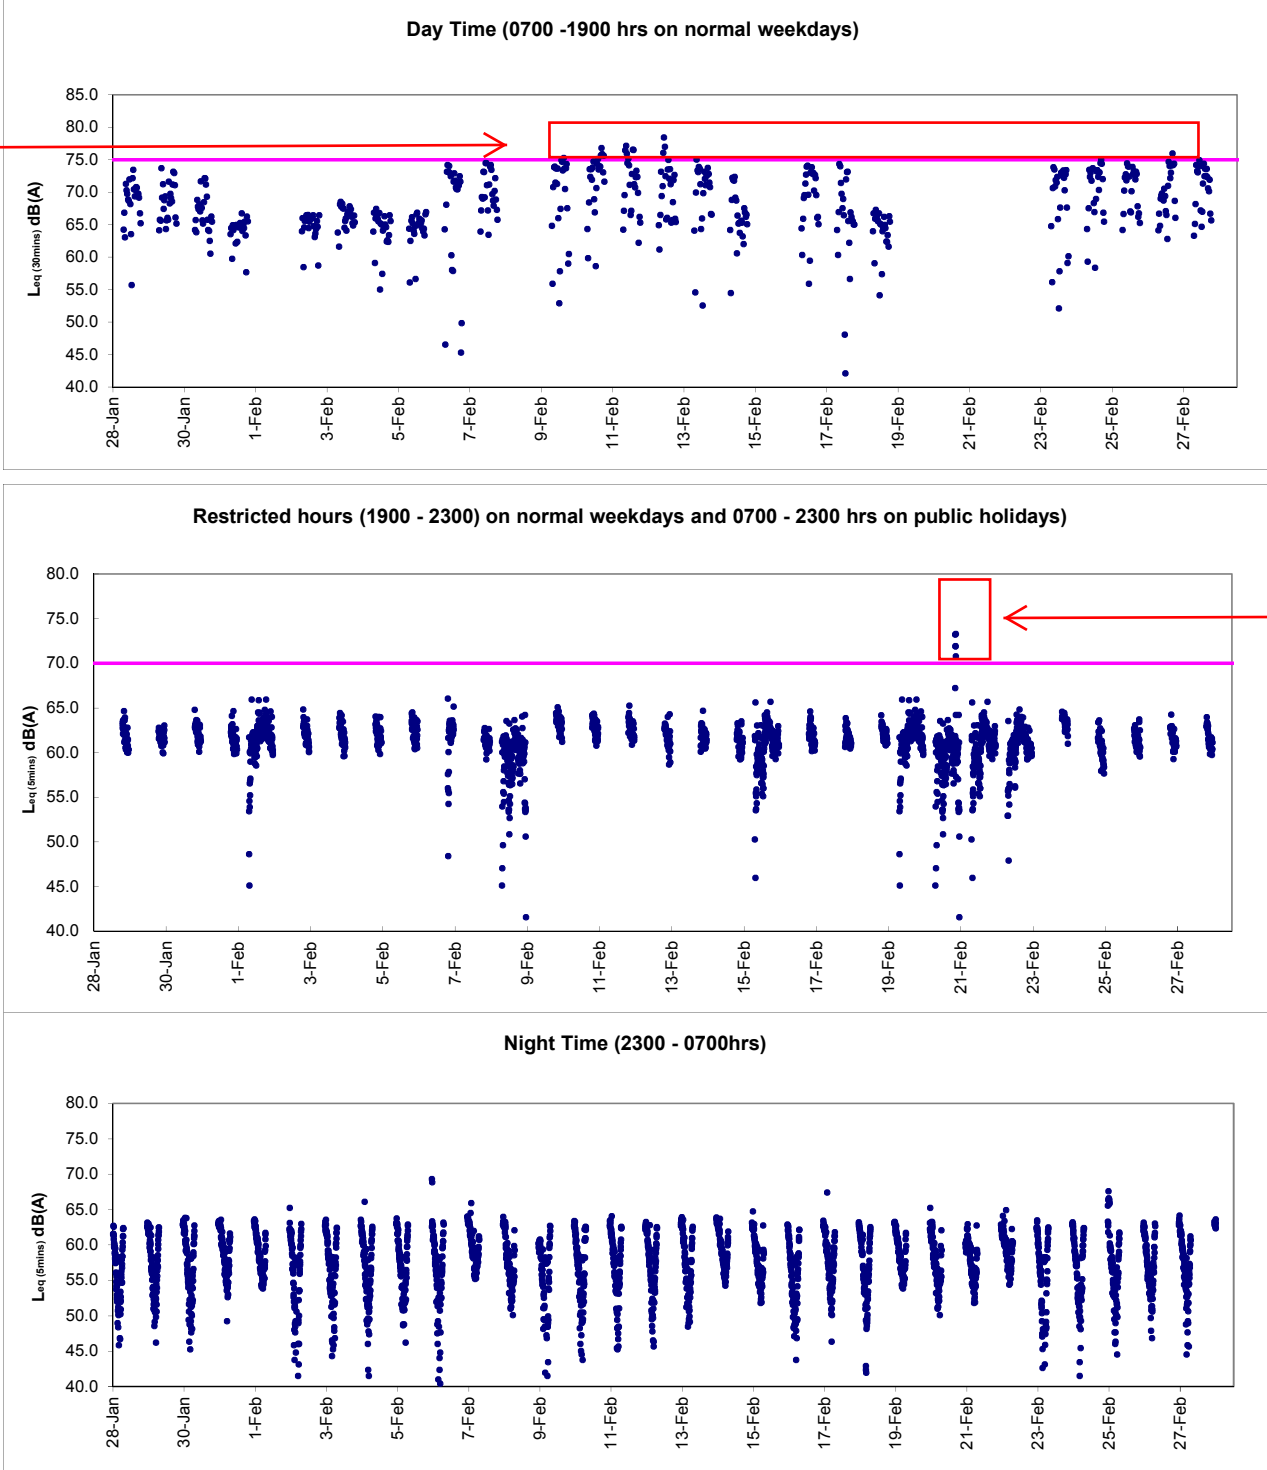
Graphic Presentation of Real Time Noise Monitoring Result (RTN2a- Hong Kong Electric Centre)

After checking with Contractor HY/2009/19, no major noise generating construction activities were undertaken at the concerned location during the recorded period while breaking works and excavation works was observed at the construction site next to the monitoring station across February 2015. As such, the exceedances were considered to be non Project related and contributed by nearby non-CWB Project construction works.

After checking with contractor HY/2009/19, no construction activity was undertaken at the concerned location during the recorded period. The exceedances were considered to be contributed by pyrotechnic display during Chinese New Year.
