Graphic Presentation of Real Time Noise Monitoring Result (RTN2a- Hong Kong Electric Centre)

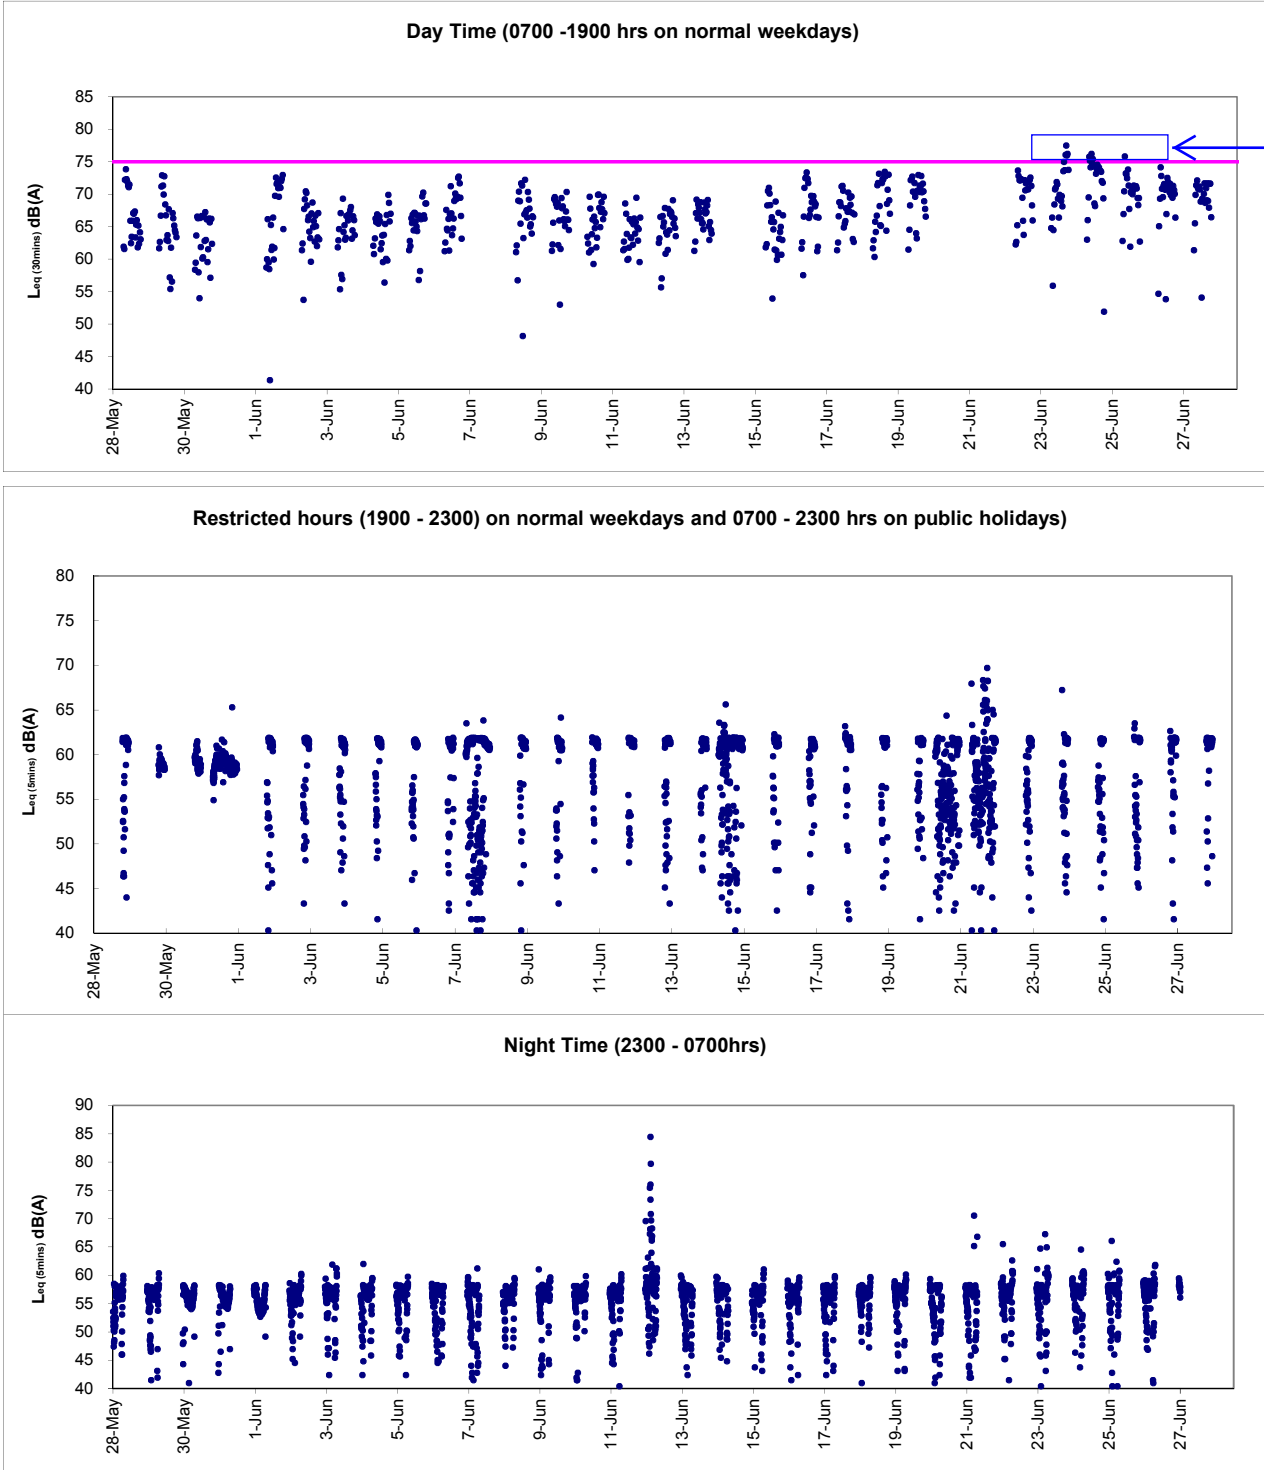
After checking with Contractor of HY/2009/19, pile cap breaking works was conducted on 23, 24 June 2015; and pile cap excavation works was conducted 25 June 2015. Noise mitigation measures including temporary noise barrier was implemented for the breaking works by the Contractor while breaking works and excavation works was noted on-going at the construction site located next to the monitoring station. In view of the above, the exceedances were considered to be non-Project related and contributed by nearby non-CWB construction site works. Nevertheless, the Contractor was reminded to strengthen the noise mitigation measures implemented for the pile cap demolition works to avoid potential cumulative impact to nearby sensitive receivers.
