Graphic Presentation of Real Time Noise Monitoring Result (Food and Environmental Hygiene Department Depot)

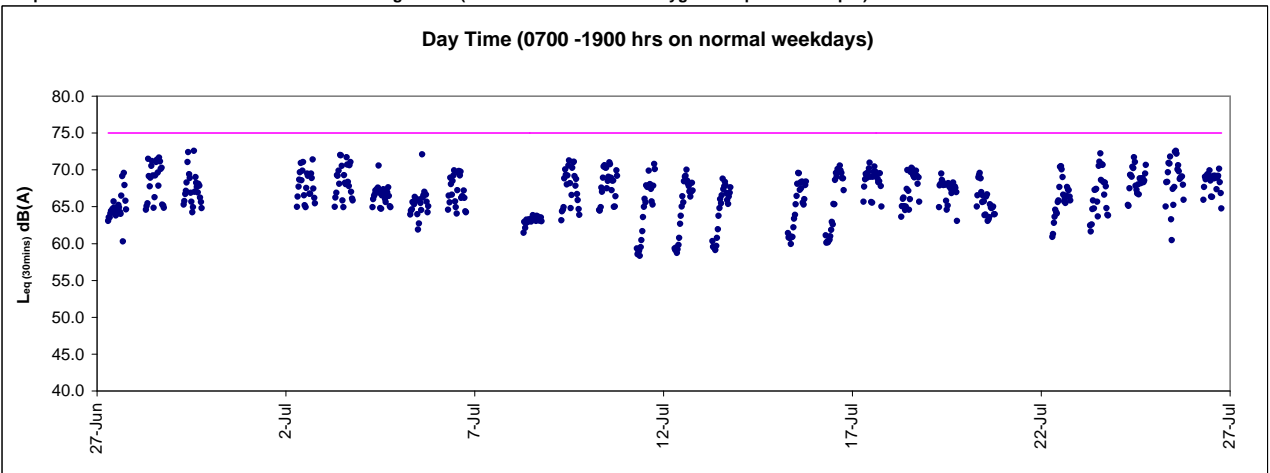
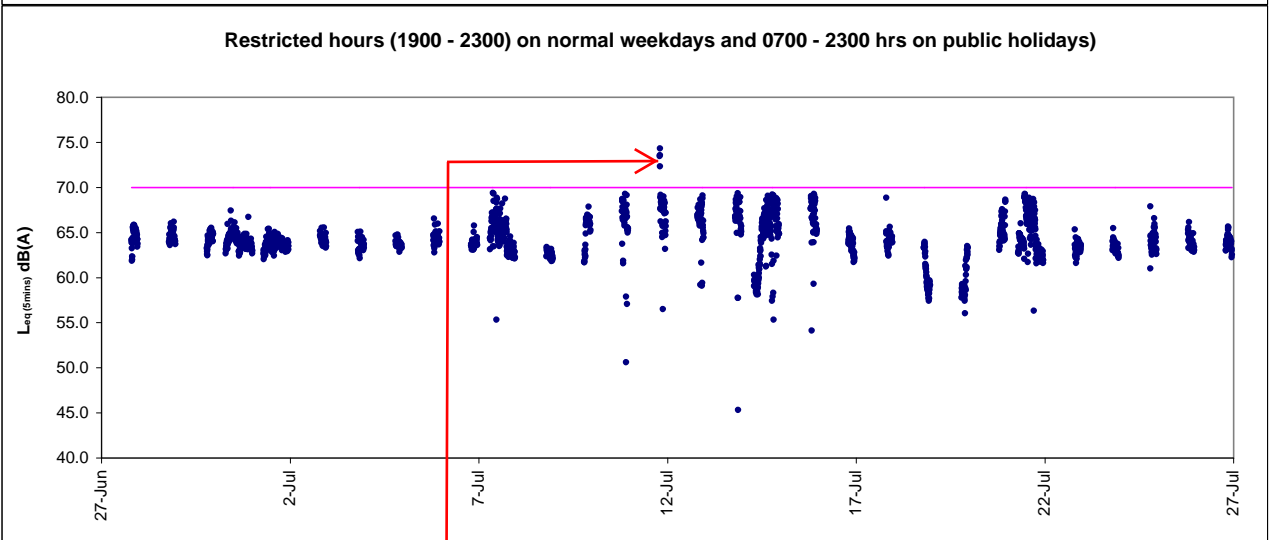
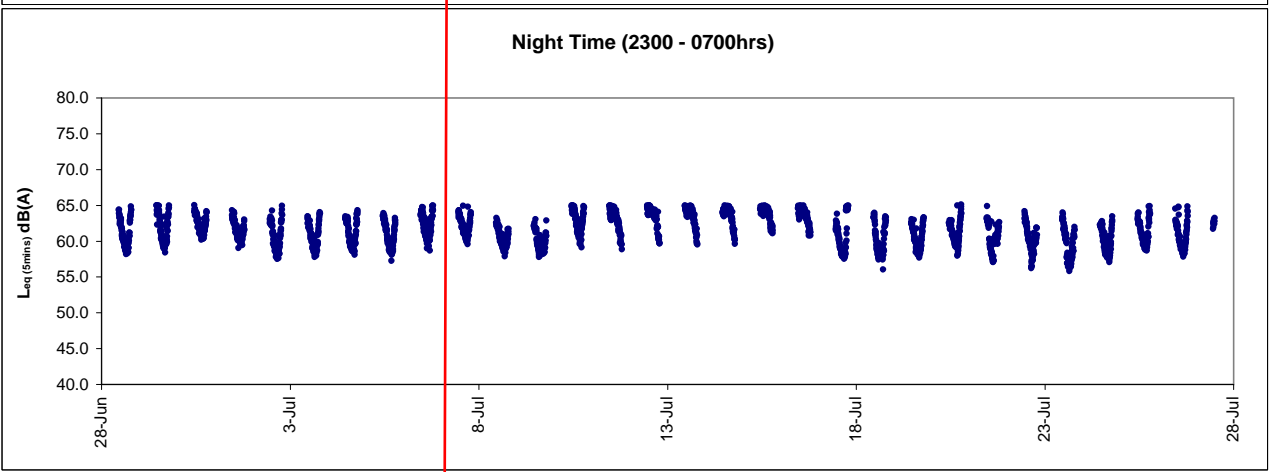
Graphic Presentation of Real Time Noise Monitoring Result (Food and Environmental Hygiene Department Depot)

After checking work activities of contractors HY/2009/17 and HY/2009/19, it was found that no works were being performed during monitoring. Exceedances were not continuous in which contributed by traffic noise at Island Eastern Corridor.

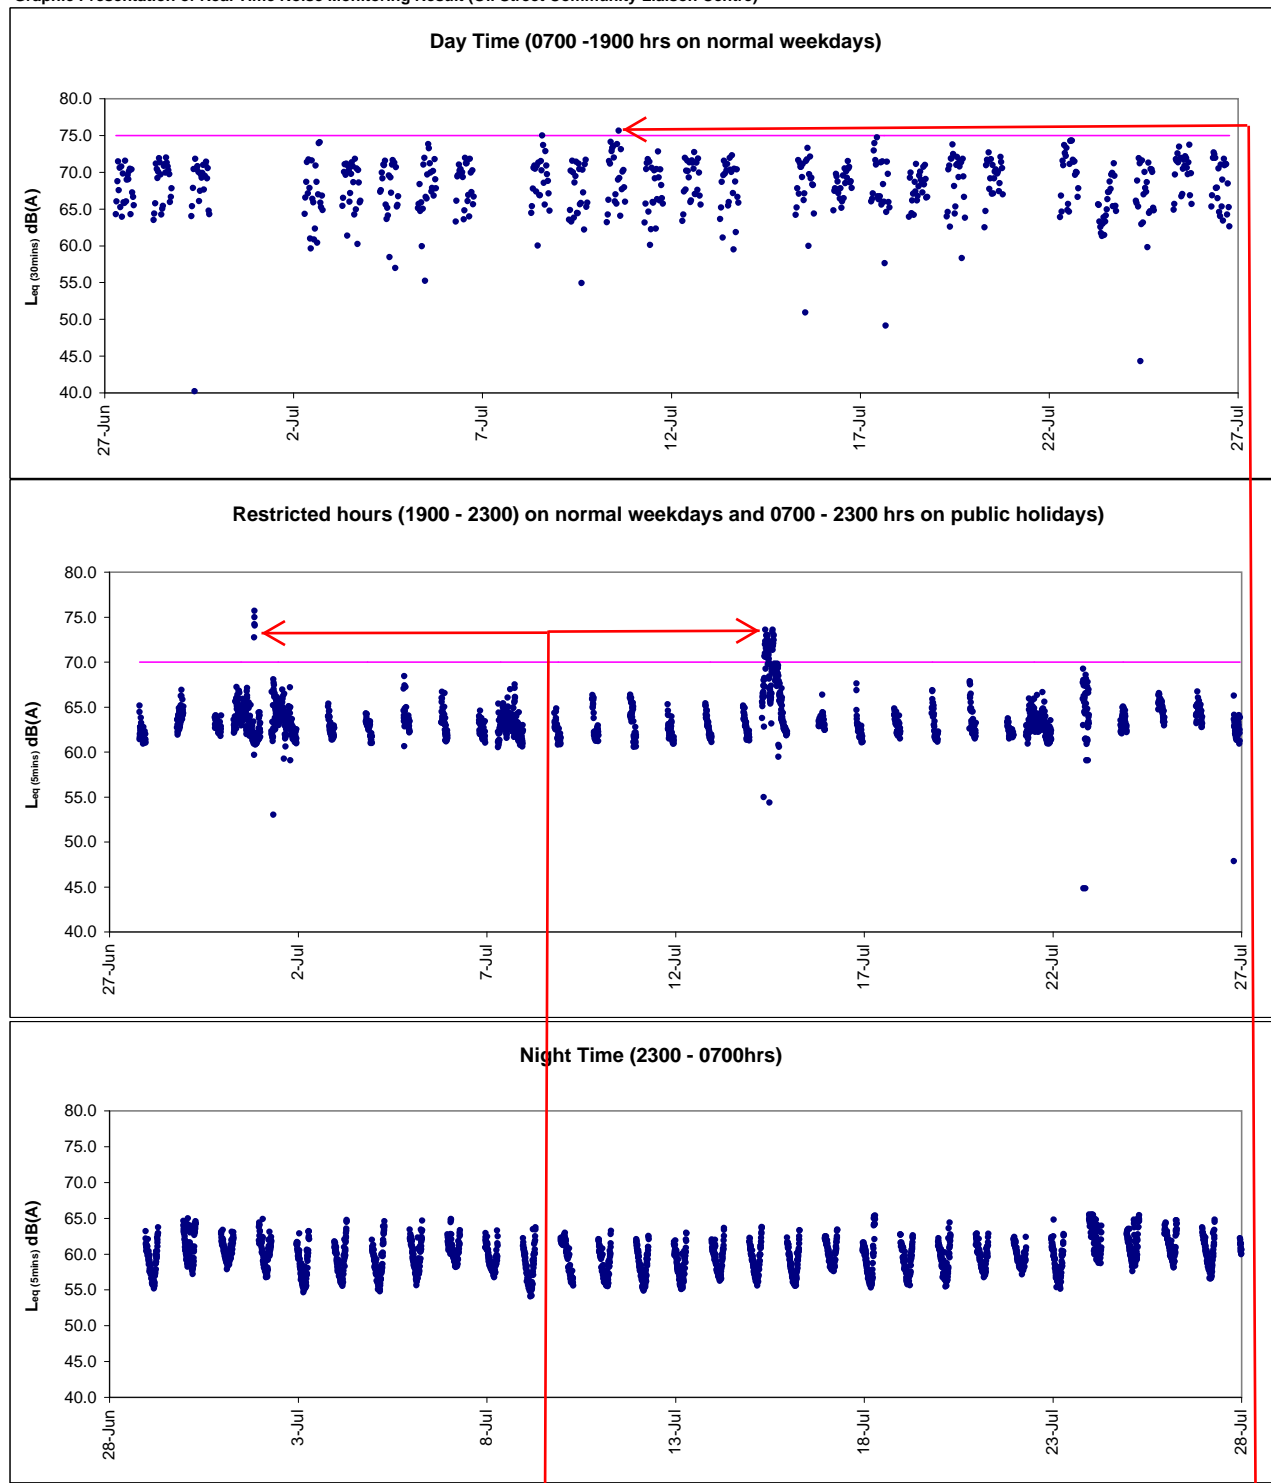
Graphic Presentation of Real Time Noise Monitoring Result (Oil Street Community Liaison Centre)

After checking work activities of contractor HY/2009/19, it was found that no works were being performed during monitoring. Exceedances were considered to be contributed by traffic noise at Island Eastern Corridor.

After checking work activities of contractor HY/2009/19, it was found that no major noisy activities were being performed. Exceedances were considered to be contributed by demolition works near the Oil Street Community Liaison Centre.

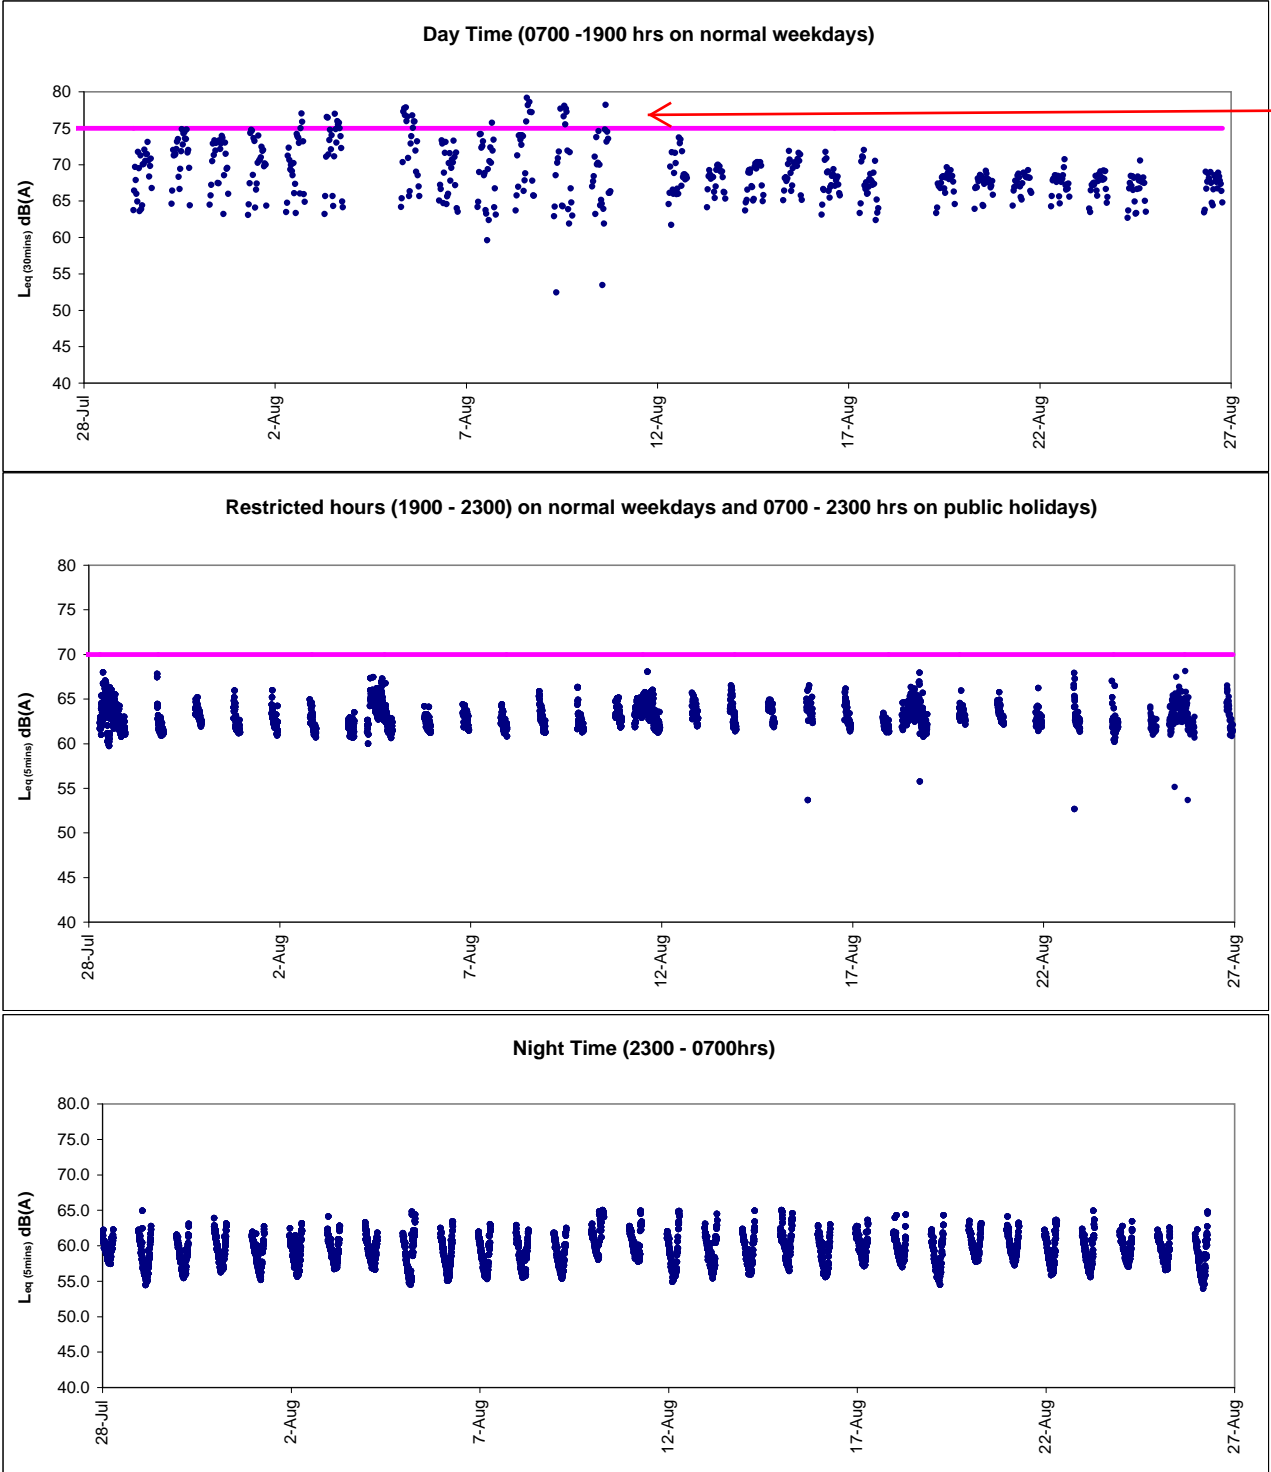
Graphic Presentation of Real Time Noise Monitoring Result (Oil Street Community Liaison Center)

After checking work activities of contractor HY/2009/19, it was found that no major noisy activities were being performed. Exceedances were considered to be contributed by demolition works near the Oil Street Community Liaison Centre.
