Graphic Presentation of Real Time Noise Monitoring Result (RTN2a- Hong Kong Electric Centre)

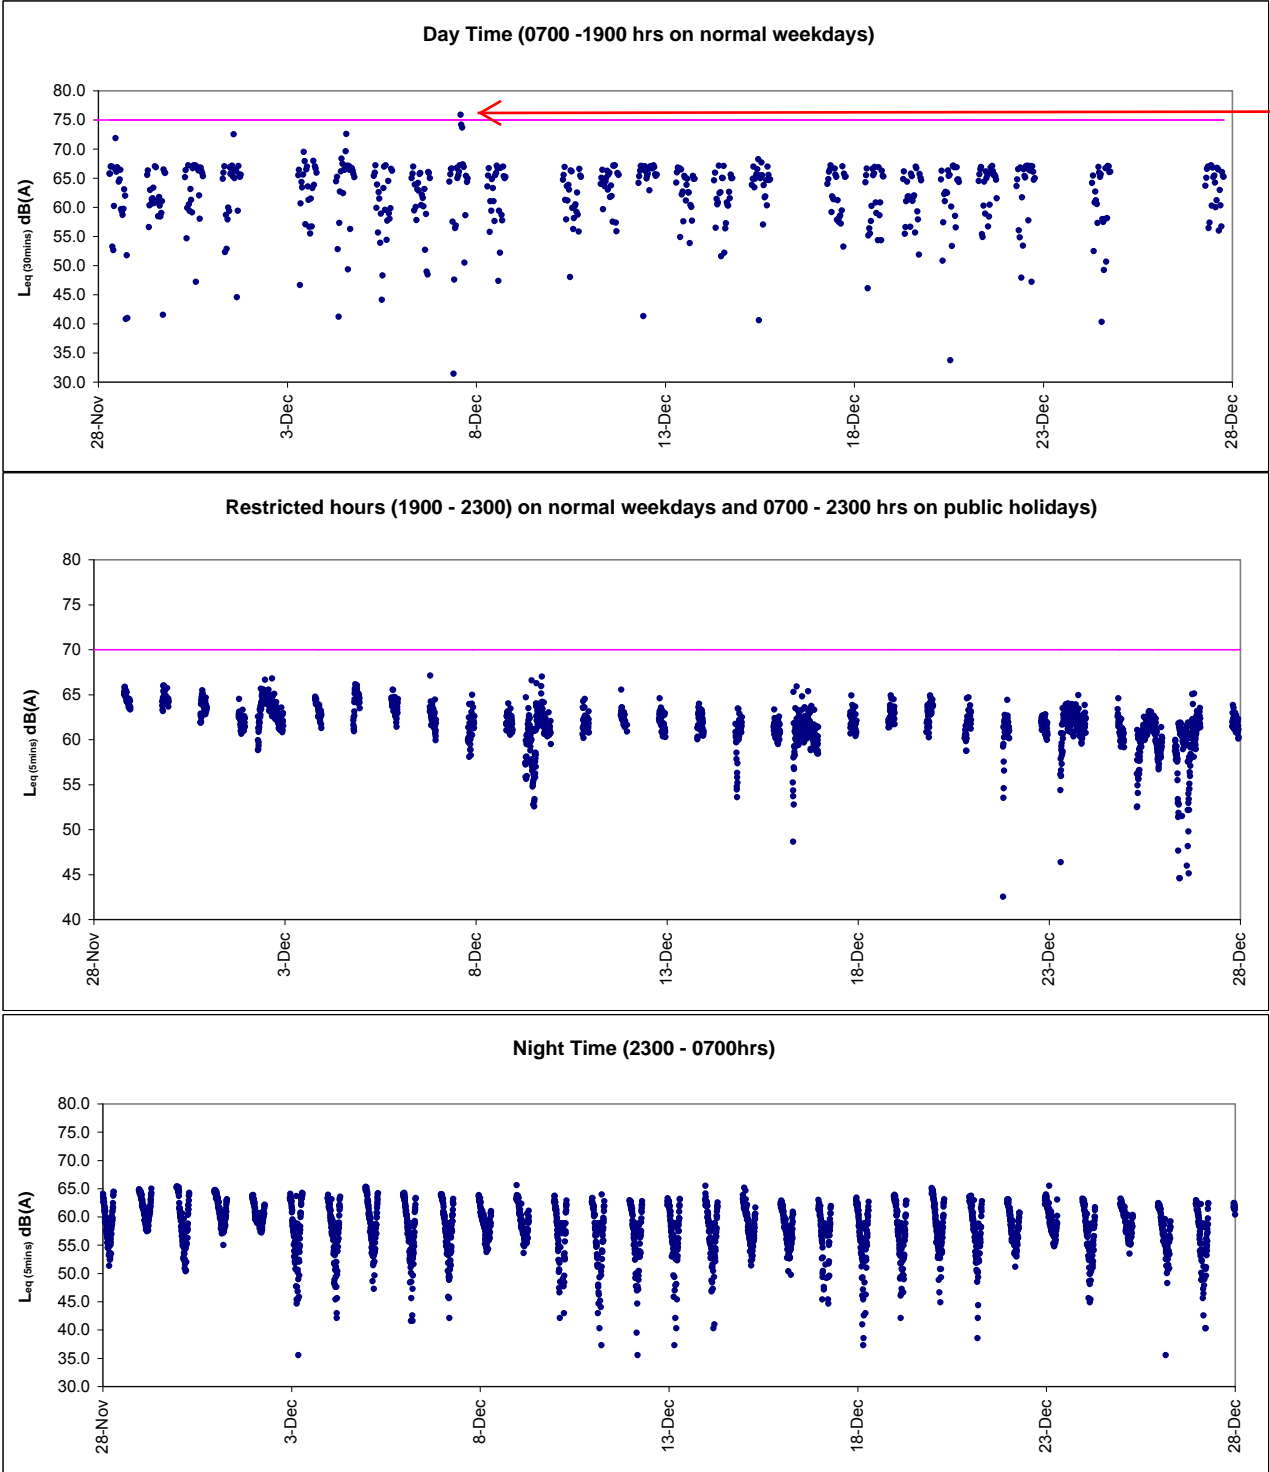
After checking with contractor HY/2009 19, no noisy construction activities were conducted during monitoring. Exceedance was considered to be contributed by the non CWB construction activities at the construction site next to Hong Kong Electric Centre

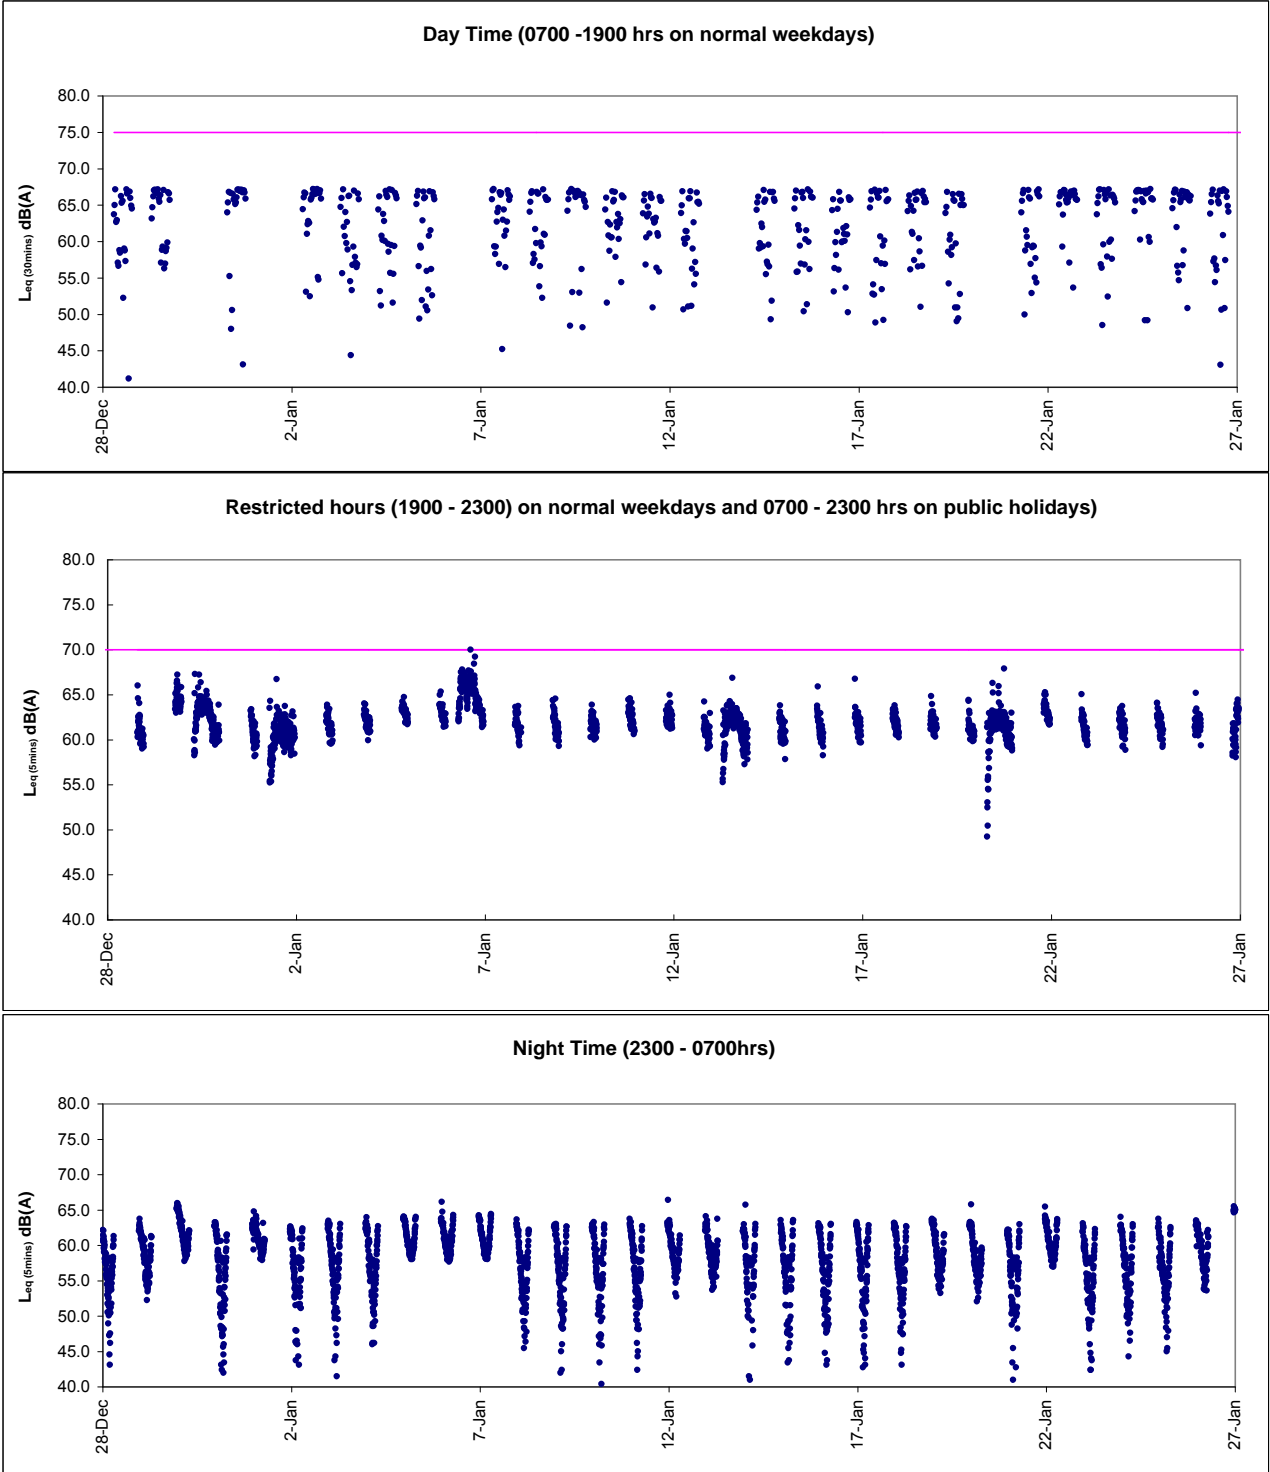
Graphic Presentation of Real Time Noise Monitoring Result (RTN2a- Hong Kong Electric Centre)

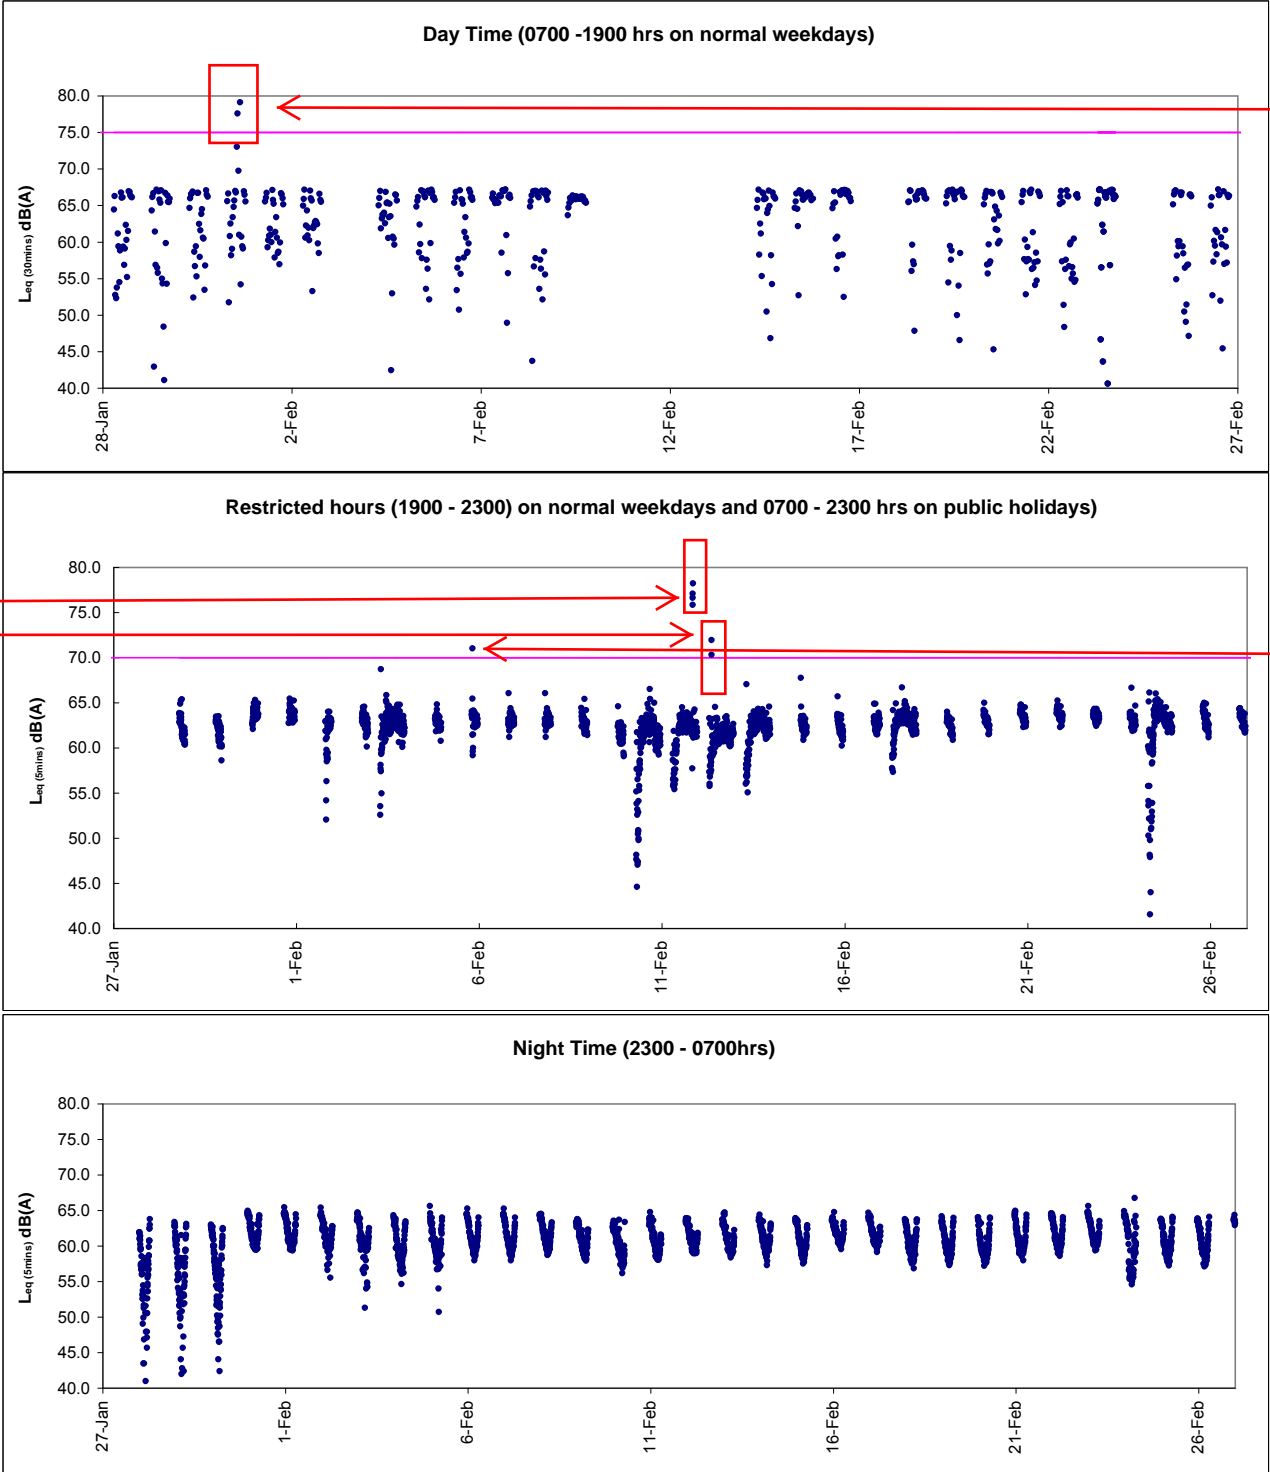
Graphic Presentation of Real Time Noise Monitoring Result (RTN2a- Hong Kong Electric Centre)

After checking with contractor HY/2009/19. No construction activities were conducted during the recorded period. Exceedances were contributed by Chinese New year pyrotechnic display.

After checking with contractor HY/2009/19, no noisy construction activities were conducted during the recorded period and the exceedance was non-continuous. Exceedances were considered to be contributed by nearby IEC traffic

After checking with contractor HY/2009/19. No construction activities were conducted during the recorded period. Exceedances were contributed by nearby IEC traffic
