**WANCHAI DEVELOPMENT PHASE II AND CENTRAL
WANCHAI BYPASS
SAMPLING, FIELD MEASUREMENT AND TESTING WORK
(STAGE 3)**

ENVIRONMENTAL PERMIT NO. EP-122/2002/E

MONTHLY ENVIRONMENTAL MONITORING & AUDIT REPORT

- SEPTEMBER 2018 -

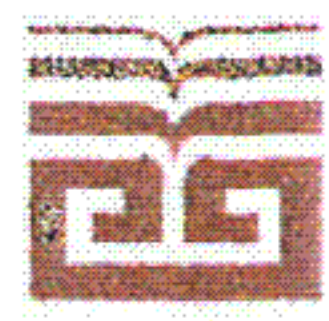
Figure 2.1

2.2.1. The design and construction of Central Reclamation Phase III involves the permanent reclamation and construction and operation of a trunk road and its road tunnel that is shown at [Figure 2.1](#).

or operated. **Table 2.1** summarises the four individual DPs under this Project. **Figure 2.1** shows the locations of these Schedule 2 DPs.

Project Layout

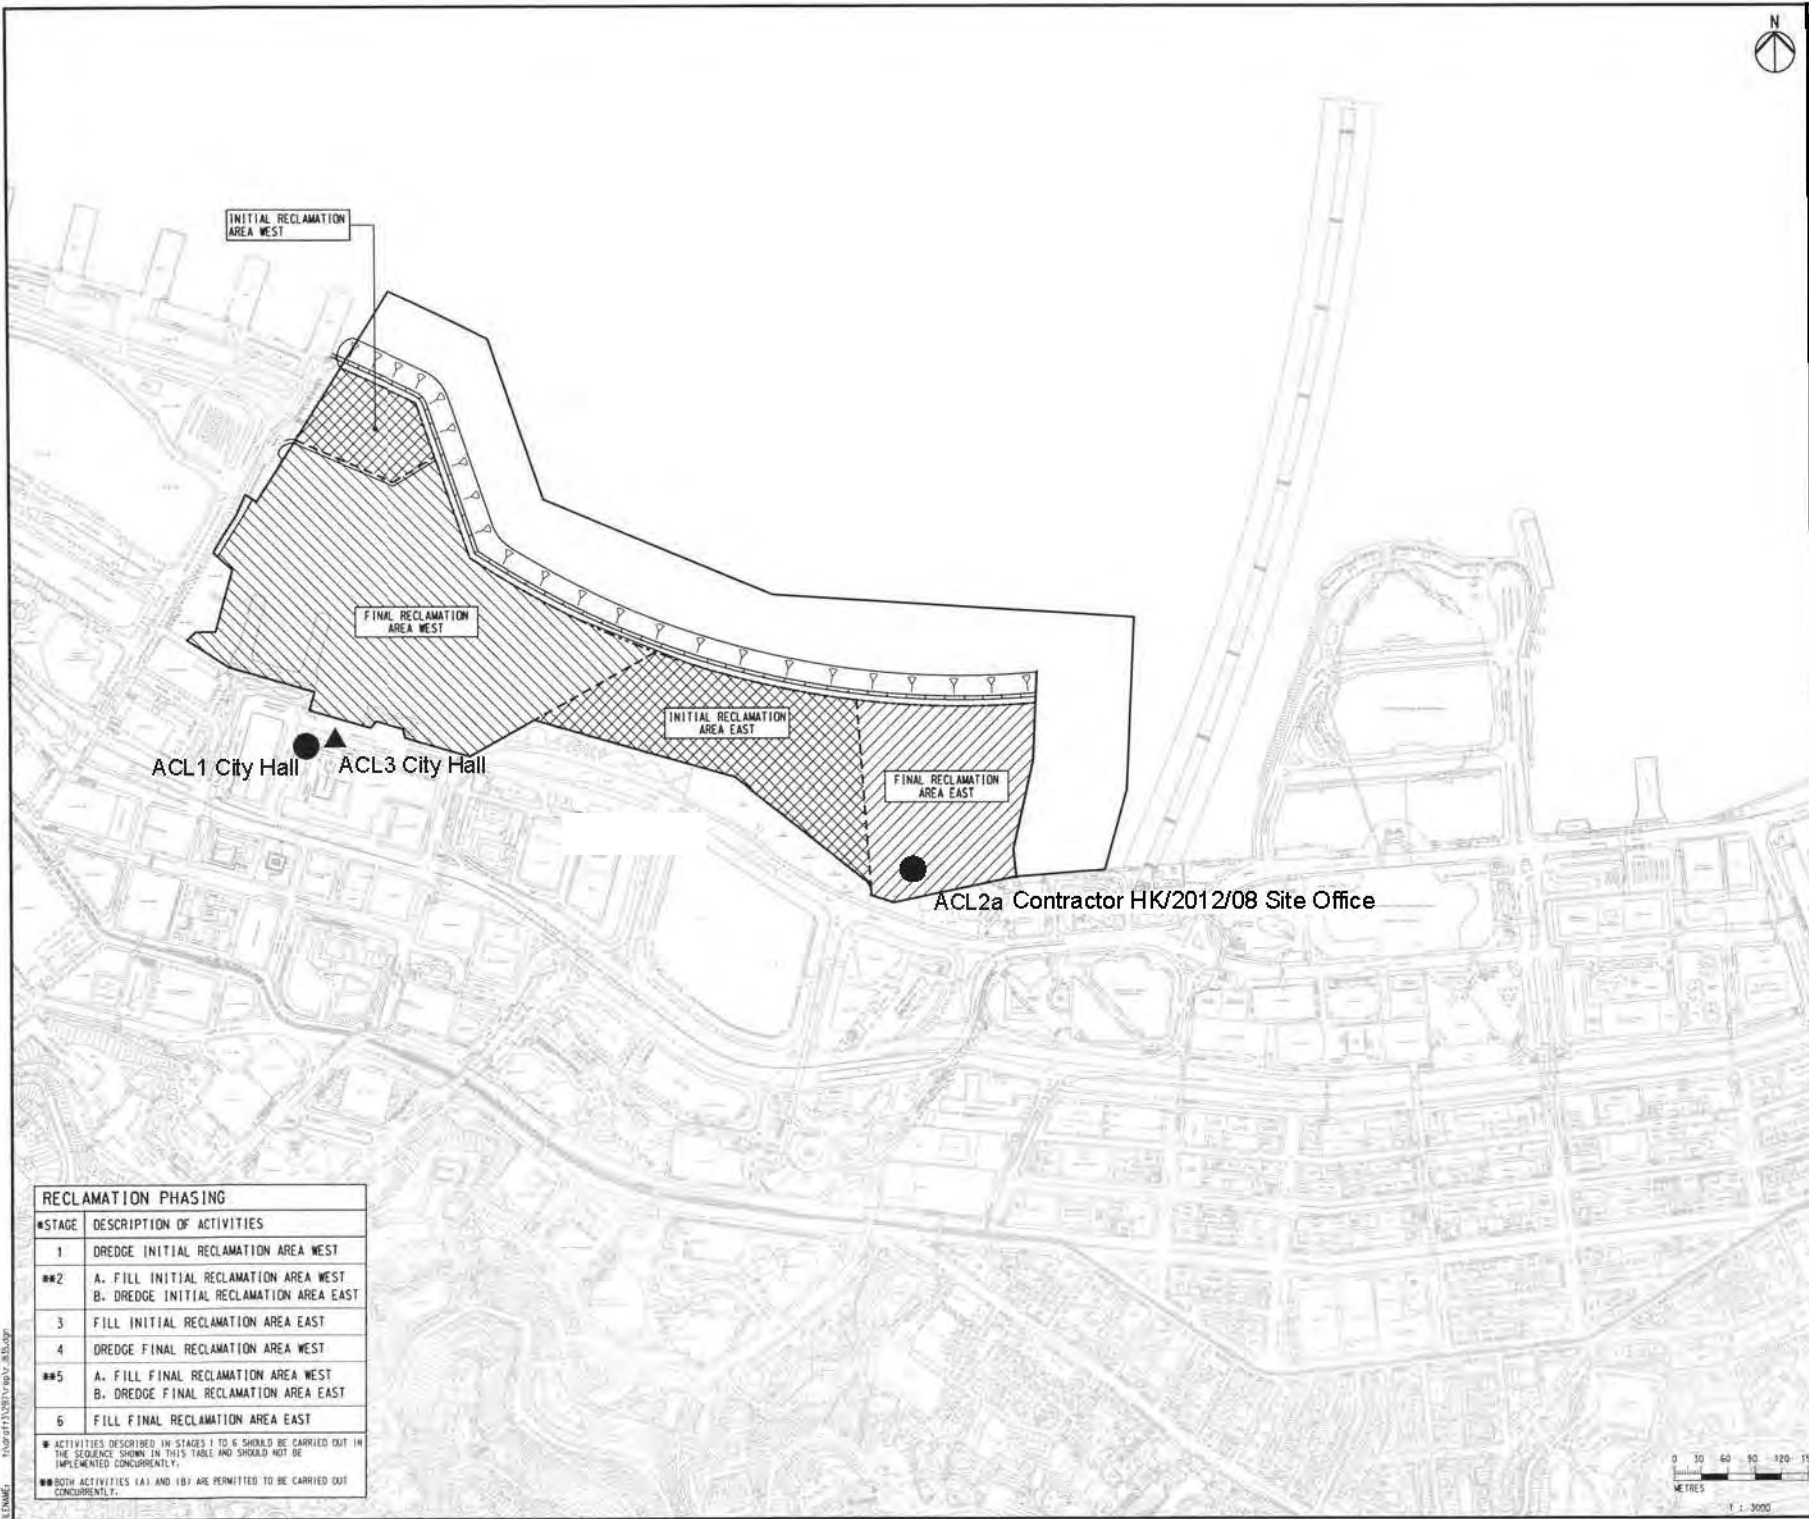
Figure 4.1

- 4.1.1. The continuous noise monitoring station for the Project is listed and shown in **Table 4.1** and **Figure 4.1**. **Appendix 4.1** shows the established Action/Limit Levels for the monitoring works.

4.2.1. The air quality monitoring stations for the Project are listed and shown in **Table 4.2** and **Figure 4.1**. **Appendix 4.1** shows the established Action/Limit Levels for the monitoring works.

4.3.1 The water quality monitoring stations for the Project are listed and shown in **Table 4.3** and **Figure 4.1**. **Appendix 4.1** shows the established Action/Limit Levels for the monitoring works.

- DUST MONITORING STATIONS
- ▲ NOISE MONITORING STATION

Fig 4.1 Location of monitoring stations

5.0.1. The environmental monitoring will be implemented based on the division of works areas of each designated project managed under different contracts with separate FEP applied by individual contractors. Overall layout showing work areas of various contracts, latest status of work commencement and monitoring stations is shown in [Figure 2.1](#) and [Figure 4.1](#). The monitoring results are presented in according to the Individual Contract(s).

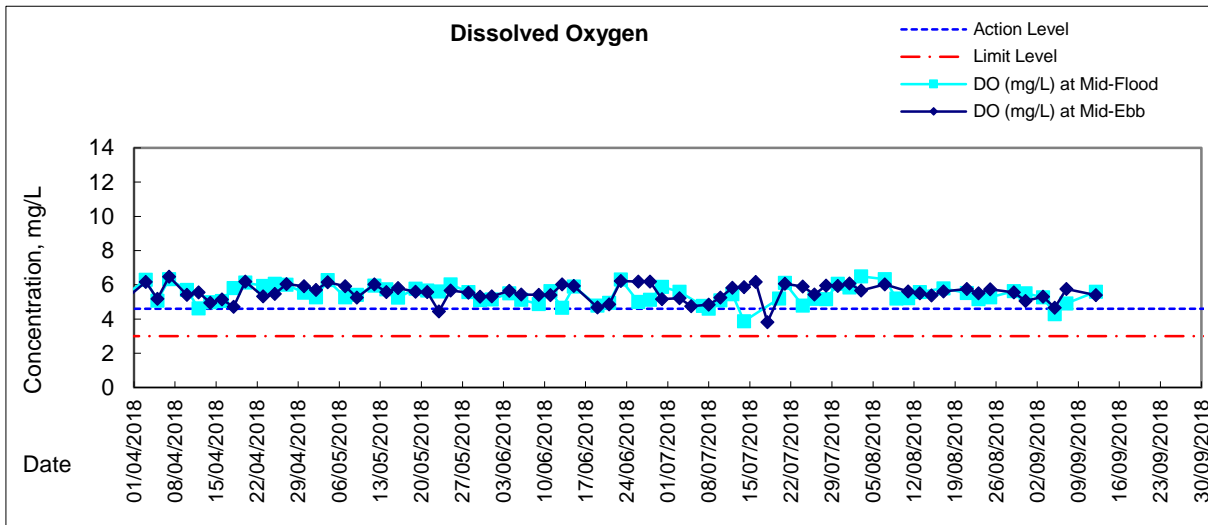
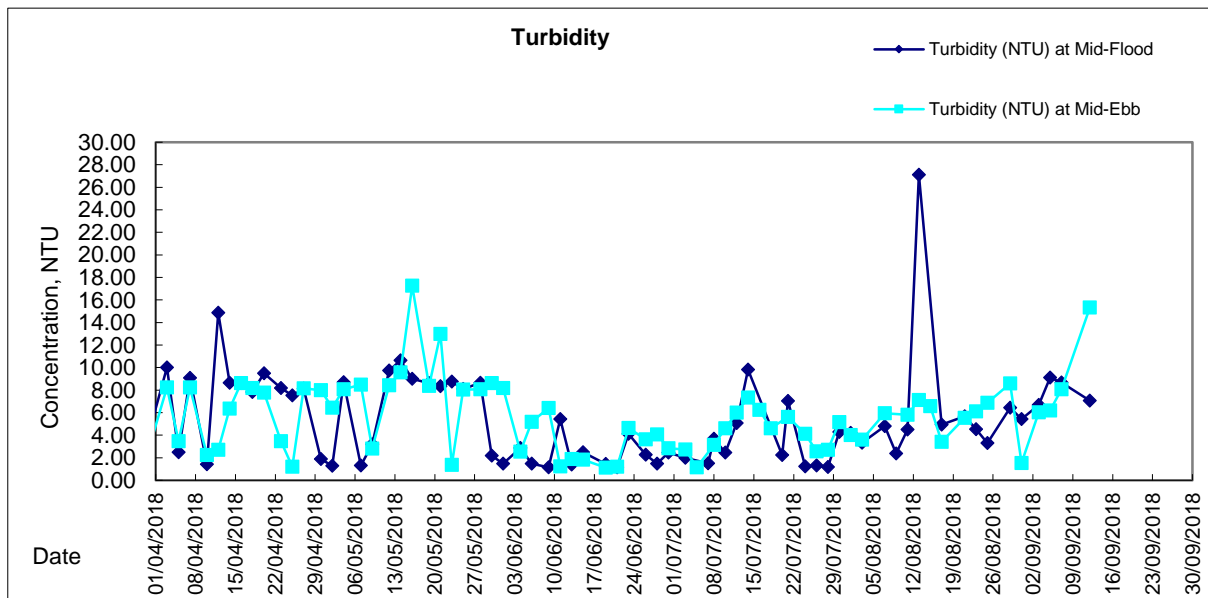
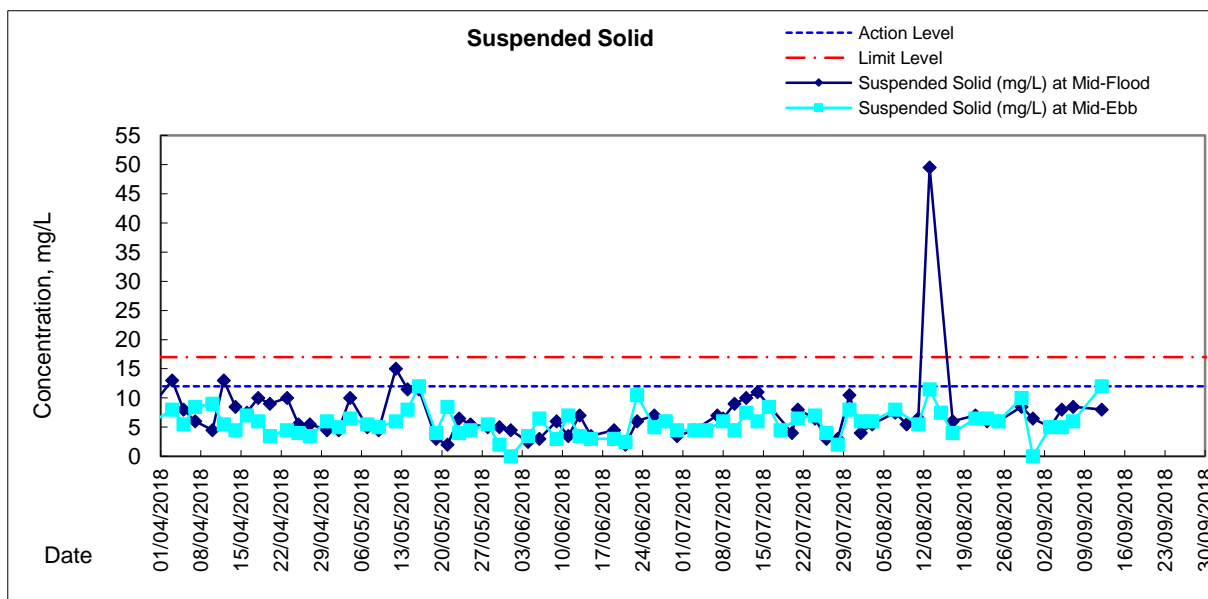
Graphic Presentation of Water Quality Result of M5B - Central Cooling Water Intake Groups

According to observation on 19 September 2018 morning, it was observed that ground surface at water quality monitoring station M5b was damaged after typhoon and the accesses of those WQM stations were fenced off due to safety concern. The scheduled Water Quality Monitoring at water quality monitoring station M5b was temporary suspended from 19 September 2018 onward.

- 5.3.7 One action level exceedance of dissolved oxygen was recorded at M5B – Central Cooling Intake on 7 September 2018 during flood tide. After investigation, no marine construction activity was conducted under Contract HK/2012/08 on the monitoring date while nearby culvert discharge was observed. In view of the above, it was considered that the exceedance was not related to Project. No exceedance was recorded on the subsequent monitoring on 10 September 2018 during ebb tide.
