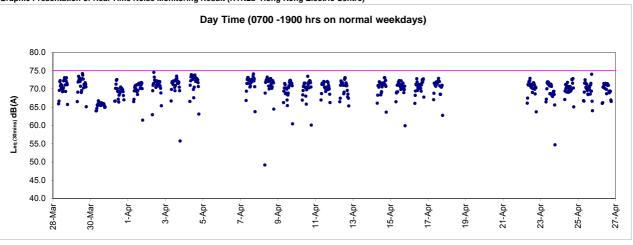
After checking with contractor HY/2009/19, no construction works were conducted at the concerned location during the recorded period. As such, the exceedances were considered to be contributed by nearby IEC traffic and nearby non- CWB Projects.

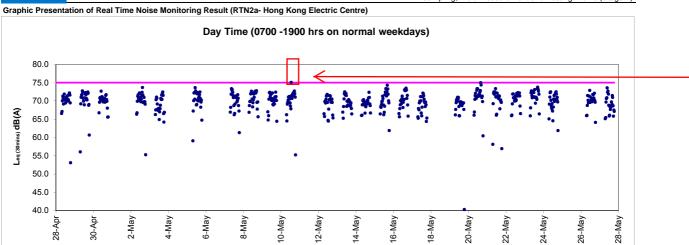
After checking with contractor HY/2009/19, no construction works were conducted at the concerned location during the recorded period and the exceedances were non-continuous and contributed by nearby IEC and slip road traffic.
