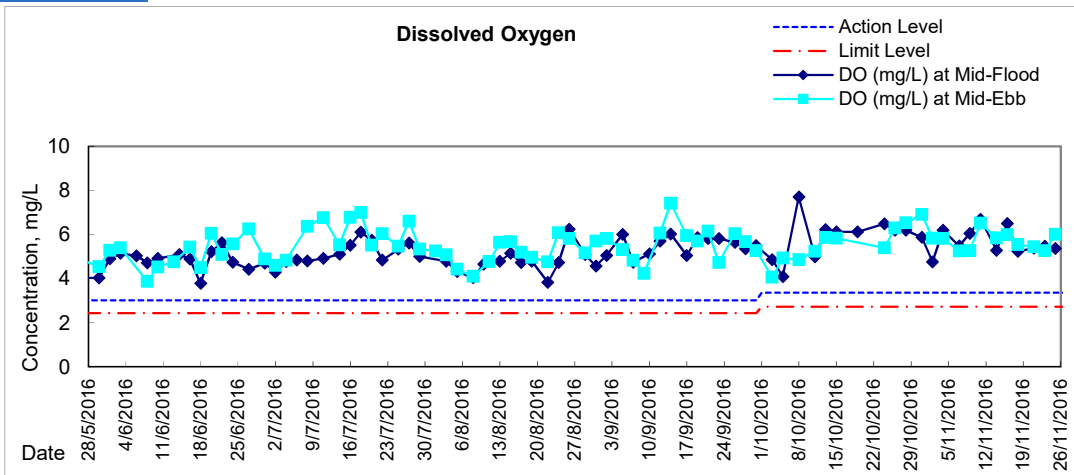
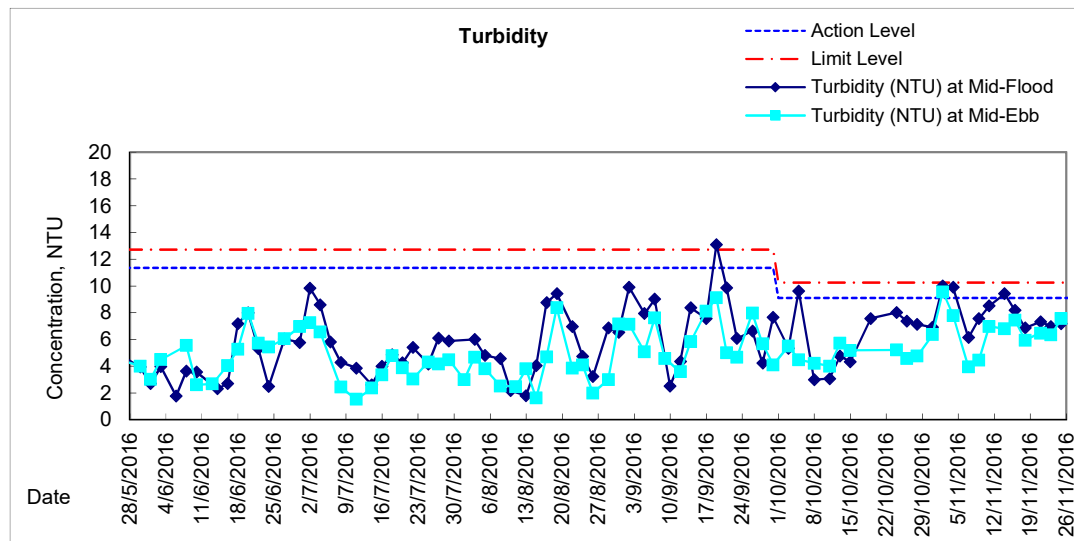
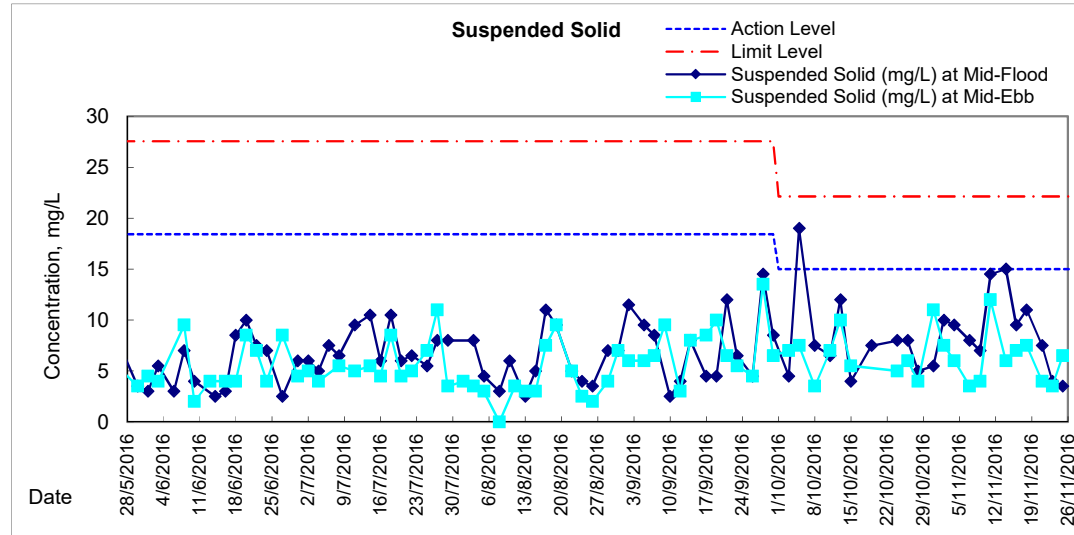
Graphic Presentation of Water Quality Result of C1 - HKCEC

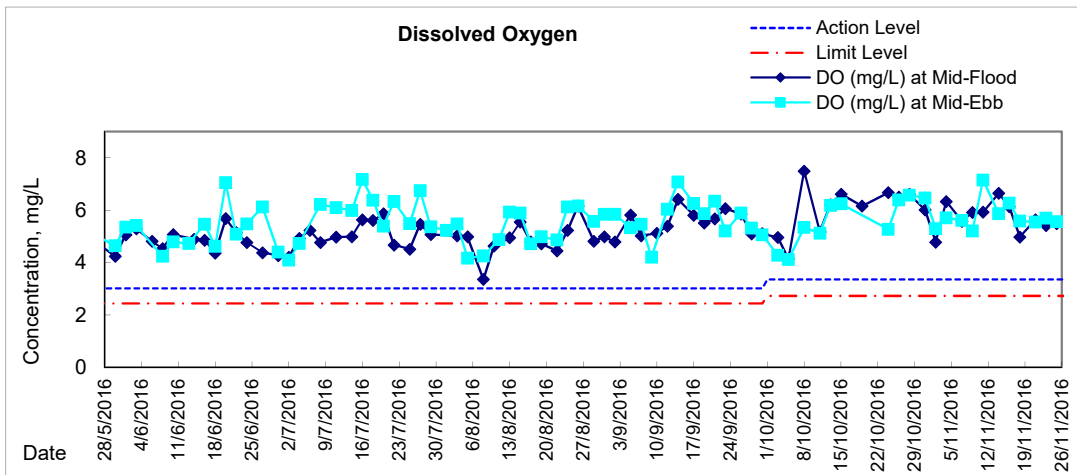
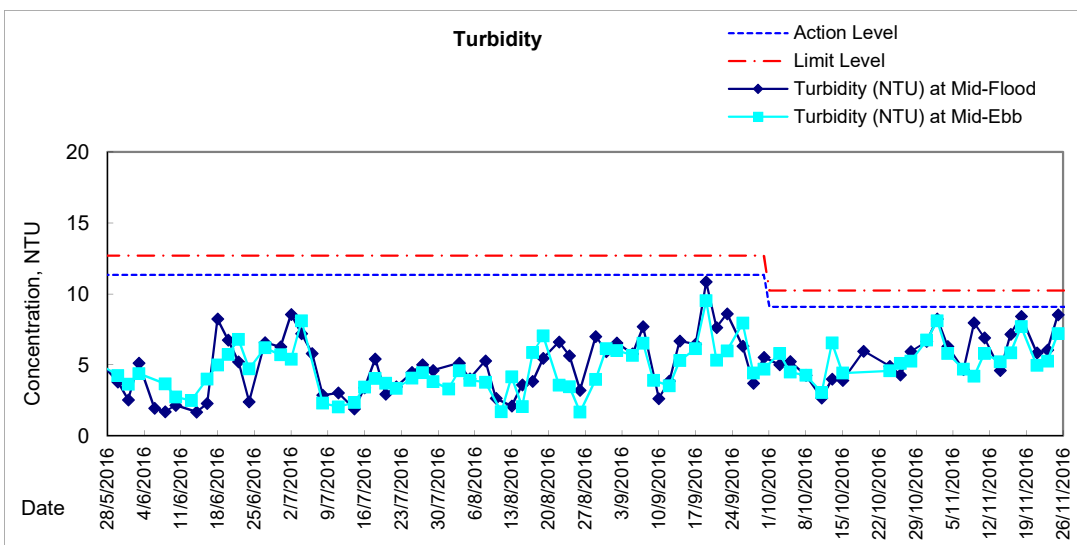
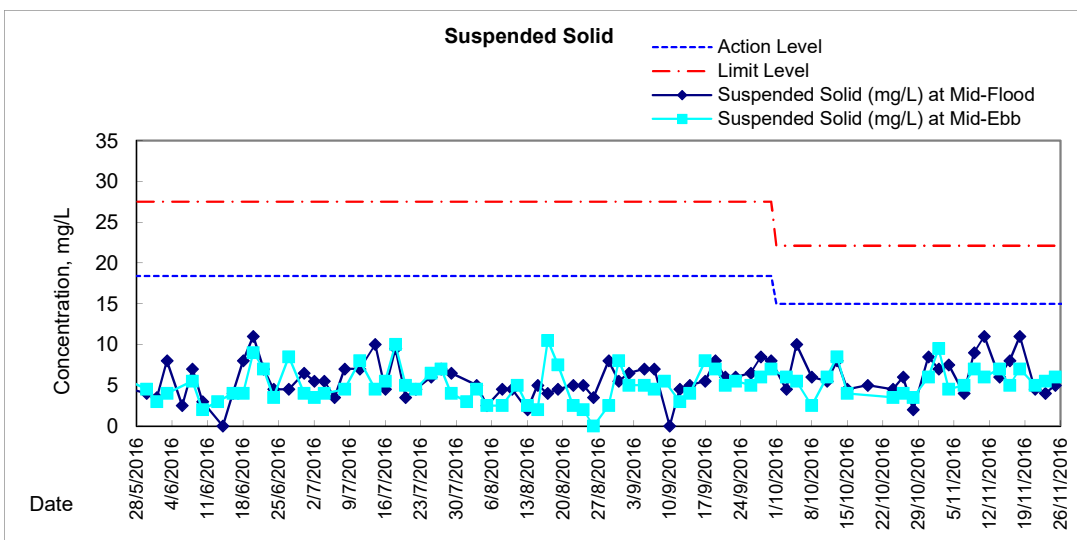
Graphic Presentation of Water Quality Result of P3 - APA

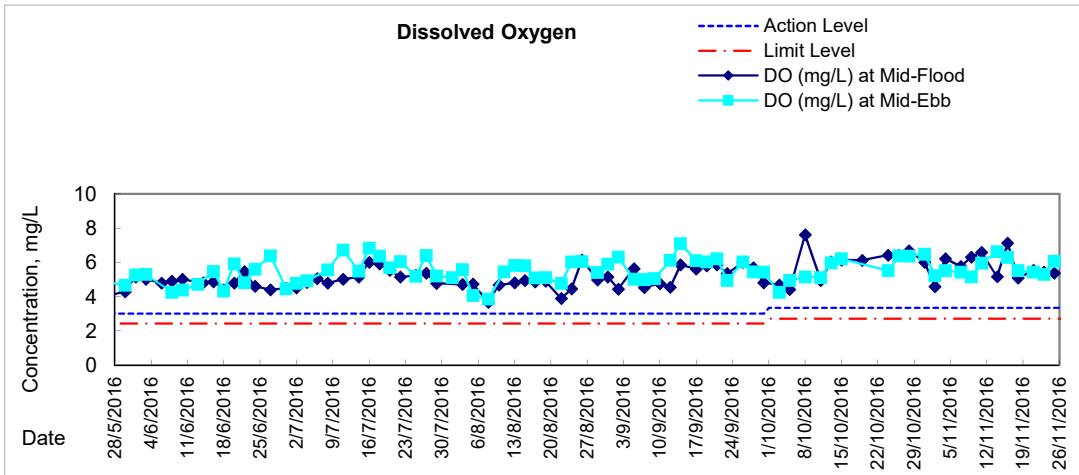
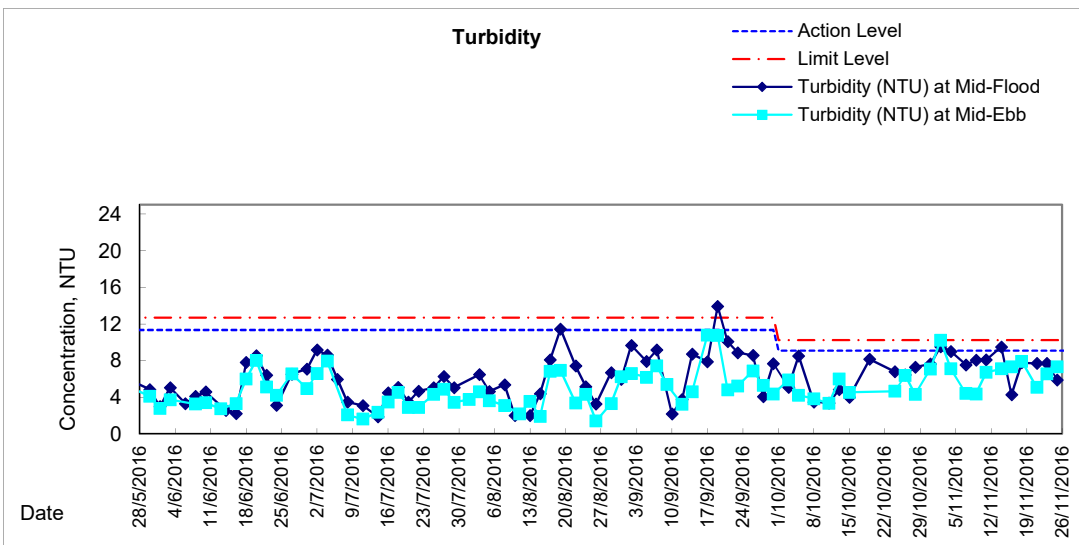
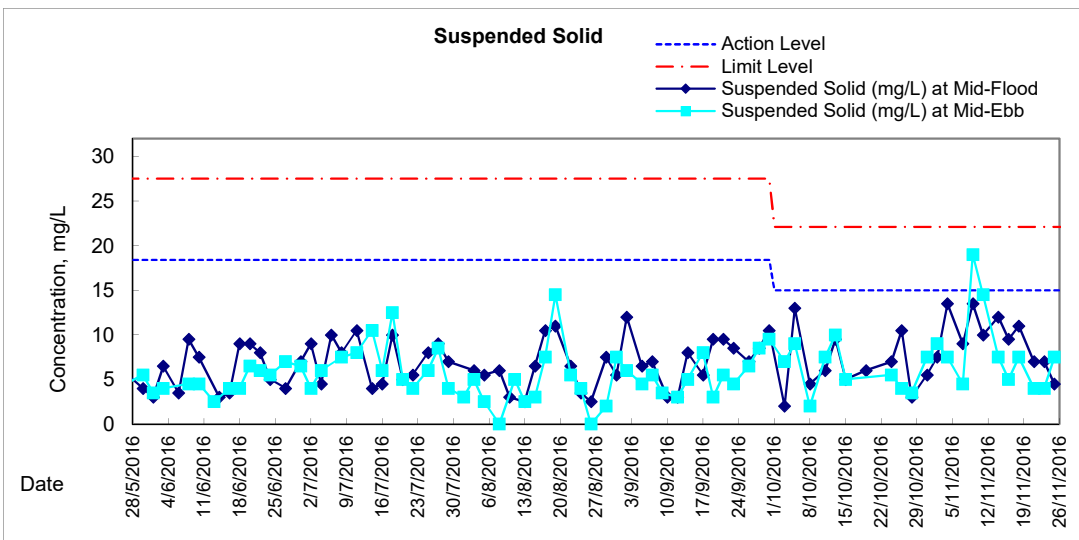
Graphic Presentation of Water Quality Result of P5 - WCT / RT / IT

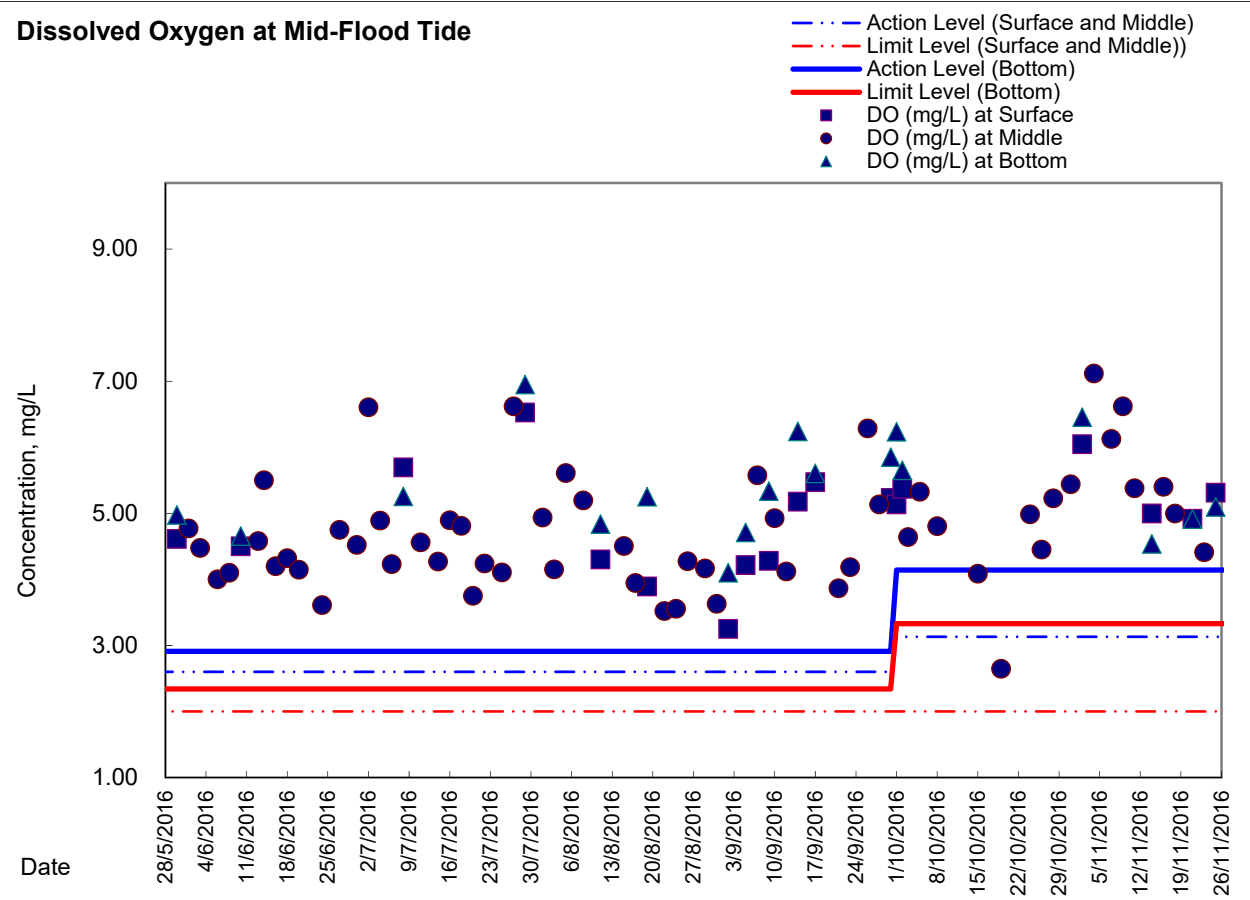
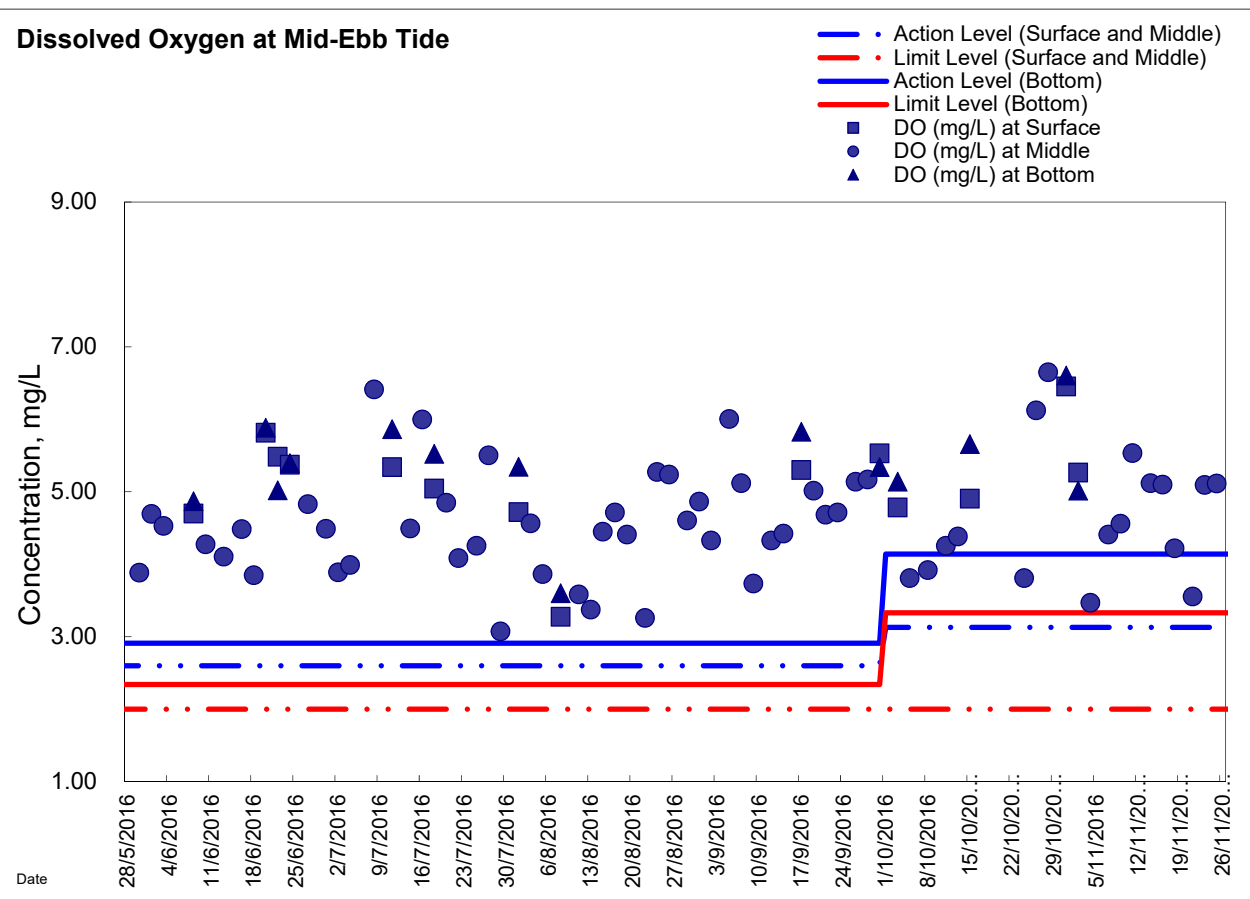
Graphic Presentation of Enhanced Water Monitoring Results (DO) at C6 - Excelsior Hotel

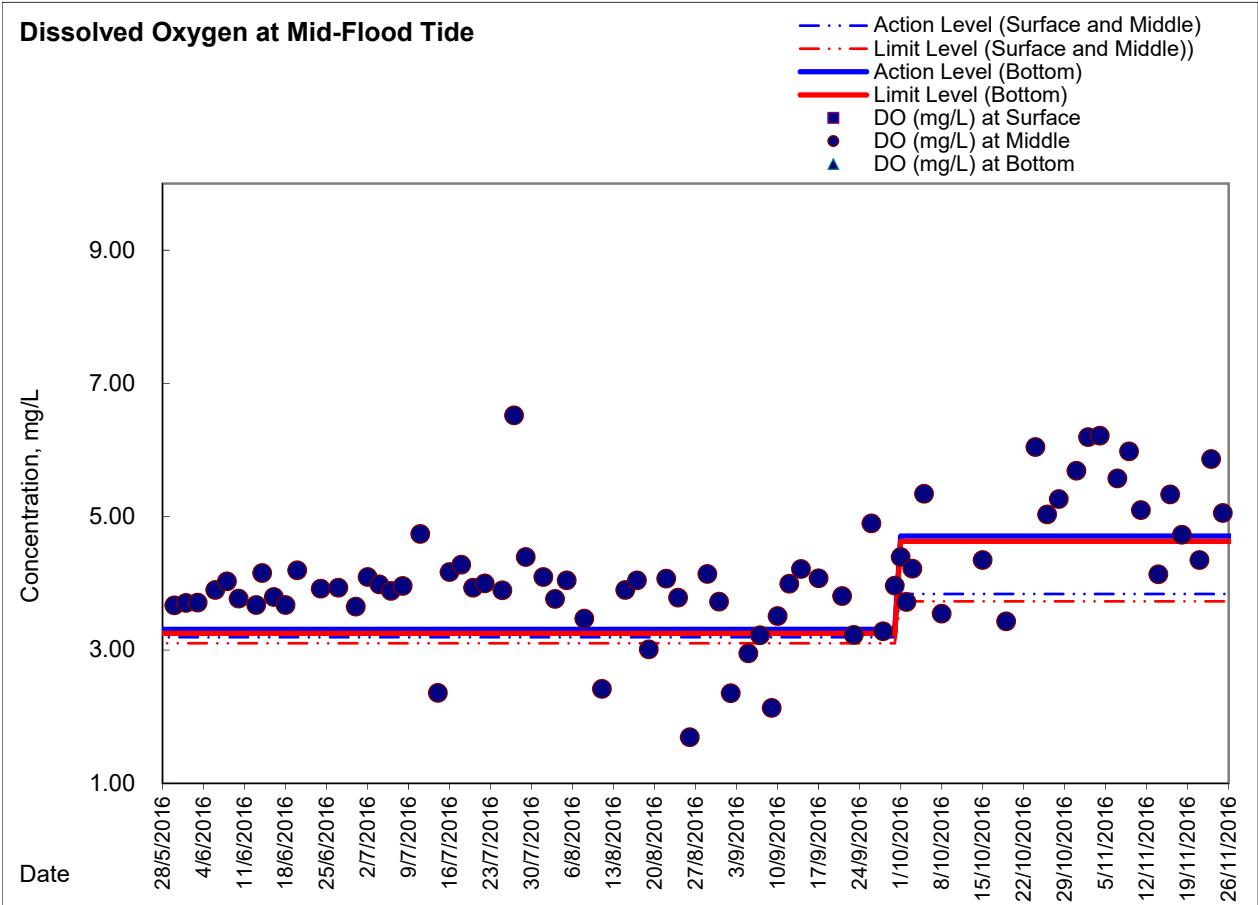
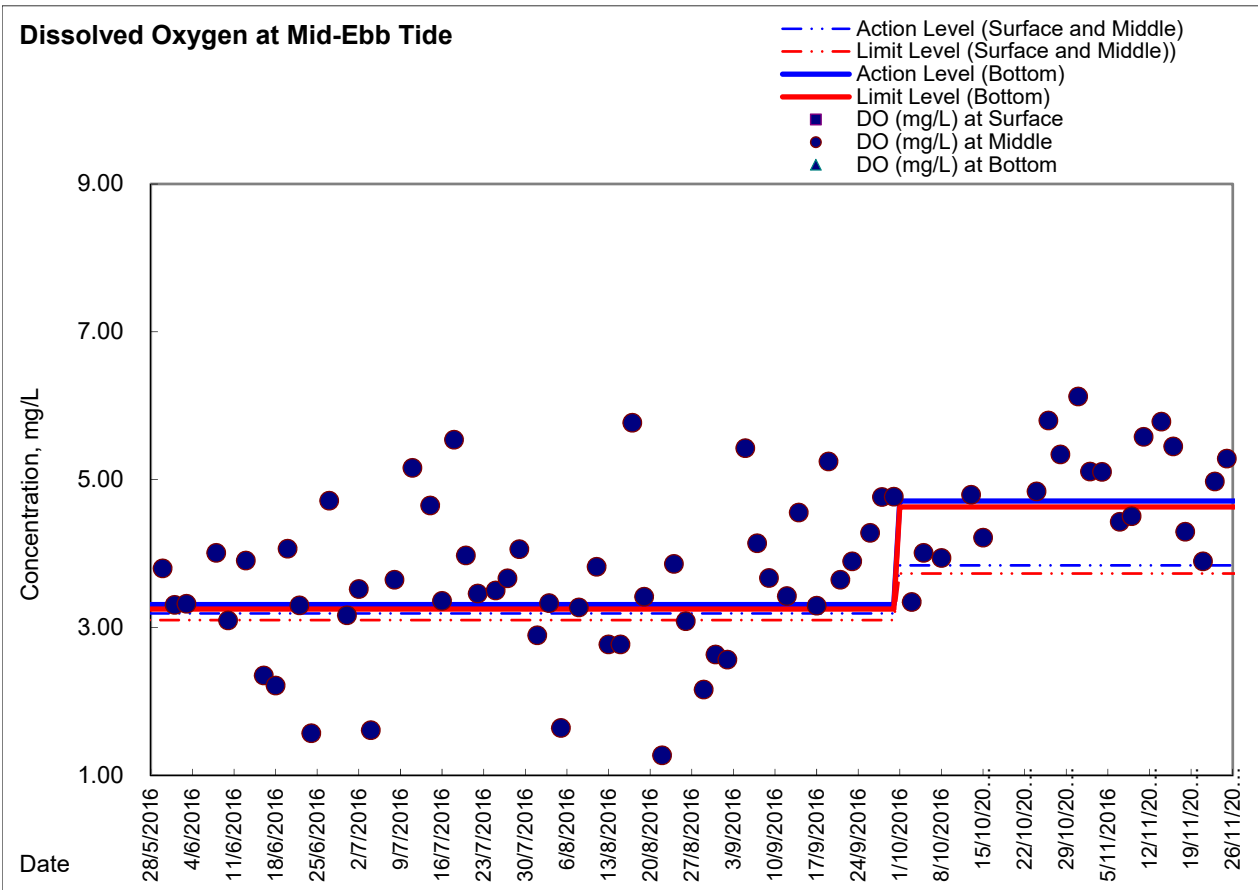
**Graphic Presentation of Enhanced Water Monitoring Results (DO) at Ex-WPCWA SW
- South-western corners of ex-Public Cargo Works Area**

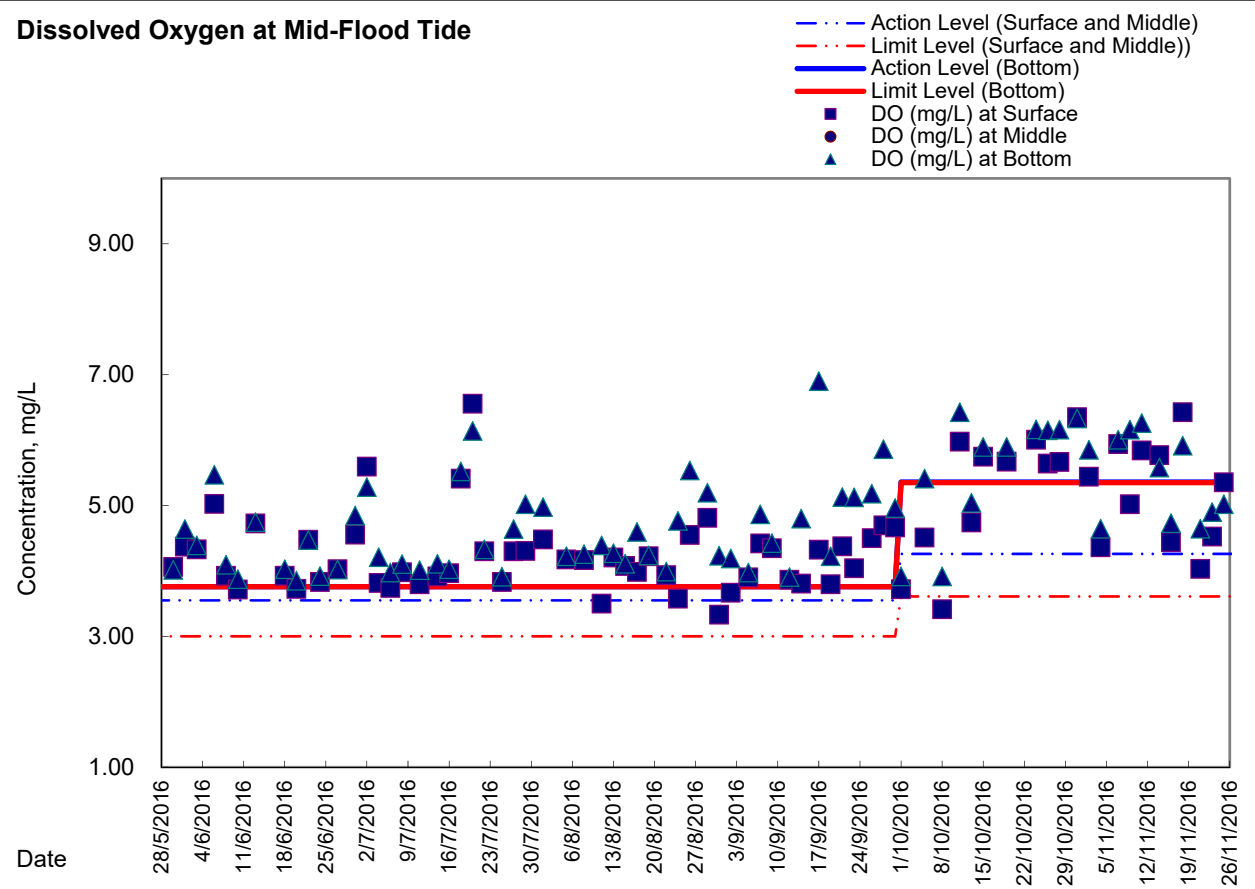
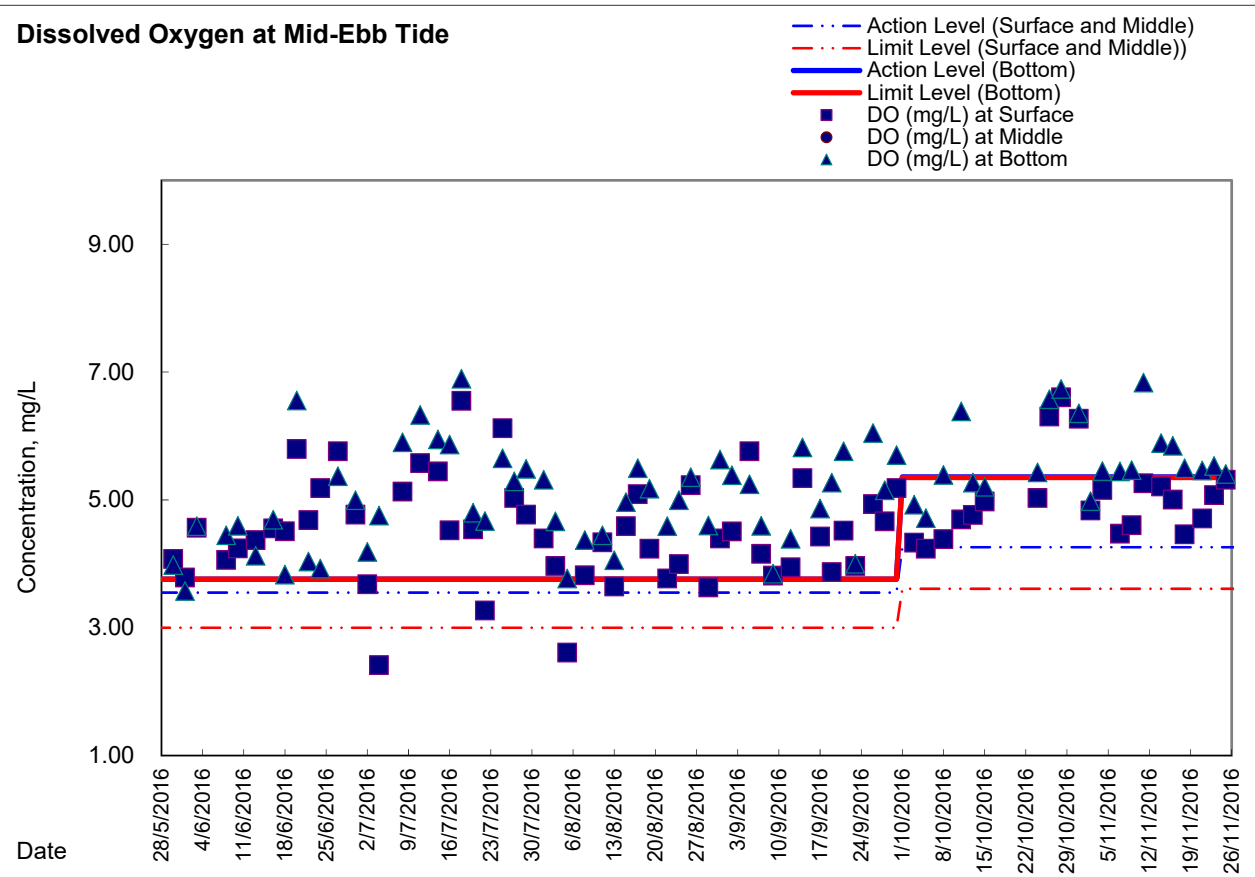
**Graphic Presentation of Enhanced Water Monitoring Results (DO) at Ex-WPCWA SE
- South-eastern corners of ex-Public Cargo Works Area**
