# Graphic Presentation of Water Quality Result of WSD19 - Sheung Wan

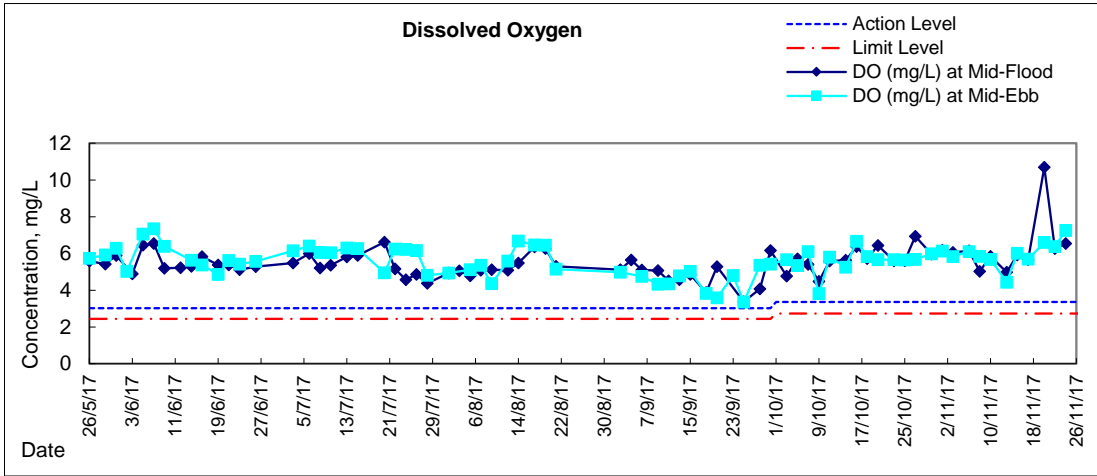
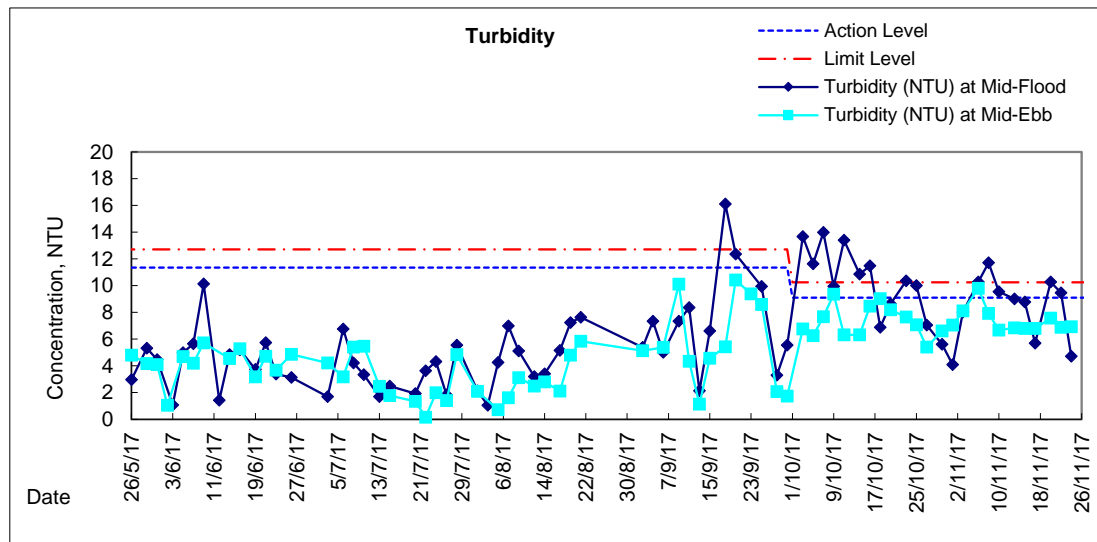
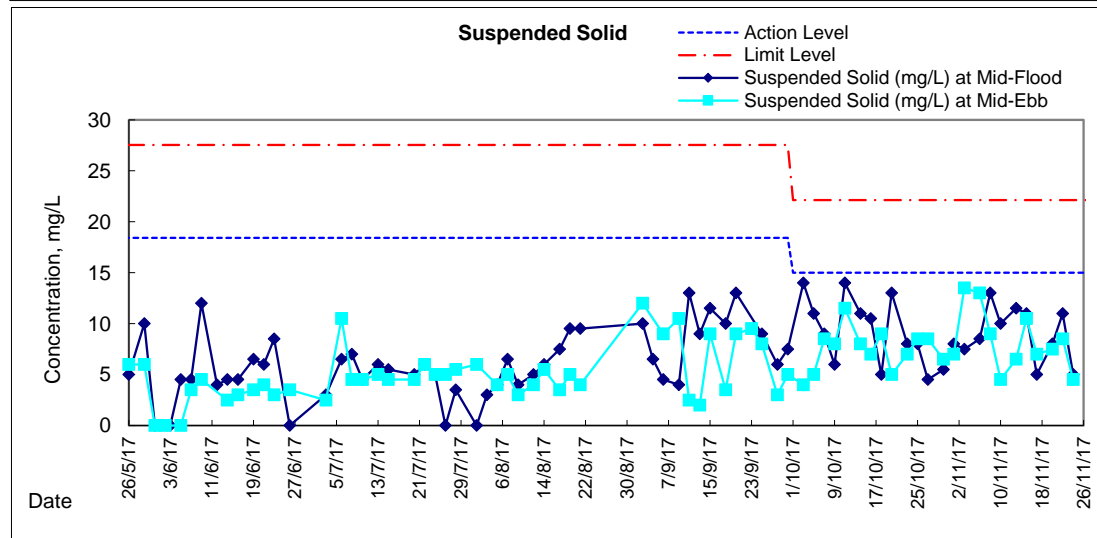
### Graphic Presentation of Water Quality Result of C1 - HKCEC

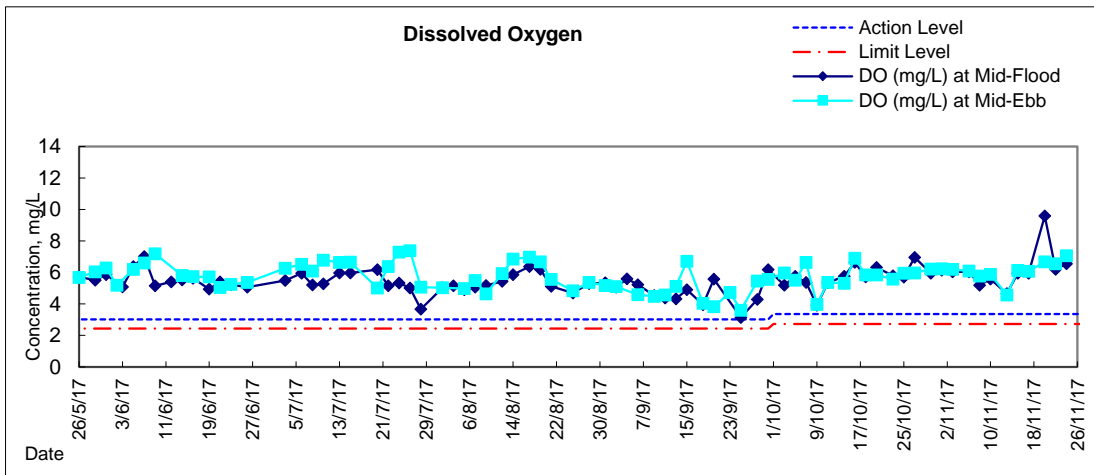
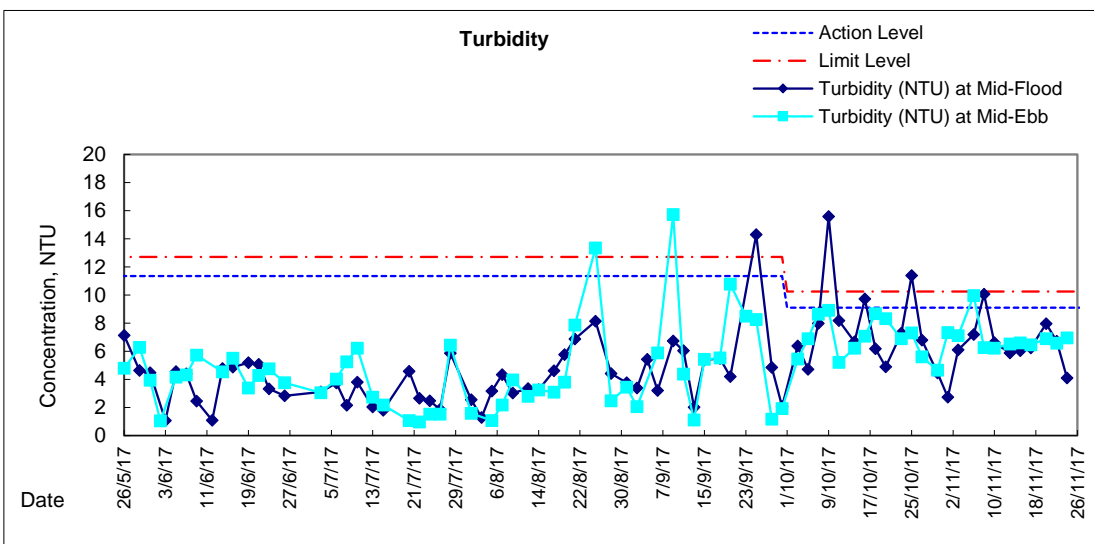
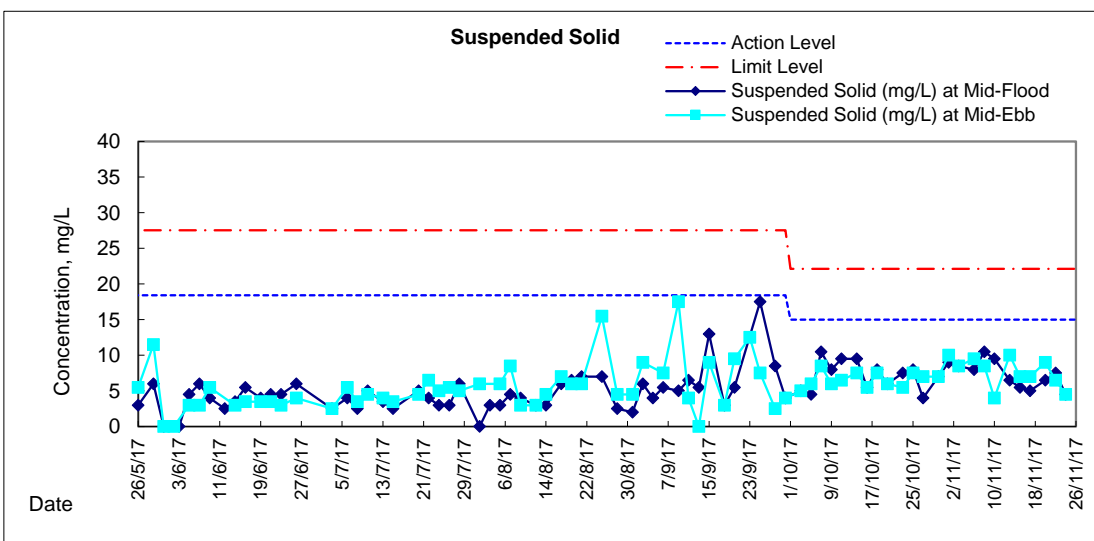
# Graphic Presentation of Water Quality Result of P1 - HKCEC Phase I

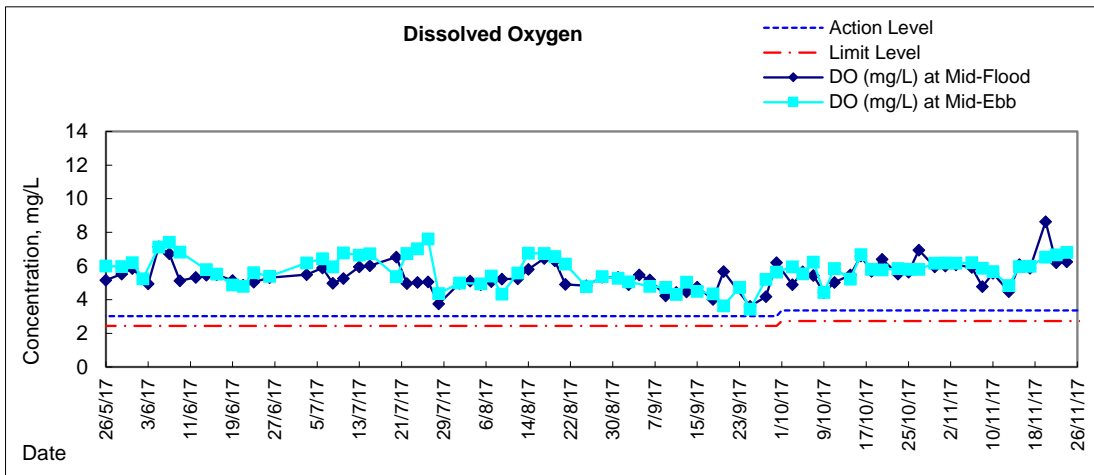
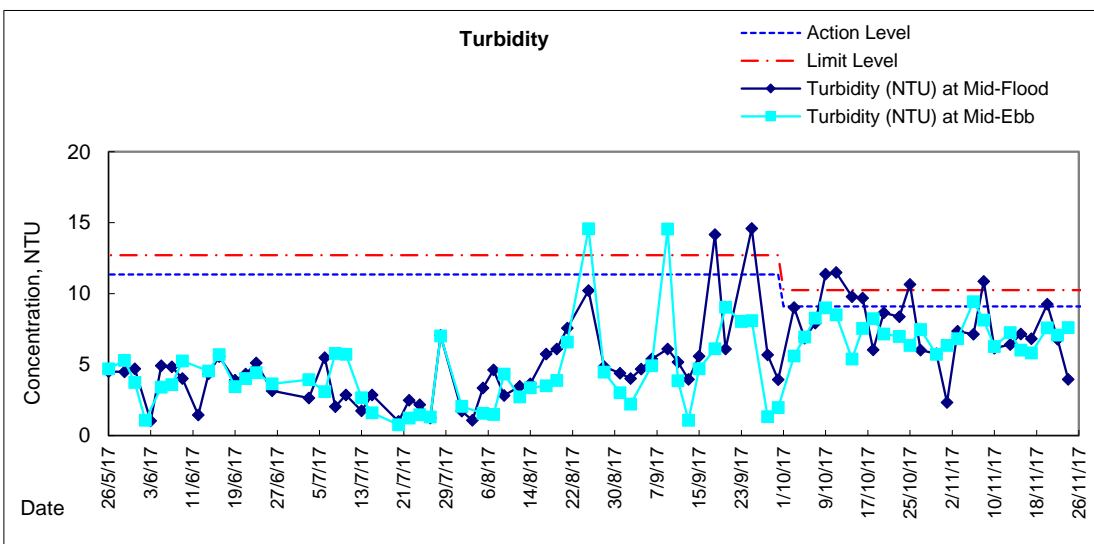
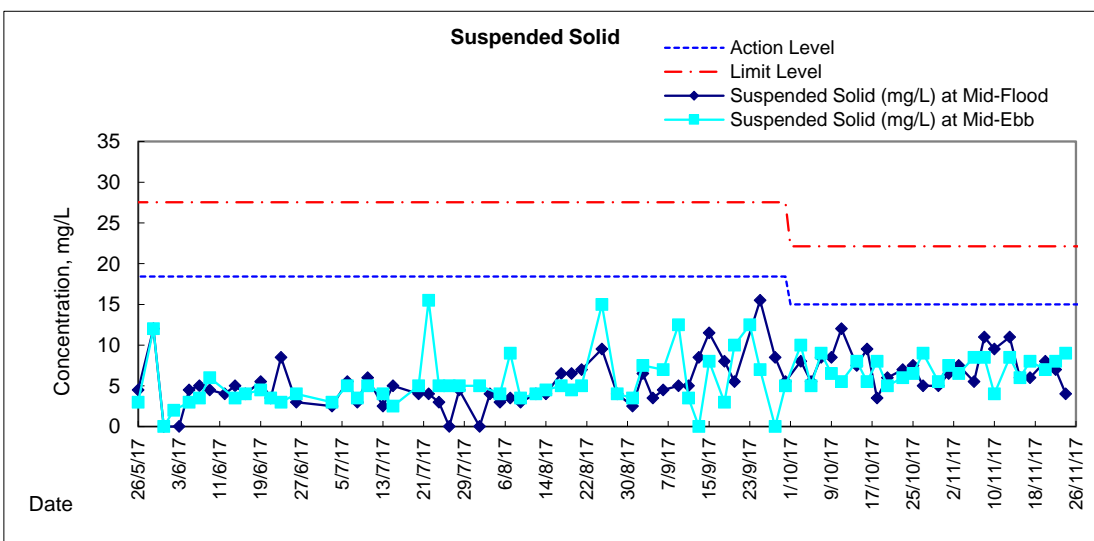
### Graphic Presentation of Water Quality Result of P3 - APA

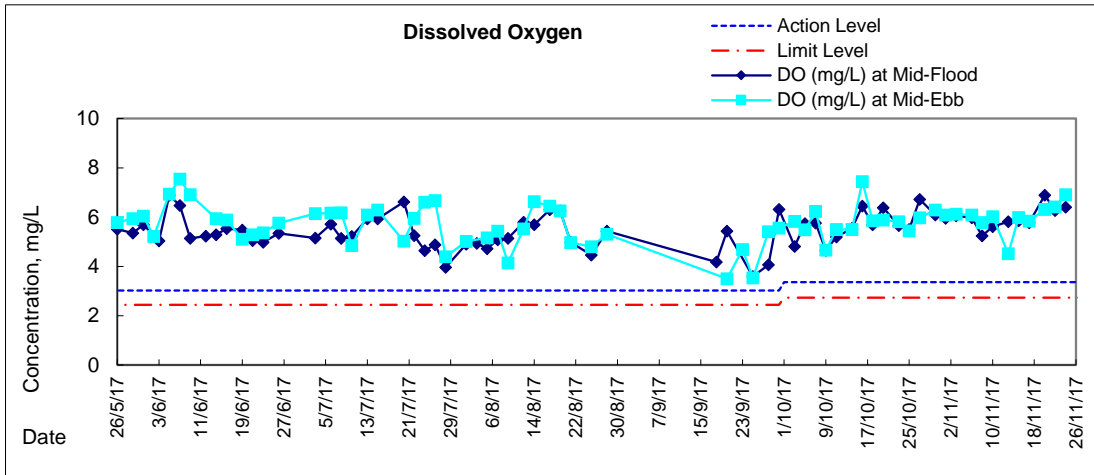
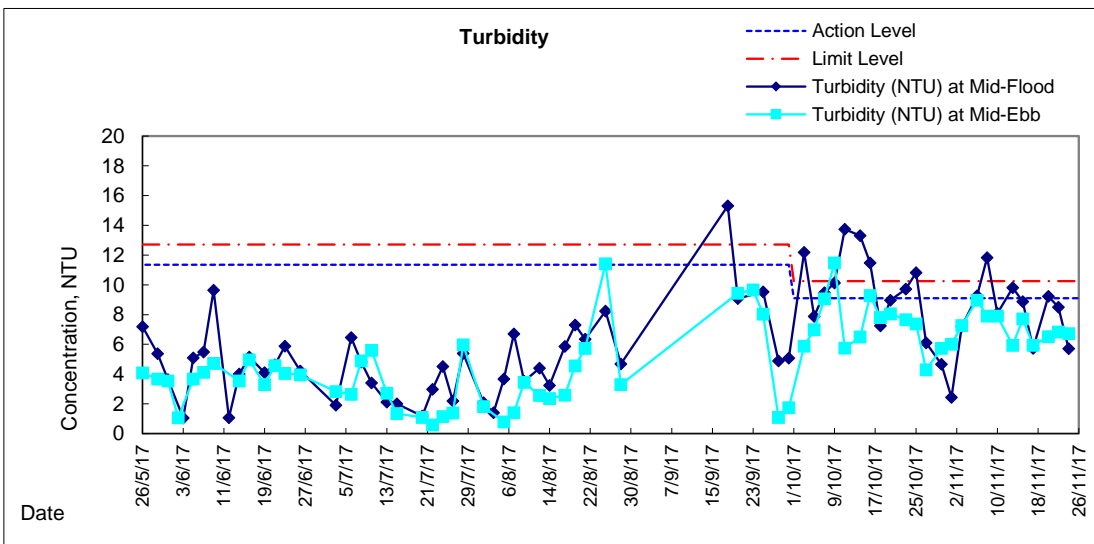
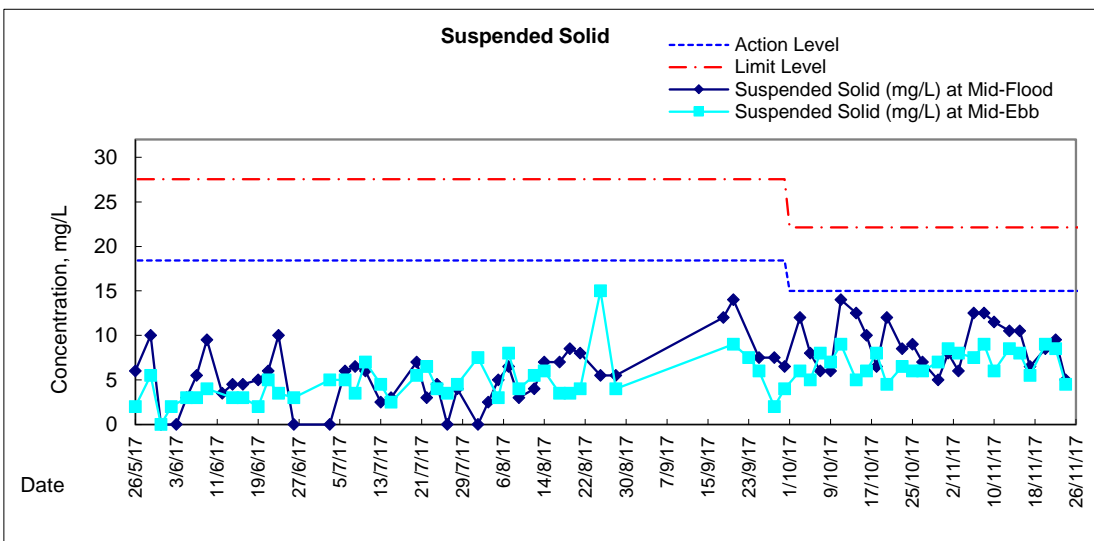
### Graphic Presentation of Water Quality Result of P5 - WCT / RT / IT

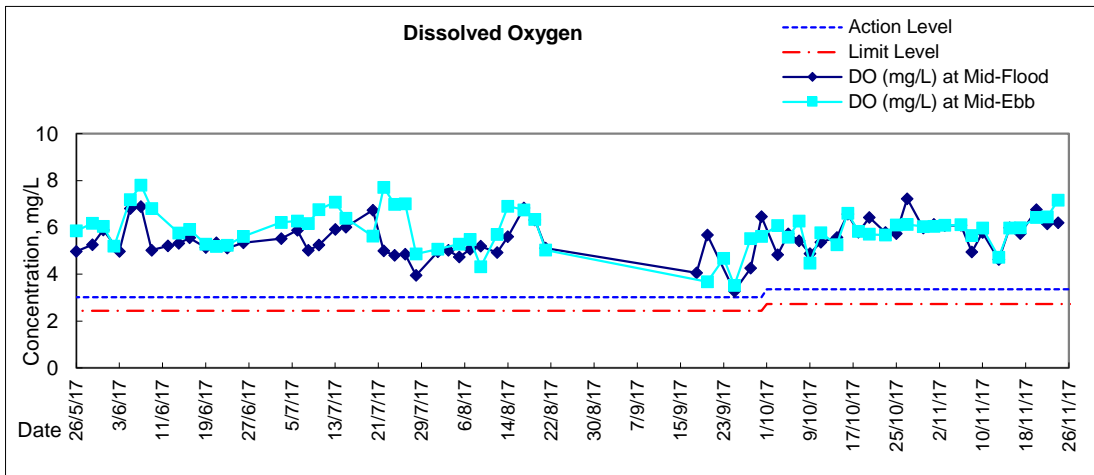
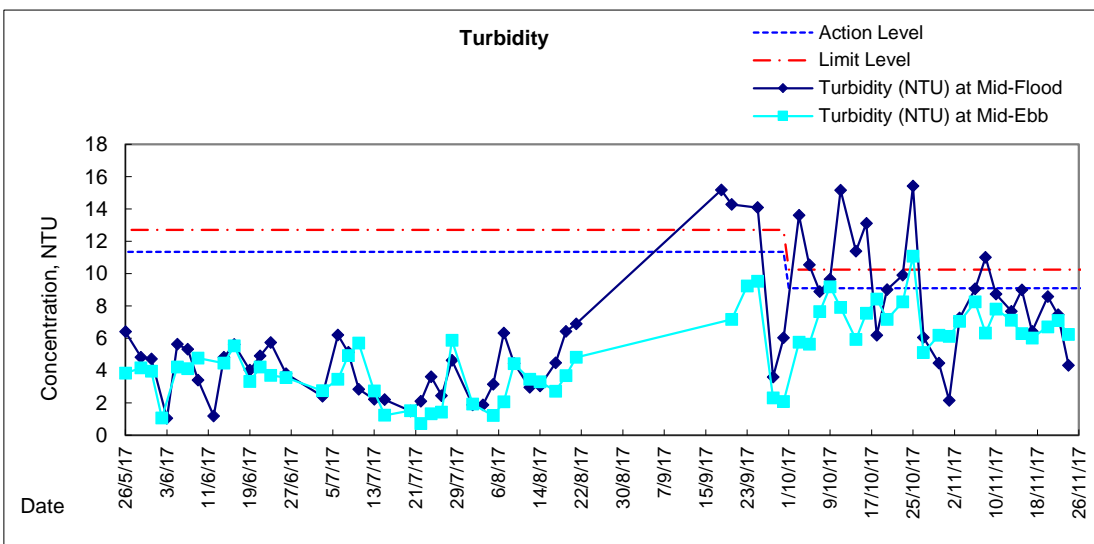
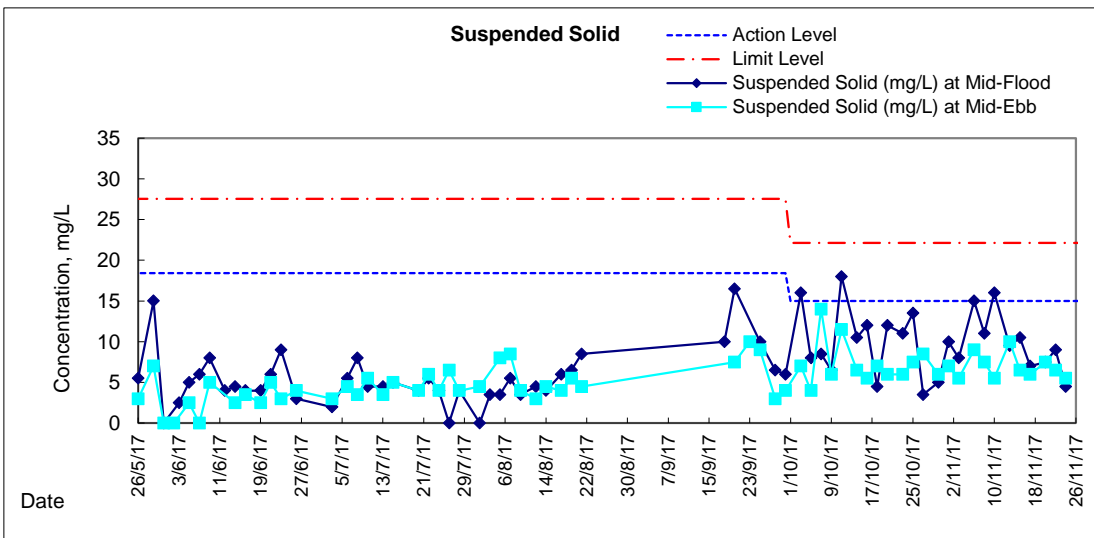
# Graphic Presentation of Water Quality Result of P4 - SOC

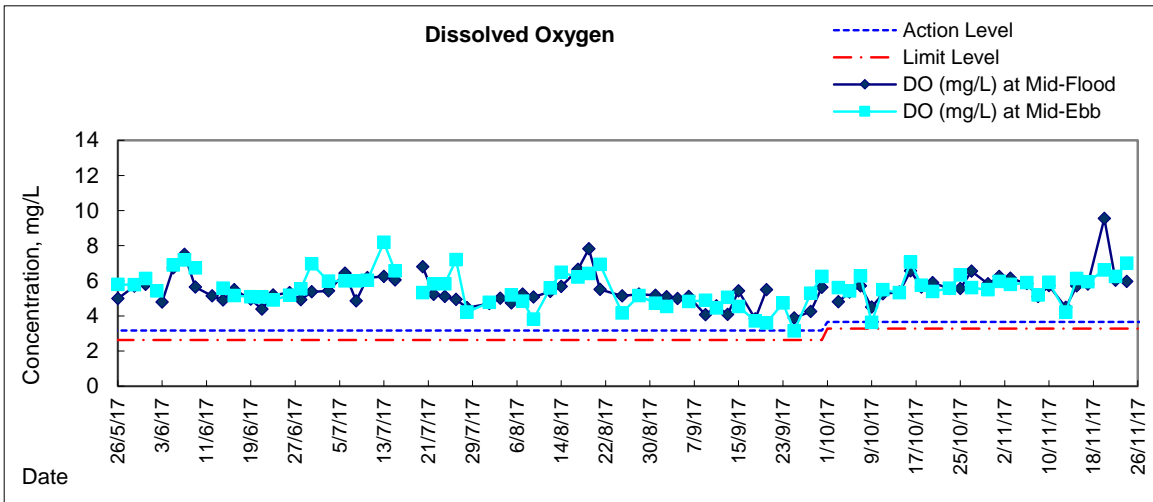
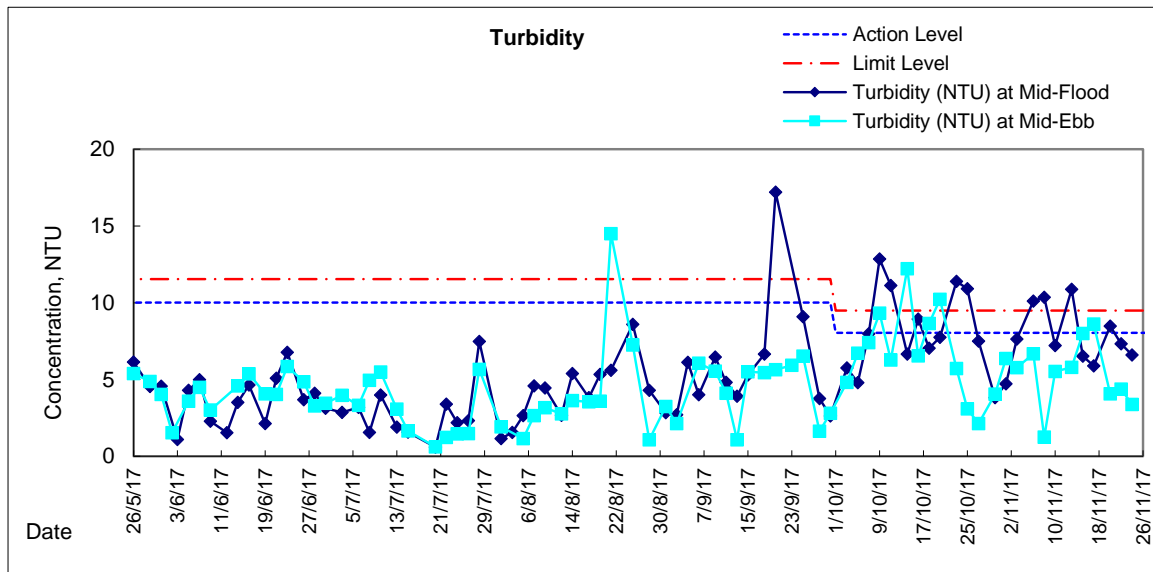
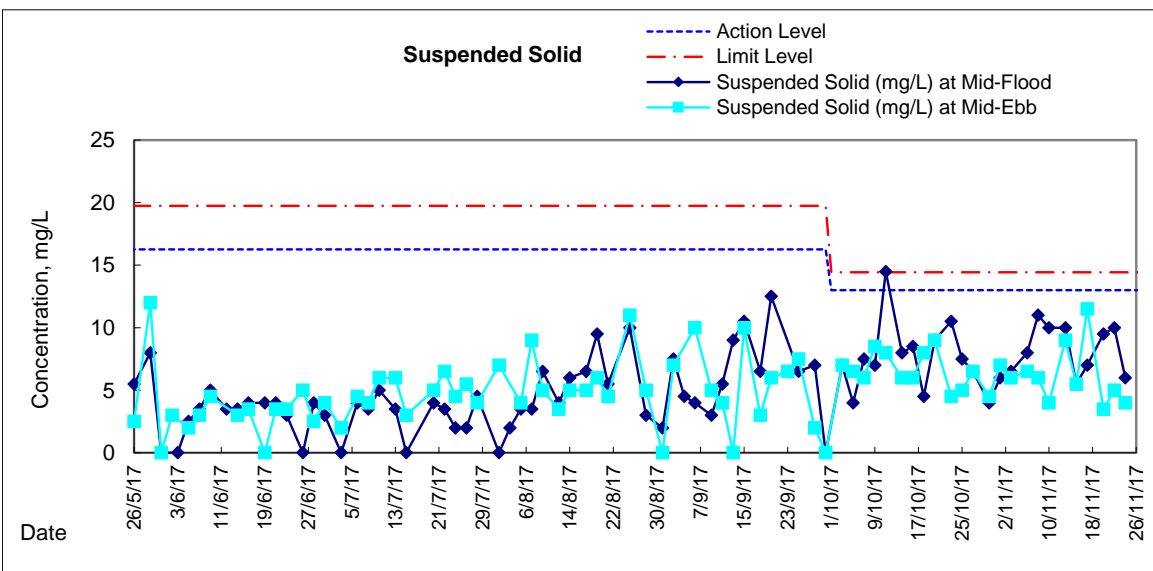
# Graphic Presentation of Water Quality Result of RW21-P789 - GEC/CRC/SHK

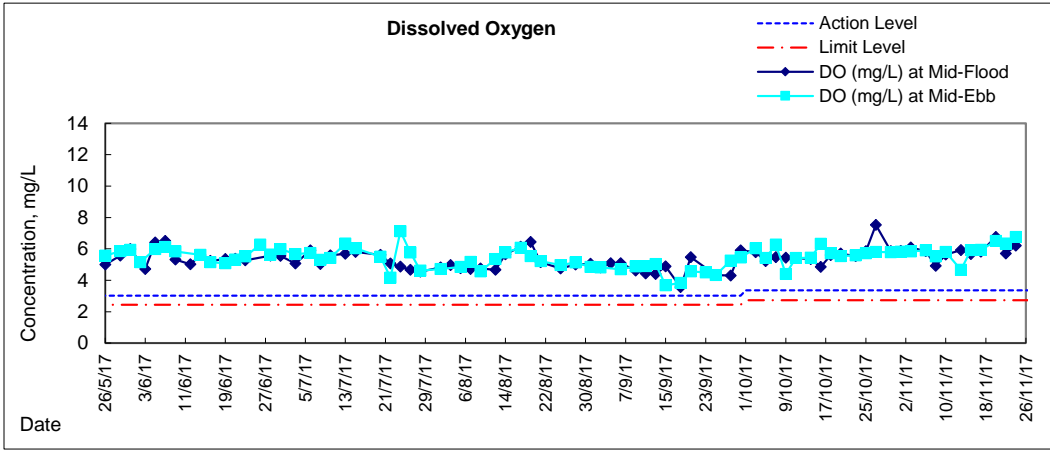
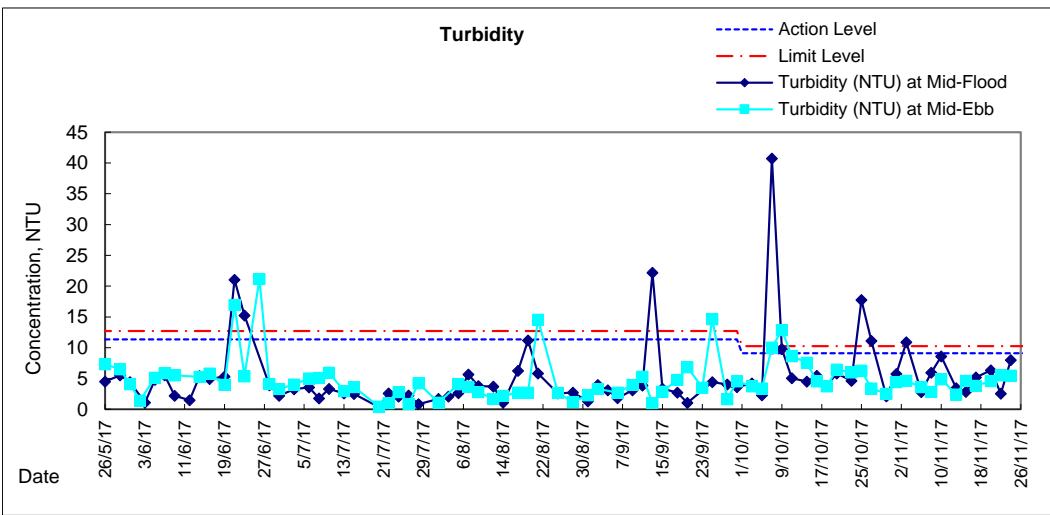
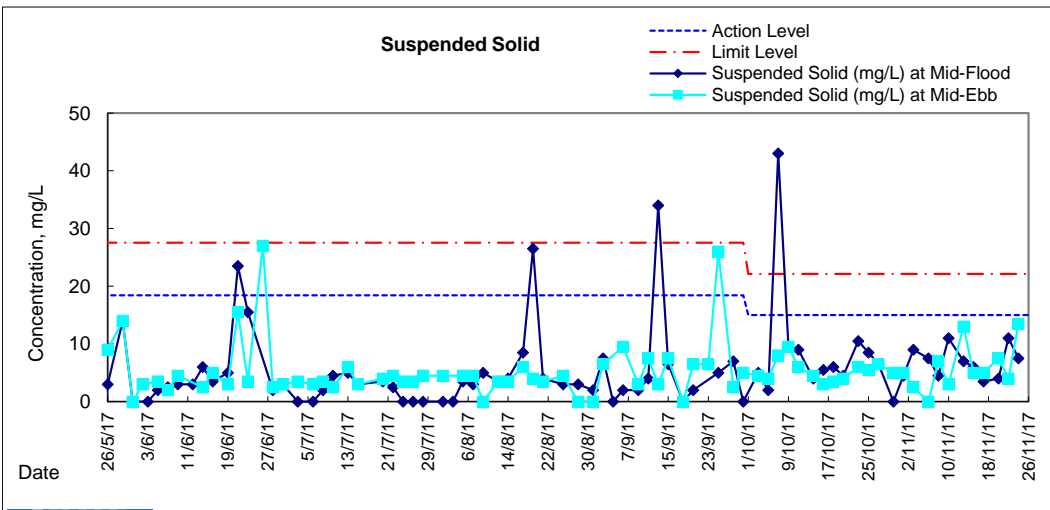
# Graphic Presentation of Water Quality Result of C7 - Windsor House

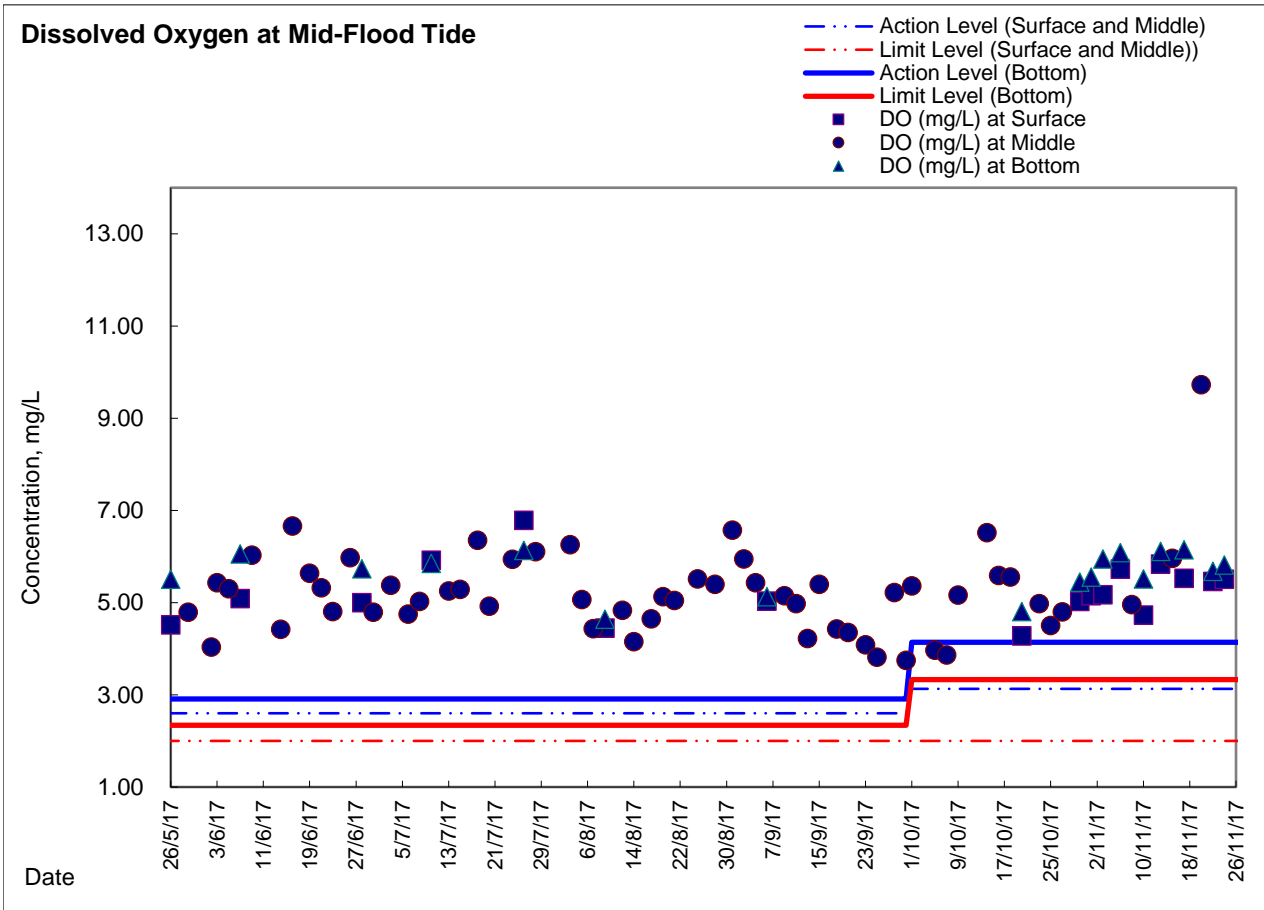
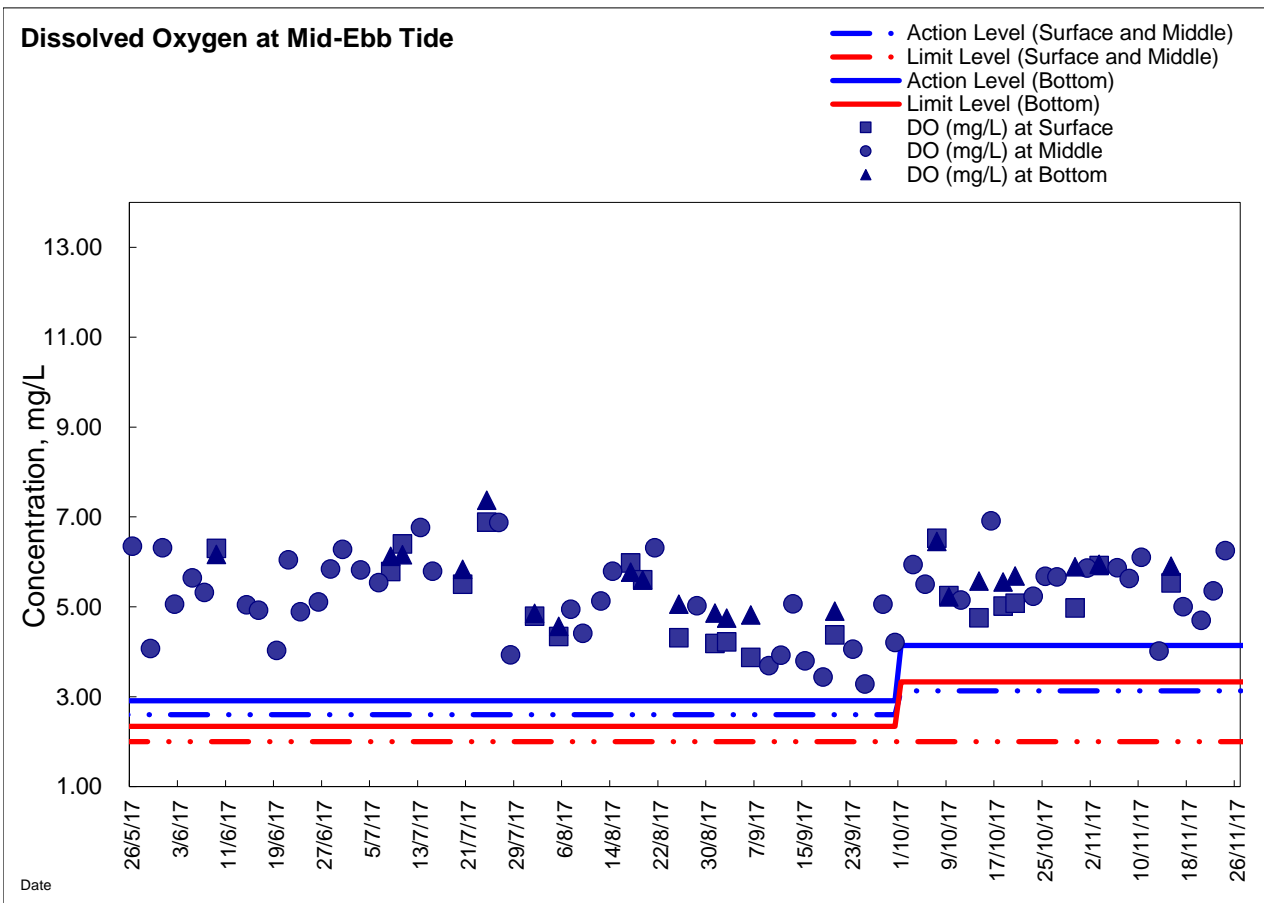
### Graphic Presentation of Enhanced Water Monitoring Results (DO) at C6 - Excelsior Hotel
