Graphic Presentation of Water Quality Result of C1 - HKCEC

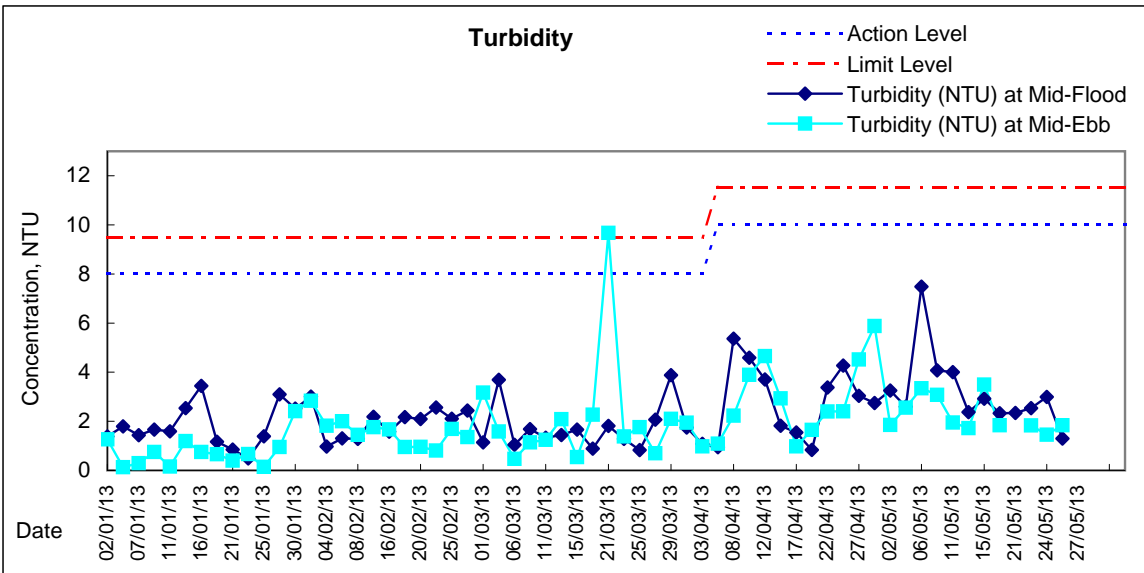
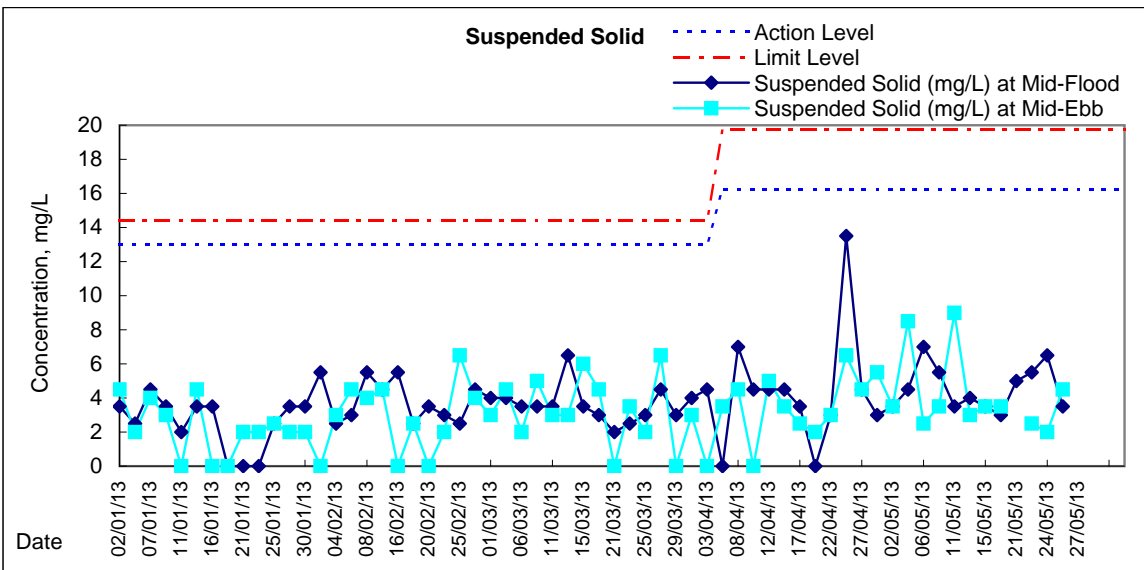
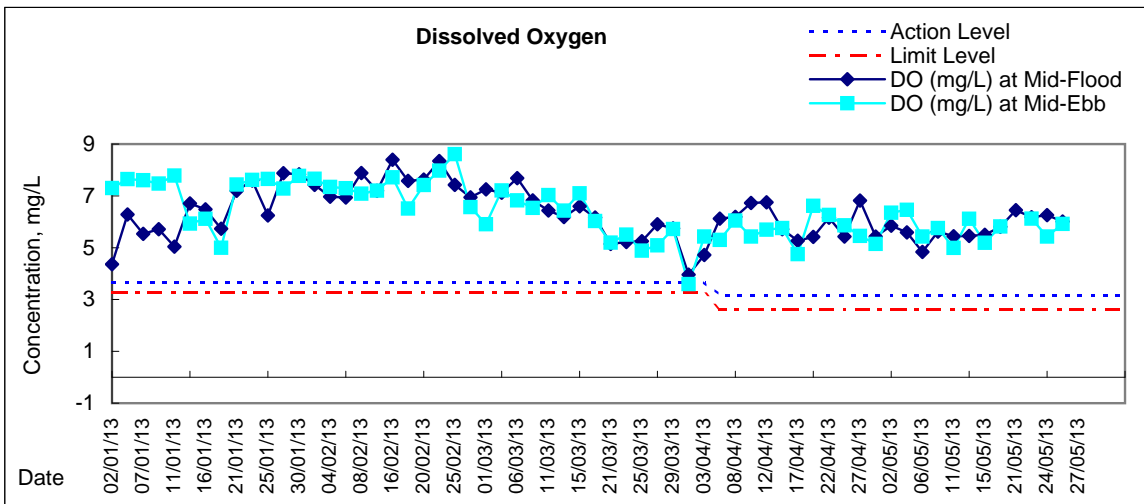
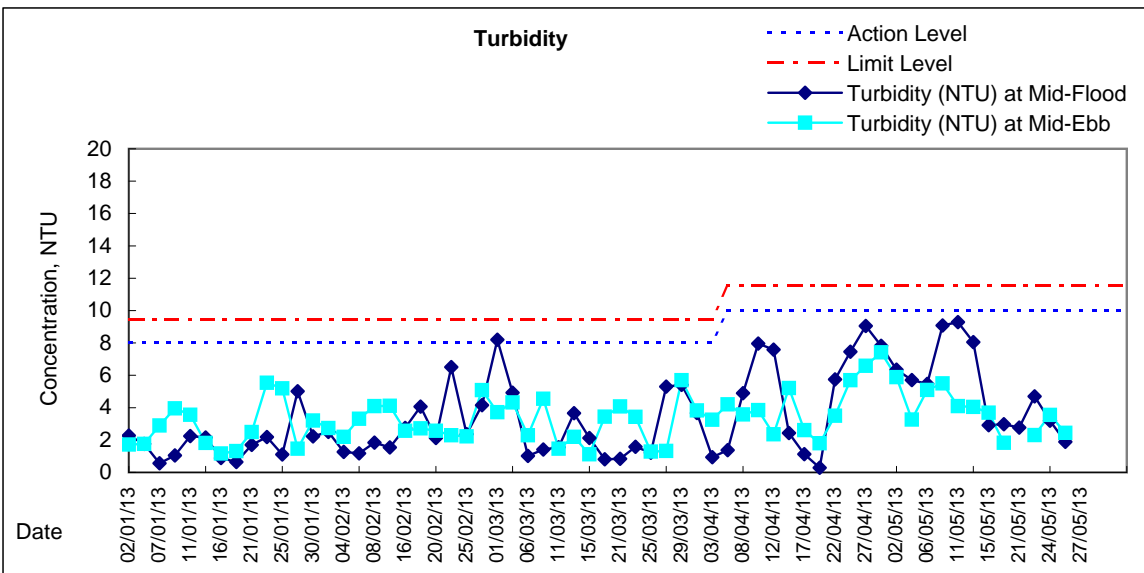
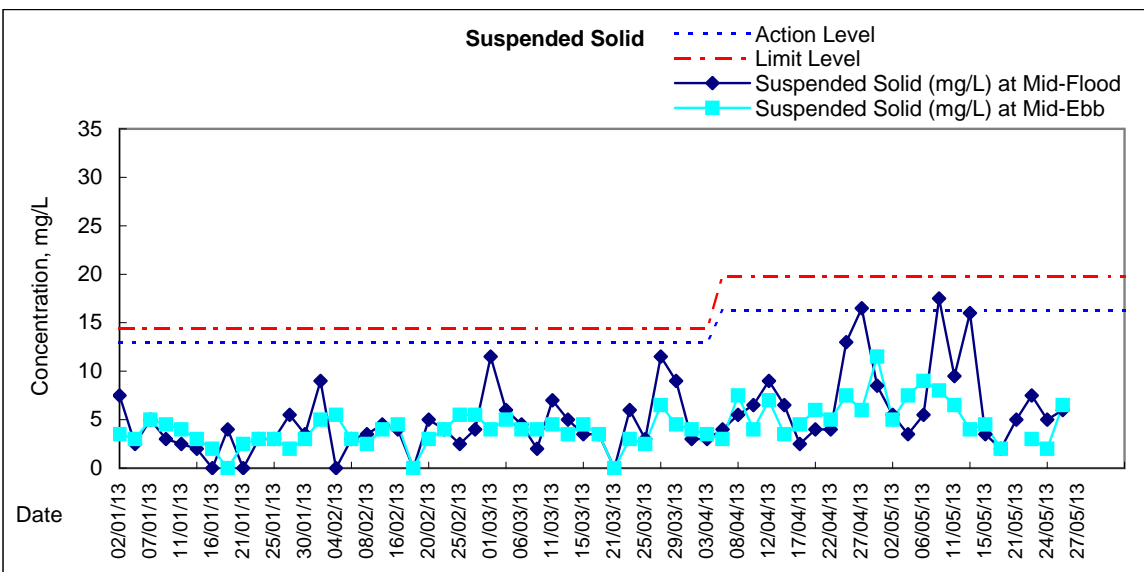
Remarks: Due to the blockage of road access to C1 on 15 Dec 2012 during mid-flood, the water quality monitoring was cancelled at C1 on 15 Dec 2012 during mid-flood.

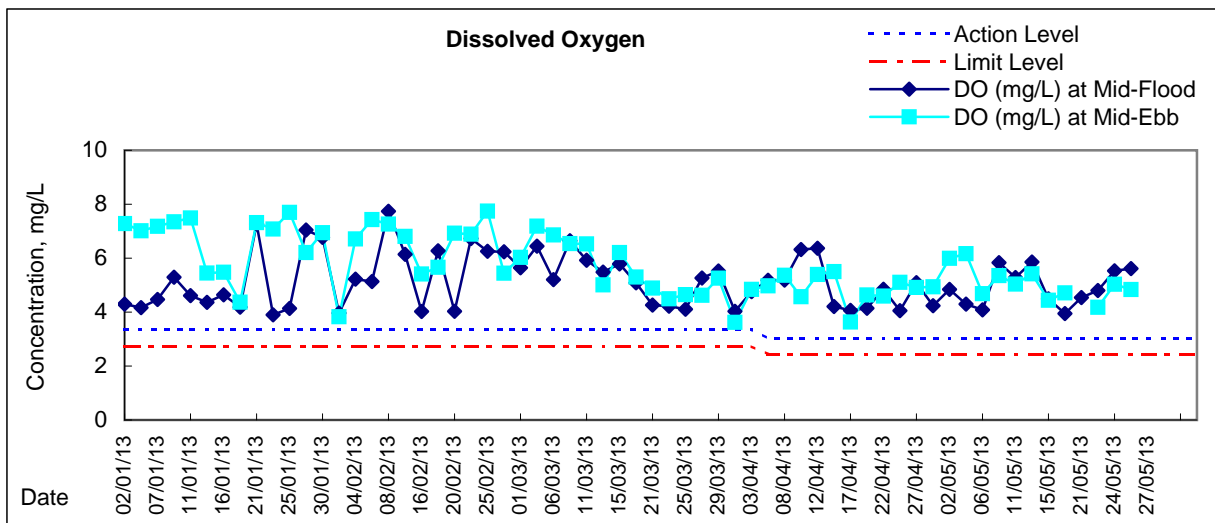
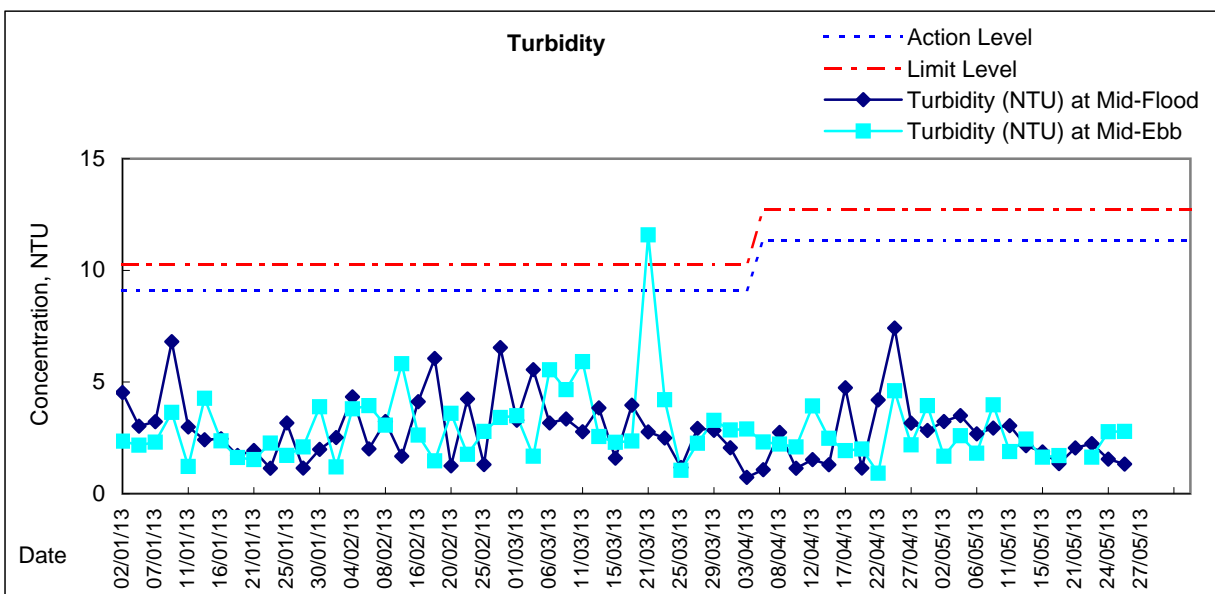
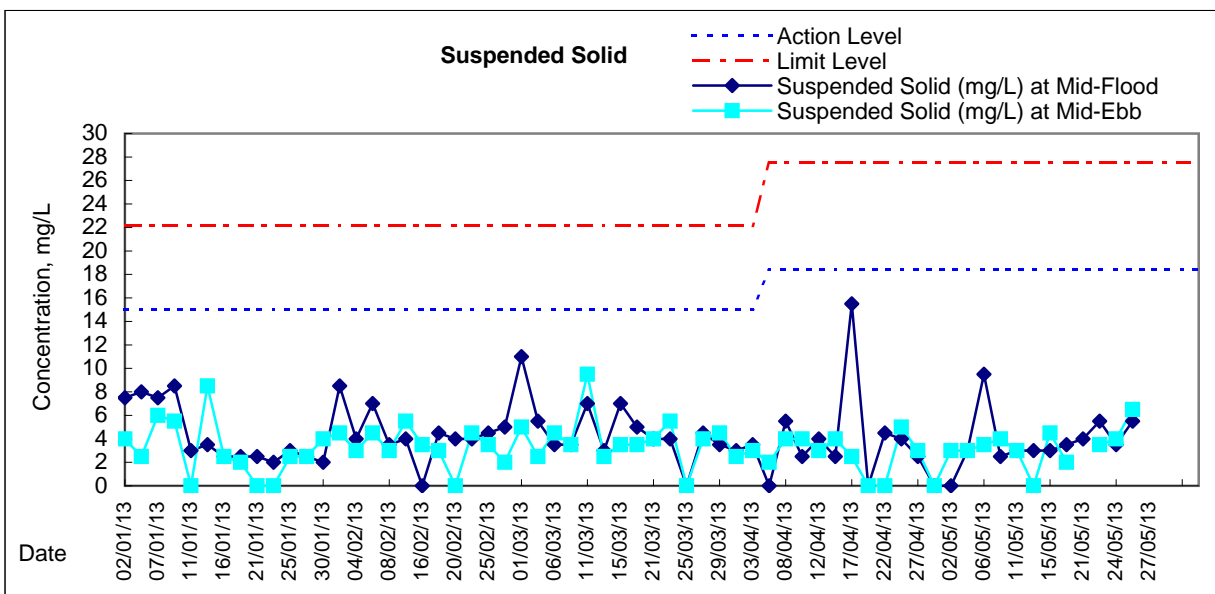
Graphic Presentation of Water Quality Result of C7 - Windsor House

*Due to the Amber rainstorm signal was hoisted on 20 May 13 at ebb tide, the water quality monitoring was cancelled.
