Graphic Presentation of Real Time Noise Monitoring Result (RTN2a- Hong Kong Electric Centre)

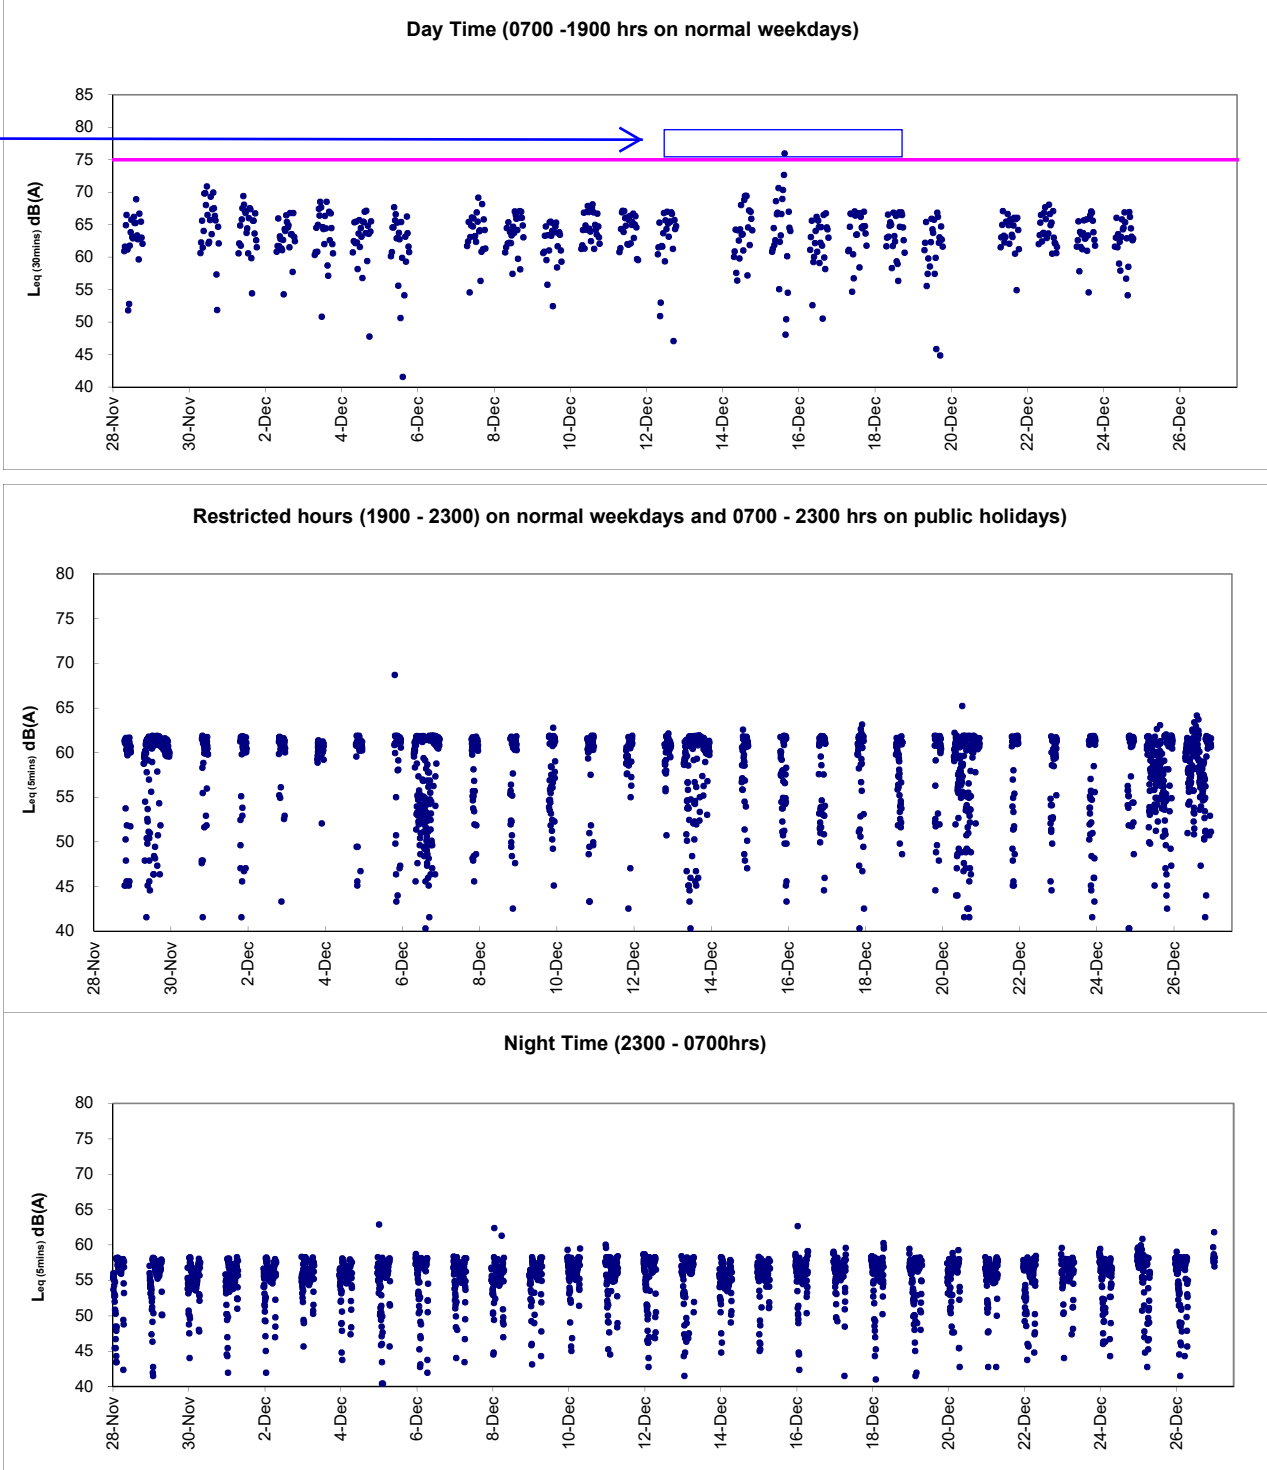
After checking with Contractor of HY/2009/19, on 15 December 2015, concreting was undertaken by Contract HY/2009/19 while steel bar cutting works for Hong Kong Electric Centre was conducted at the roof top by non-CWB Contractor immediately next to the noise monitoring station. In view of the mitigation measures implemented and the non-CWB works conducted next to the monitoring station as major noise contribution, the exceedance was considered as non-Project related.
