WANCHAI DEVELOPMENT PHASE II AND CENTRAL  
WANCHAI BYPASS  
SAMPLING, FIELD MEASUREMENT AND TESTING WORK  
(STAGE 3)

ENVIRONMENTAL PERMIT NO. EP-122/2002/E

MONTHLY ENVIRONMENTAL MONITORING & AUDIT REPORT

- AUGUST 2017 -

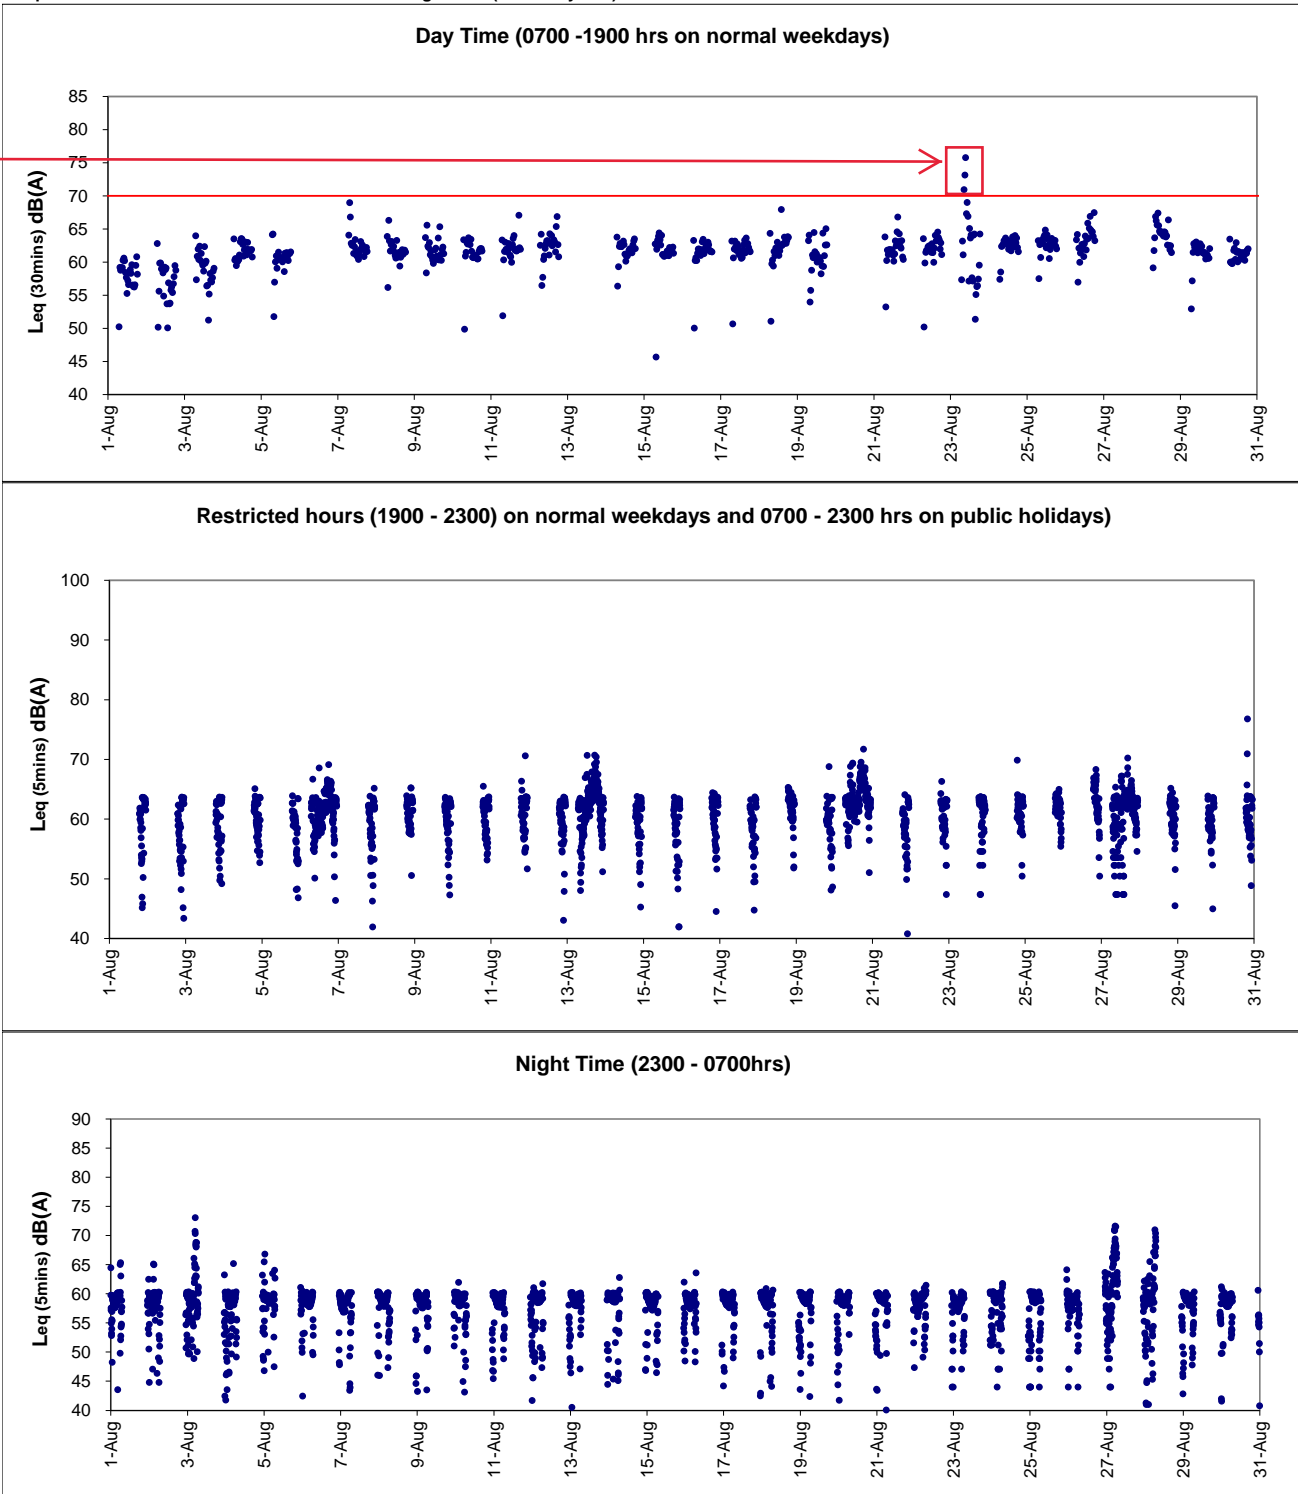
Graphic Presentation of Continuous Noise Monitoring Result (ACL3-City Hall)

After the investigation, no construction works was conducted under Contractor HK/2012/08 at CRIII area and Contractor HY/2009/18 at P1 Road on 23 August 2017. Meanwhile, adverse weather condition was recorded during the reporting period and was considered as potential noise contribution. As such, the exceedances were considered as non-Project related.

- 5.1.6 [Limit level exceedances were recorded at ACL3 – City Hall on 23 August 2017 during daytime in the reporting month.](#)
- 5.1.7 [After the investigation, no construction activities was conducted by Contractor HY/2009/18 at P1 Road on 23 August 2017. Meanwhile, adverse weather condition was recorded during the reporting period and was considered as potential noise contribution. As such, the exceedances were considered as non-Project related.](#)
- 5.1.8 Continuous noise monitoring results measured in this reporting period are reviewed and summarized. Details of continuous noise monitoring results and graphical presentation can be referred to [Appendix 5.2](#).
