**WANCHAI DEVELOPMENT PHASE II AND CENTRAL
WANCHAI BYPASS
SAMPLING, FIELD MEASUREMENT AND TESTING WORK
(STAGE 3)**

ENVIRONMENTAL PERMIT NO. EP-122/2002/E

MONTHLY ENVIRONMENTAL MONITORING & AUDIT REPORT

- MARCH 2018 -

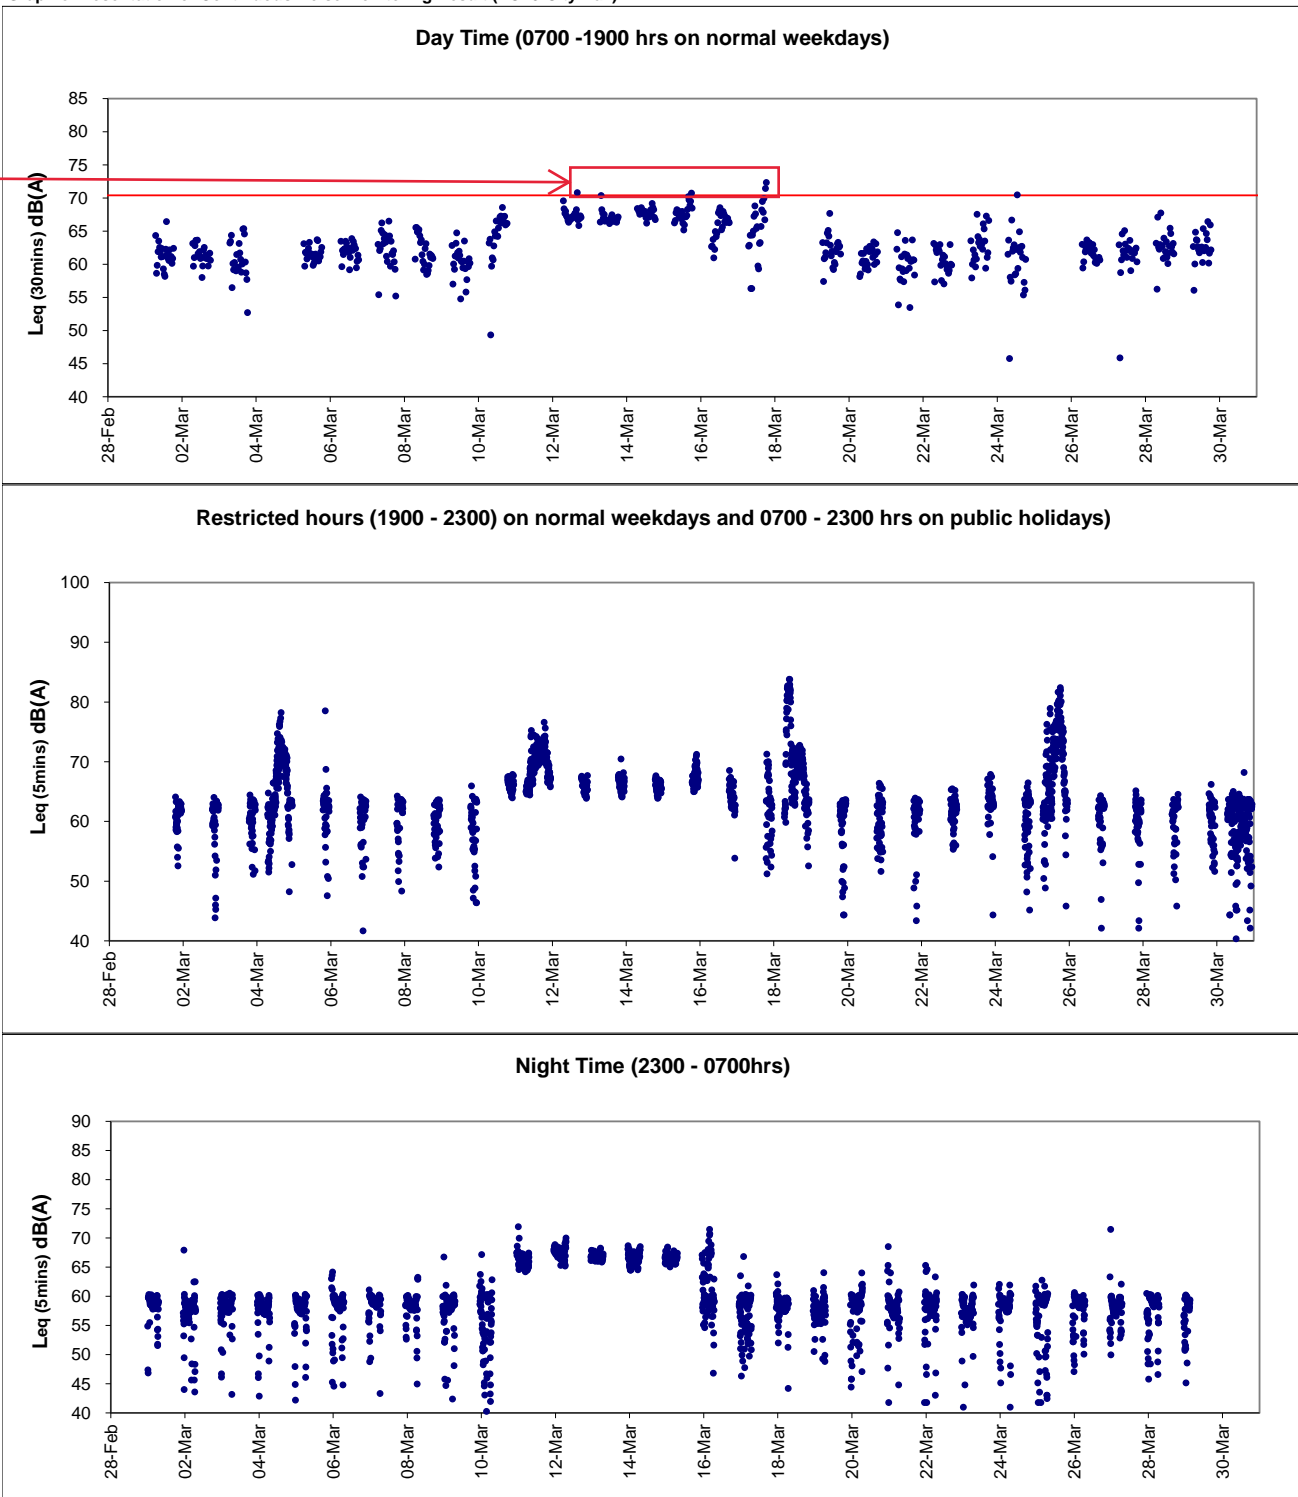
Graphic Presentation of Continuous Noise Monitoring Result (ACL3-City Hall)

After the investigation, no construction works was conducted by Contractor HK/2012/08 at CRIII area on 12, 15 and 17 March 2018. Meanwhile, preparation works for public event was held at area opposite to the monitoring station during the concerned period and considered as the major noise contribution. As such, the exceedance was considered as non-project related.
