CONTRACT NO: HY/2019/18

**WANCHAI DEVELOPMENT PHASE II AND CENTRAL
WANCHAI BYPASS
SAMPLING, FIELD MEASUREMENT AND TESTING WORKS
(STAGE 4)**

MONTHLY ENVIRONMENTAL MONITORING & AUDIT REPORT

- MARCH 2020 -

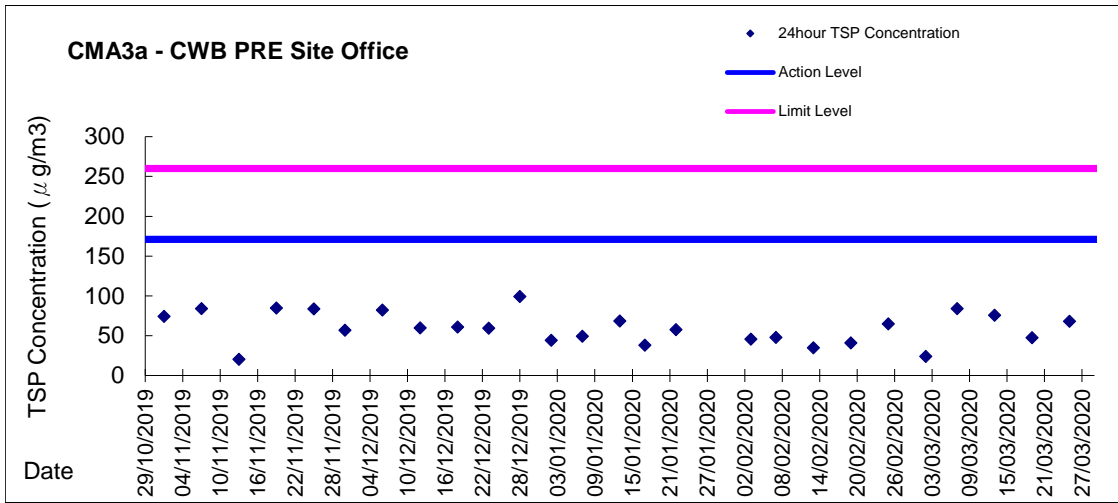
Graphic Presentation of 24 hour TSP Result
