CONTRACT NO: HK/2011/07

**WANCHAI DEVELOPMENT PHASE II AND CENTRAL
WANCHAI BYPASS
SAMPLING, FIELD MEASUREMENT AND TESTING WORK
(STAGE 2)**

**QUARTERLY ENVIRONMENTAL MONITORING
AND AUDIT REPORT**

- MARCH 2013 TO MAY 2013 -

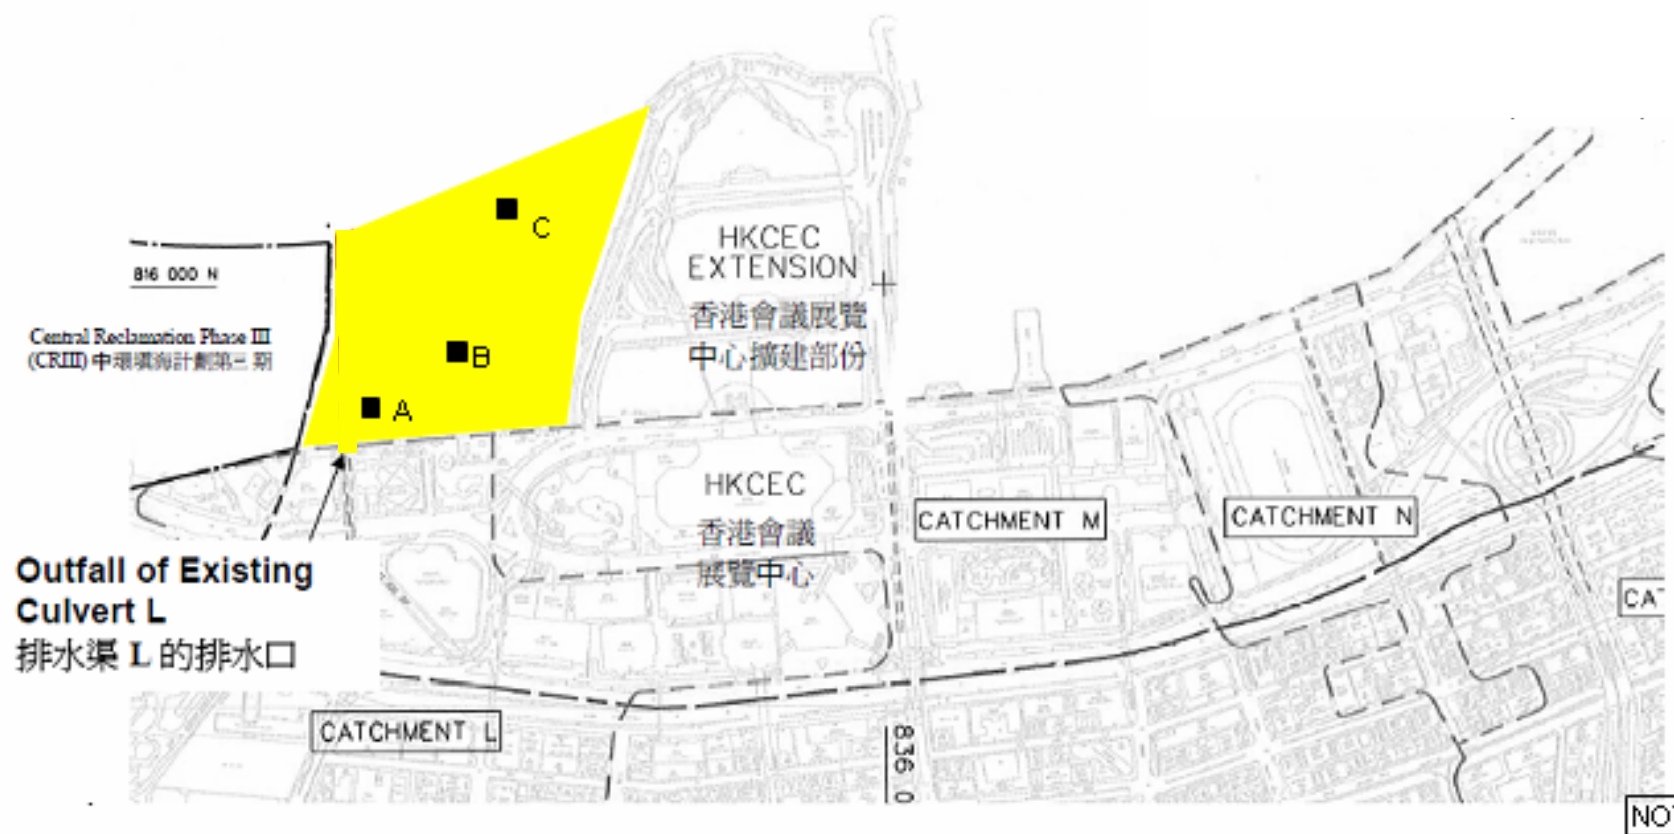
Additional DO Monitoring Station
 (A: 835468E, 815857N
 B: 835572E, 815961N
 C: 835659E, 816271N)

Location Plan of Additional Dissolved Oxygen Monitoring Stations for Culvert L Water Discharge Flow

3.3.15 In response to the Condition 2.18 of the Environmental Permit no. EP-356/2009 requiring that a silt curtain / impermeable barrier system be installed to channel water discharge flow from Culvert L to locations outside the embayment area, a proposed replacement of the requirement with additional dissolved oxygen monitoring has been conducted at three monitoring stations, namely A, B and C between the eastern seawall of Central Reclamation Phase III and the HKCEC Extension since November 2011 under EP-356/2009 so that DO level between the eastern seawall of Central Reclamation Phase II and the HKCEC extension could be continuously monitored.

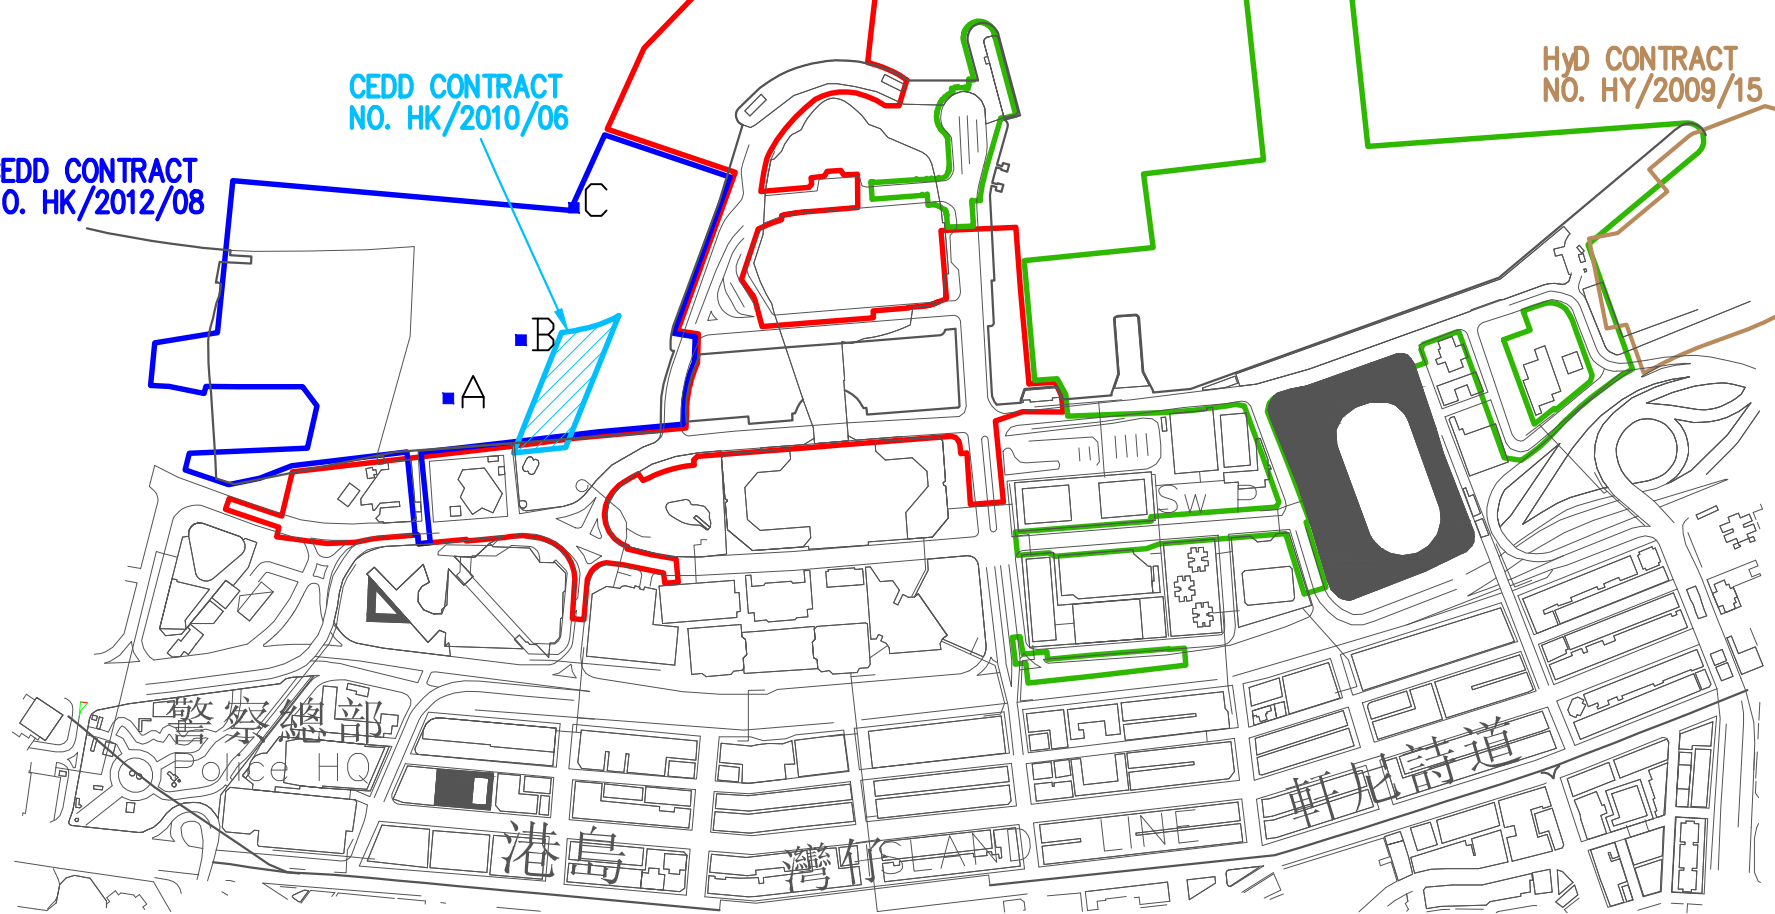
LOCATIONS OF ADDITIONAL DISSOLVED OXYGEN MONITORING STATIONS FOR CULVERT L WATER DISCHARGE FLOW

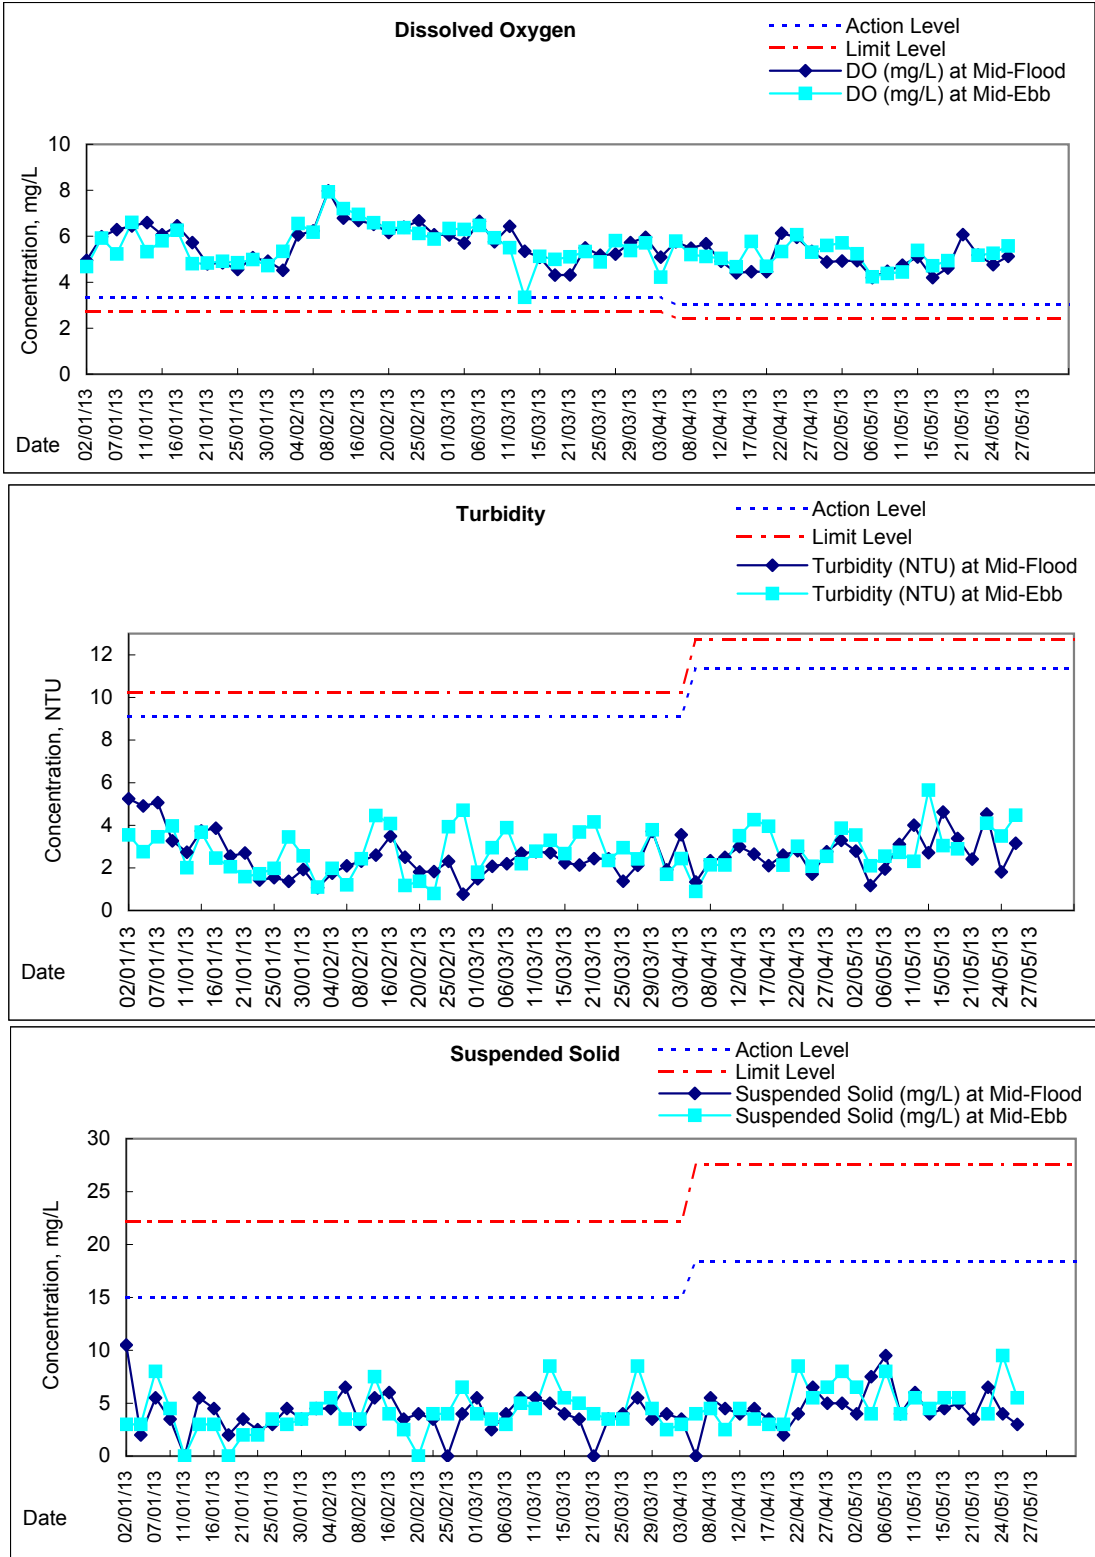
Graphic Presentation of Water Quality Result of C1 - HKCEC

Remarks: Due to the blockage of road access to C1 on 15 Dec 2012 during mid-flood, the water quality monitoring was cancelled at C1 on 15 Dec 2012 during mid-flood.

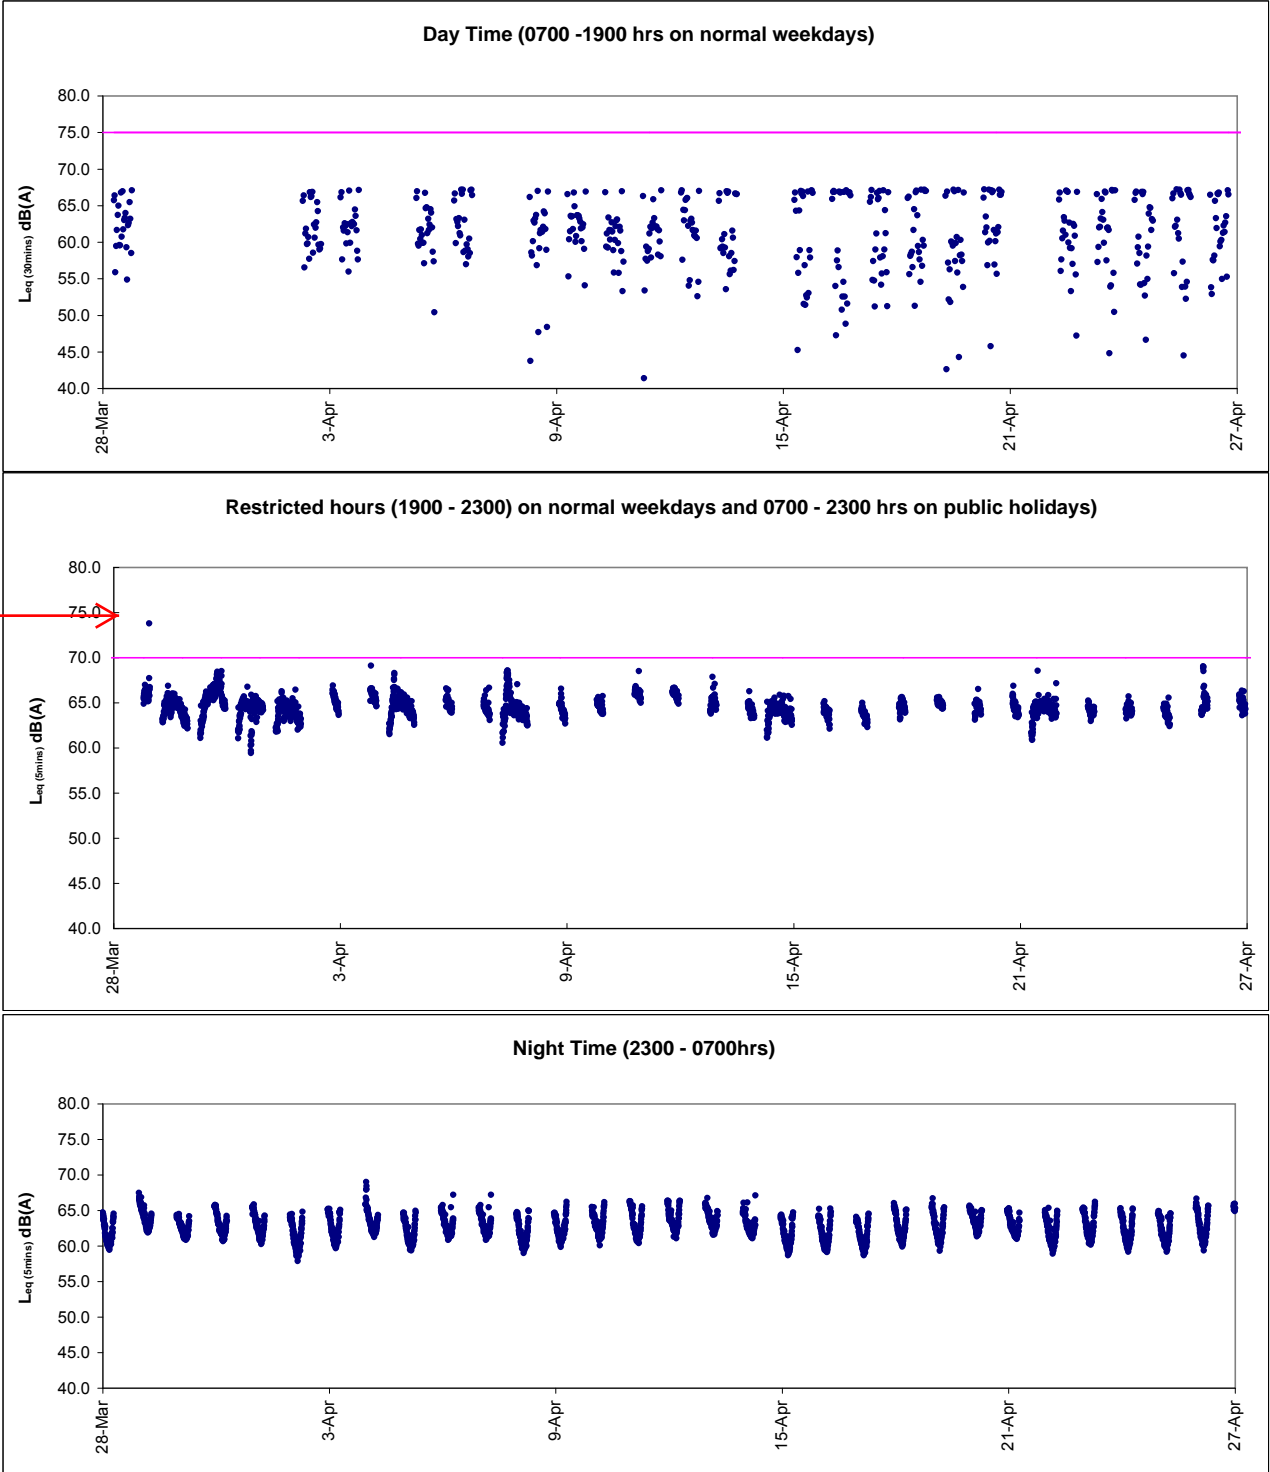
Graphic Presentation of Real Time Noise Monitoring Result (RTN2a- Hong Kong Electric Centre)

After checking with contractor HY/2009/19, no noisy construction activities were conducted during the recorded period and the exceedance was non-continuous. Exceedances were considered to be contributed by nearby IEC traffic

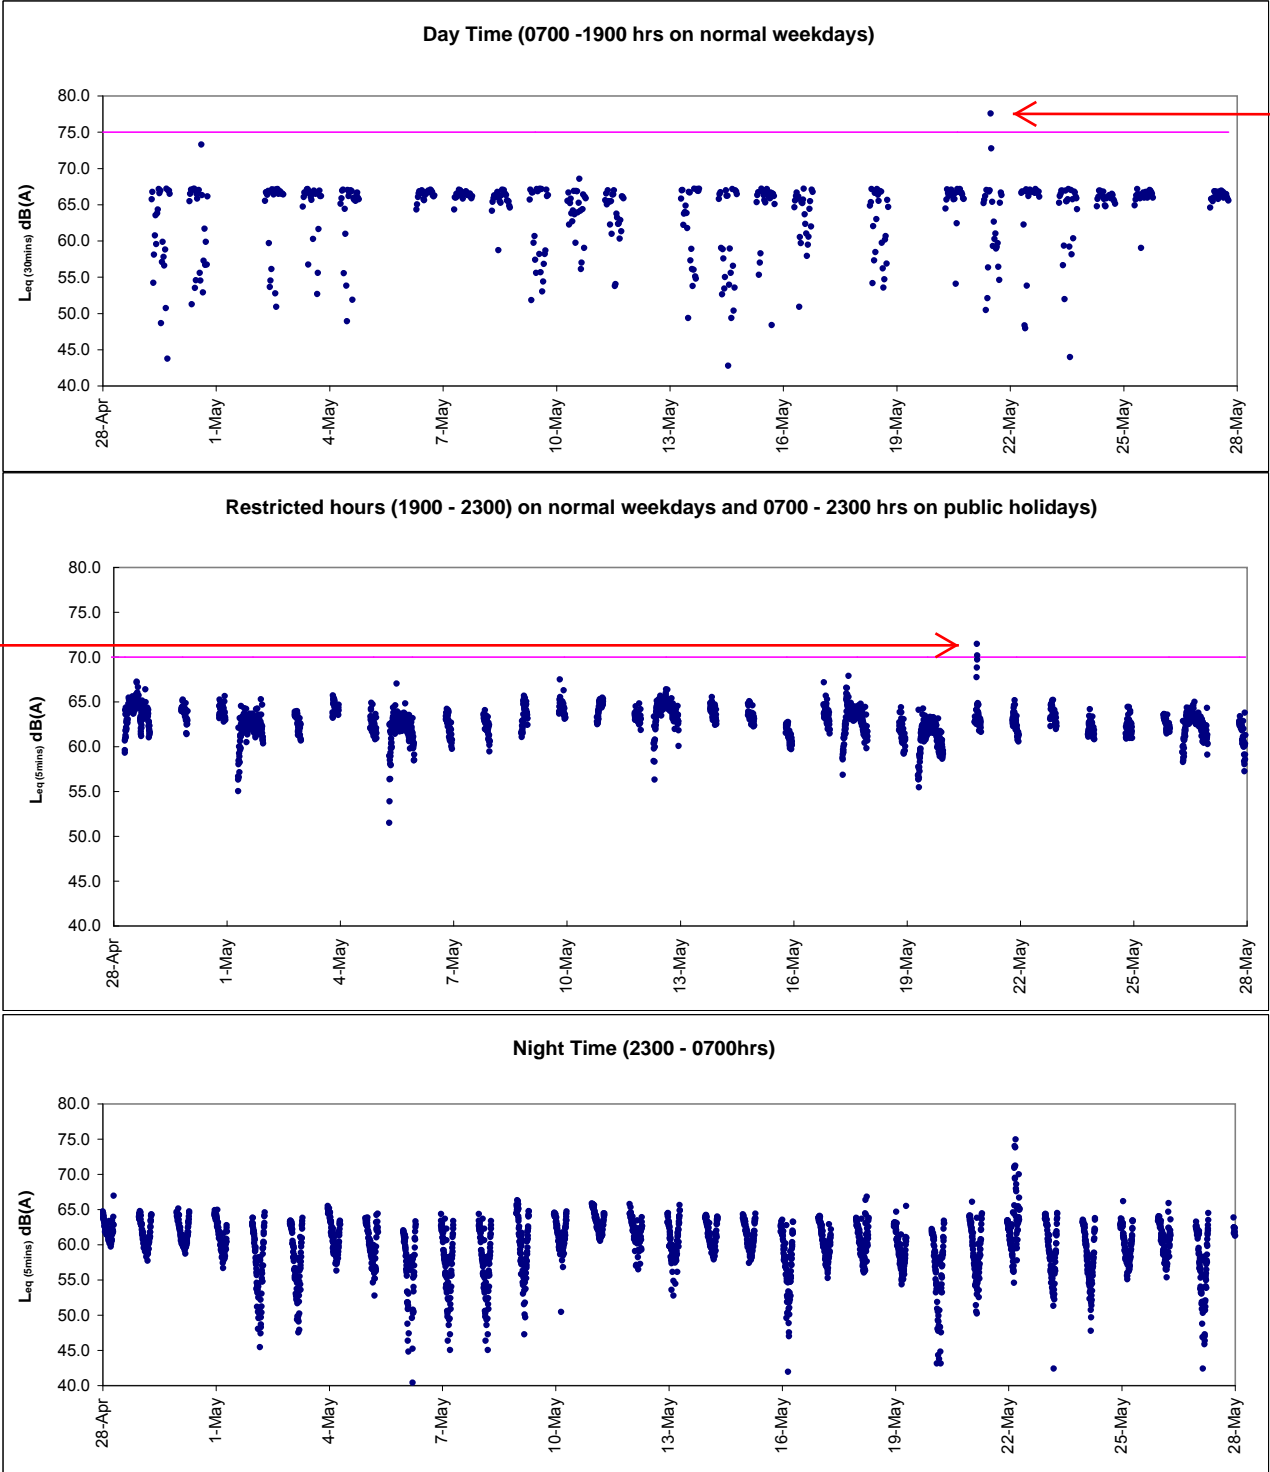
Graphic Presentation of Real Time Noise Monitoring Result (RTN2a- Hong Kong Electric Centre)

After checking with contractor HY/2009/19, no construction works were conducted at the concerned location during the recorded period. As such, the exceedances were considered to be contributed by nearby IEC traffic

After checking with contractor HY/2009/19, no noisy construction works were conducted at the concerned location during the recorded period and the exceedance was non-continuous. As such, the exceedances were considered to be contributed by nearby IEC traffic
