CONTRACT NO: HK/2011/07

**WANCHAI DEVELOPMENT PHASE II AND CENTRAL
WANCHAI BYPASS
SAMPLING, FIELD MEASUREMENT AND TESTING WORK
(STAGE 2)**

**QUARTERLY ENVIRONMENTAL MONITORING
AND AUDIT REPORT**

- JUNE 2013 TO AUGUST 2013 -

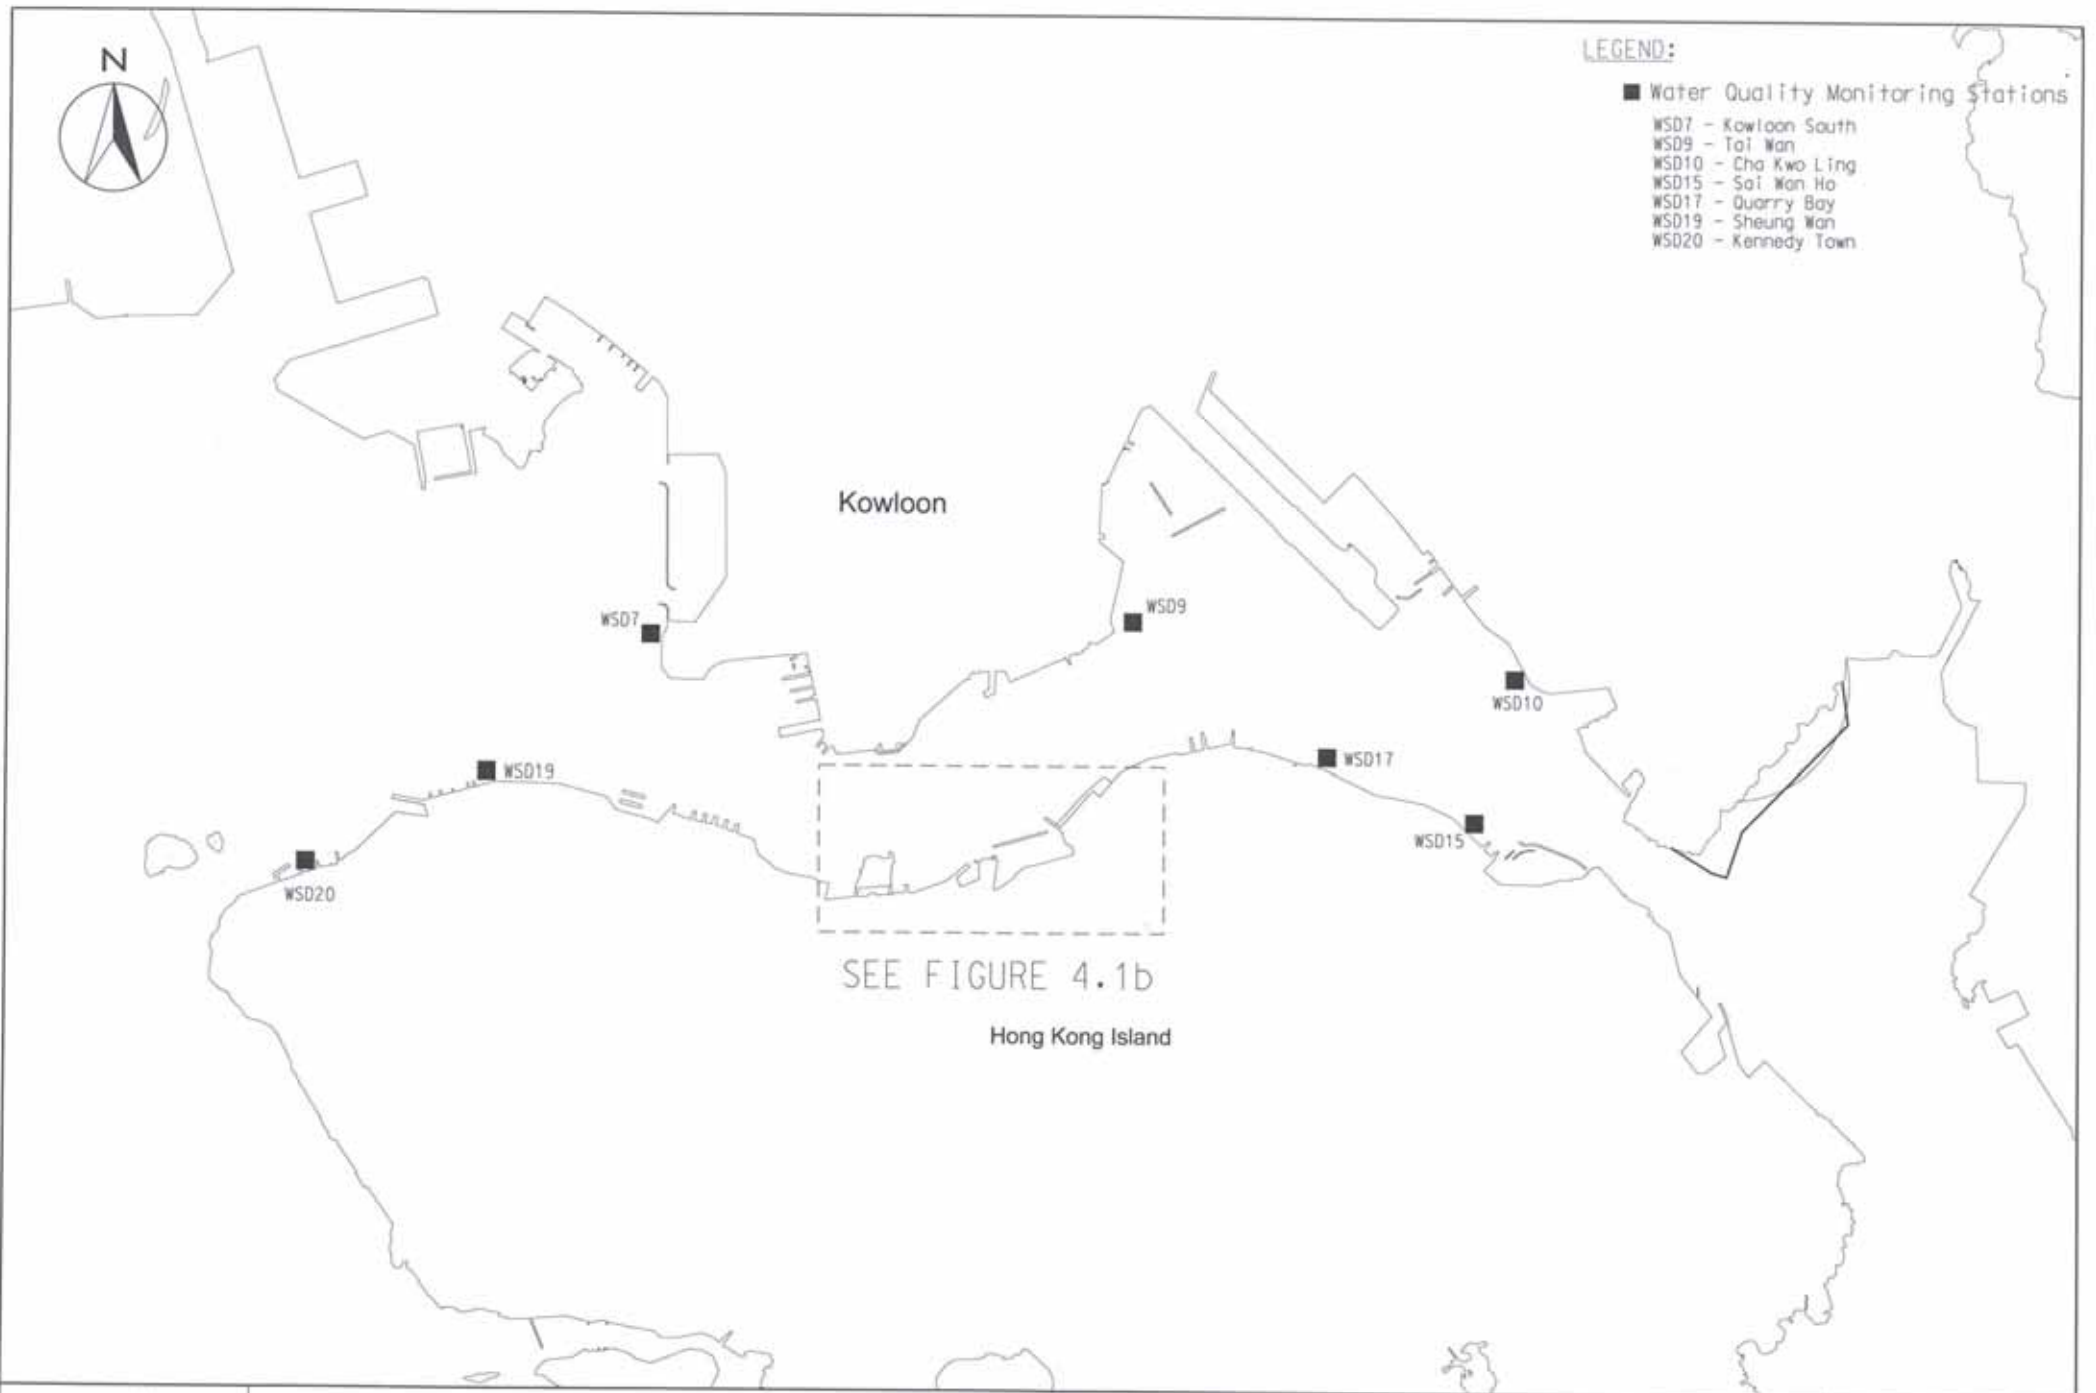
Figure 3.1

Locations of Monitoring Stations

3.3.11. Dissolved oxygen monitoring at the intakes C6 and C7 in Causeway Bay Typhoon Shelter when there is temporary reclamation in Causeway Bay Typhoon Shelter and at the south-western and south-eastern corners of the ex-Wan Chai Public Cargo Working Area. The proposed water quality monitoring stations of the Project are shown in **Table 3.6** and **Figure 3.1**.

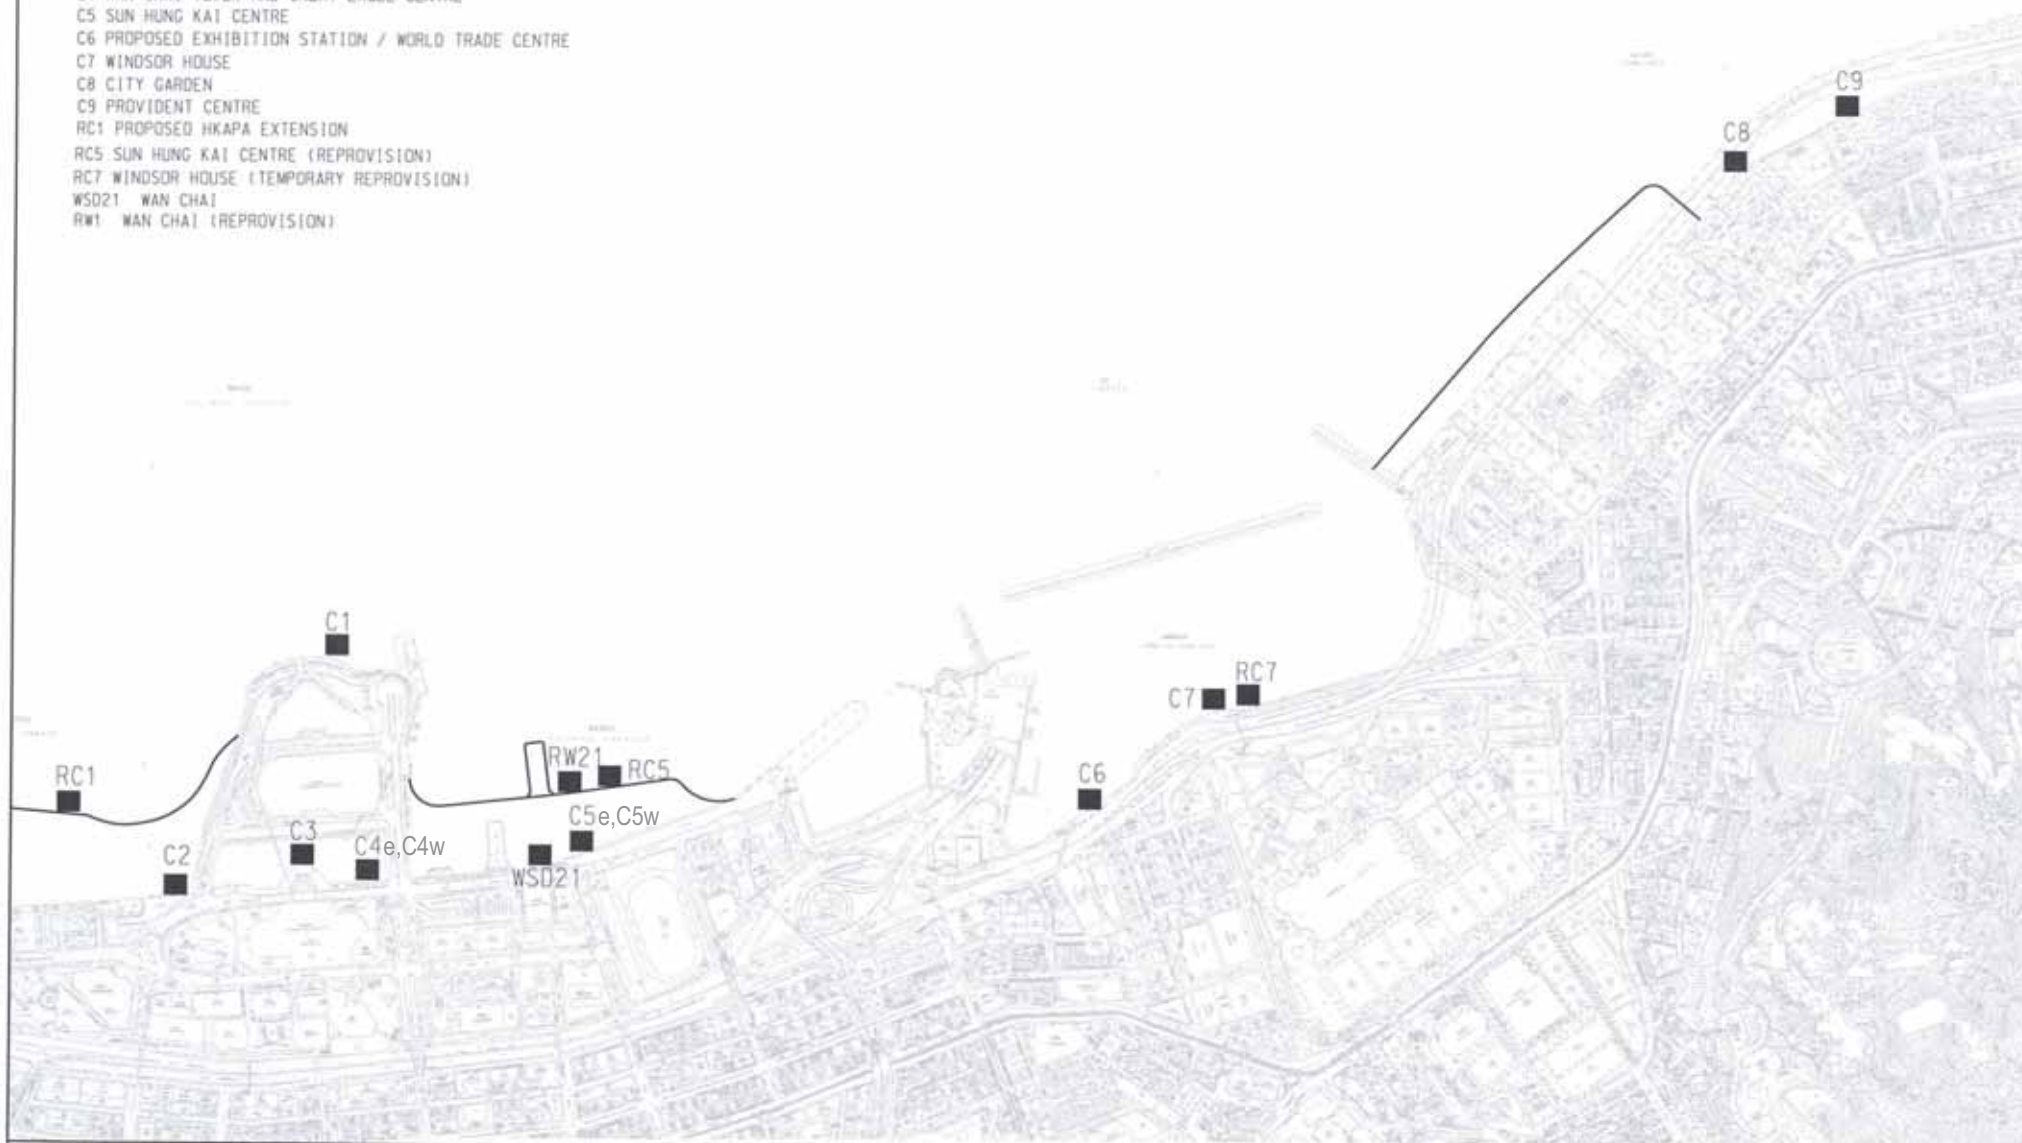
WATER QUALITY MONITORING STATIONS

- C1 HONG KONG CONVENTION AND EXHIBITION CENTRE EXTENSION
- C2 TELECOM HOUSE/HK ACADEMY FOR PERFORMING/ SHUI ON CENTRE
- C3 HONG KONG CONVENTION AND EXHIBITION CENTRE PHASE I
- C4 WAN CHAI TOWER AND GREAT EAGLE CENTRE
- C5 SUN HUNG KAI CENTRE
- C6 PROPOSED EXHIBITION STATION / WORLD TRADE CENTRE
- C7 WINDSOR HOUSE
- C8 CITY GARDEN
- C9 PROVIDENT CENTRE
- RC1 PROPOSED HKAPA EXTENSION
- RC5 SUN HUNG KAI CENTRE (REPROVISION)
- RC7 WINDSOR HOUSE (TEMPORARY REPROVISION)
- WSD21 WAN CHAI
- RW1 WAN CHAI (REPROVISION)
