CONTRACT NO: HK/2011/07

WANCHAI DEVELOPMENT PHASE II AND CENTRAL  
WANCHAI BYPASS  
SAMPLING, FIELD MEASUREMENT AND TESTING WORK  
(STAGE 2)

QUARTERLY ENVIRONMENTAL MONITORING  
AND AUDIT REPORT

- SEPTEMBER 2013 TO NOVEMBER 2013 -

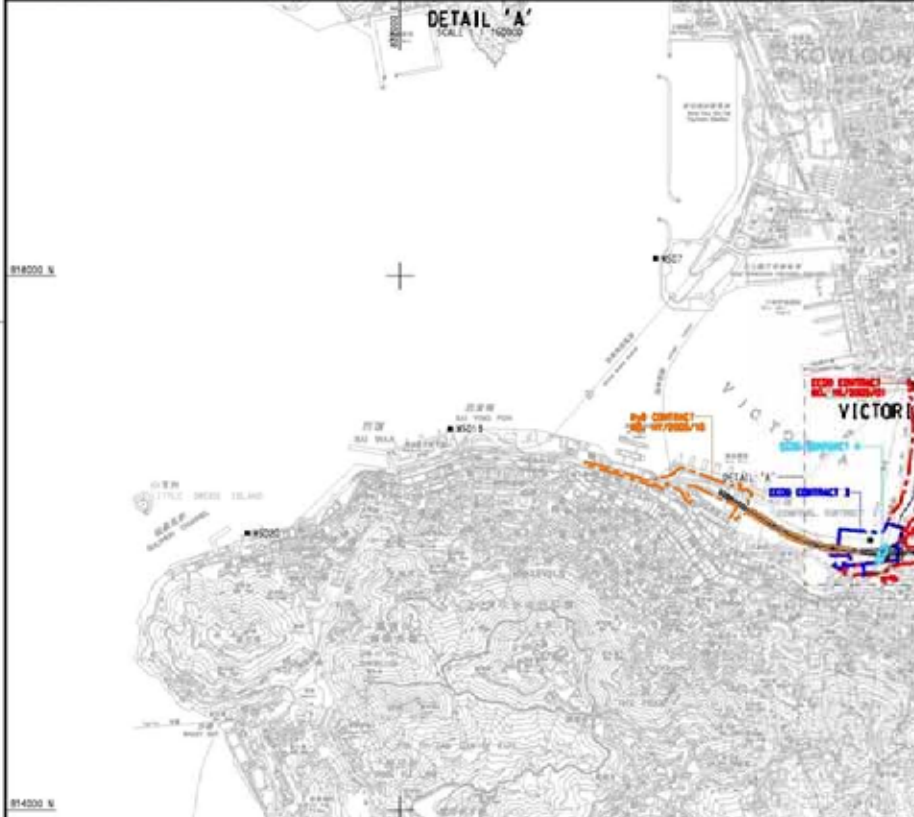
***Figure 2.1***

- 2.2.1. The Project is located mainly in Wan Chai North, Causeway Bay and North Point, and is demarcated by Gloucester Road and Victoria Park Road to the south, Fenwick Pier Street to the west and Tong Shui Road Interchange to the east, as shown in **Figure 2.1**.

***Project Layout***

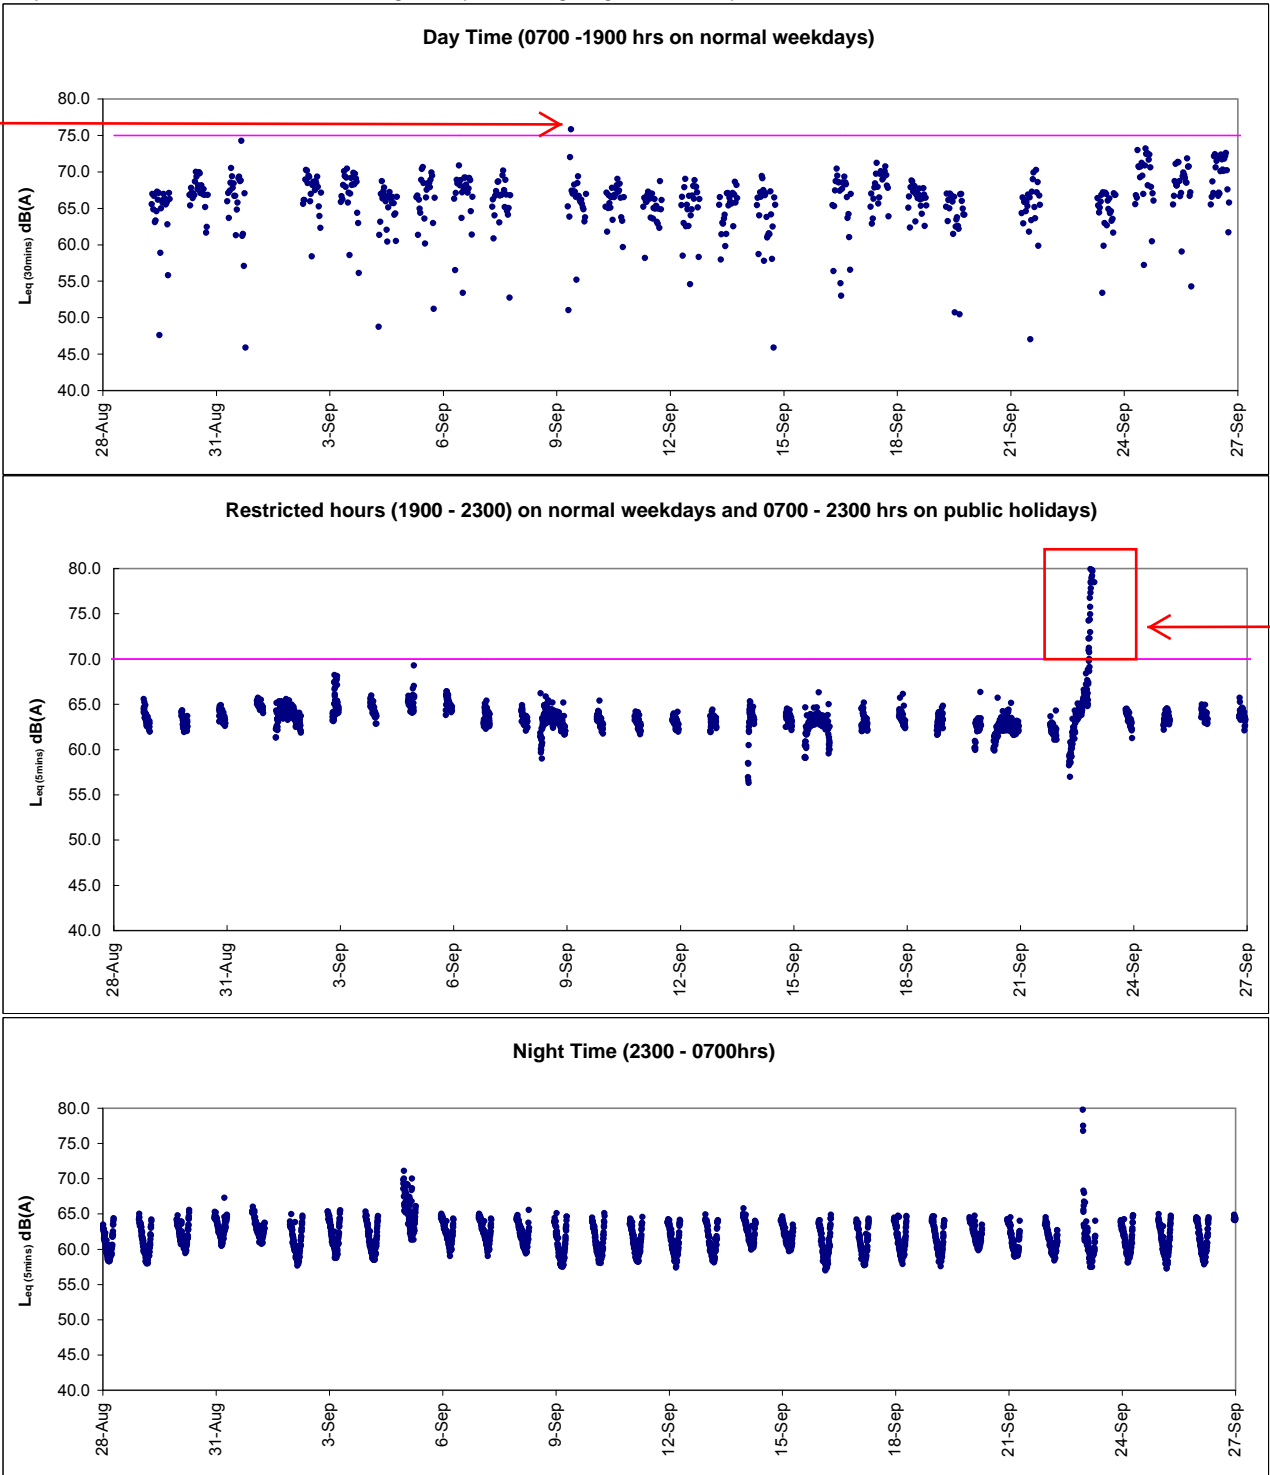
Graphic Presentation of Real Time Noise Monitoring Result (RTN2a- Hong Kong Electric Centre)

After checking with contractor HY/2009/19, no major noisy construction works were conducted at the concerned location during the recorded period and the exceedance was non-continuous. As such, the exceedances were considered to be contributed by nearby IEC traffic

After checking with contractor HY/2009/19, no construction work was conducted at the concerned location during the recorded period. The continuous exceedances were considered to be contributed by adverse weather condition during hoisting of Gale warning signal.

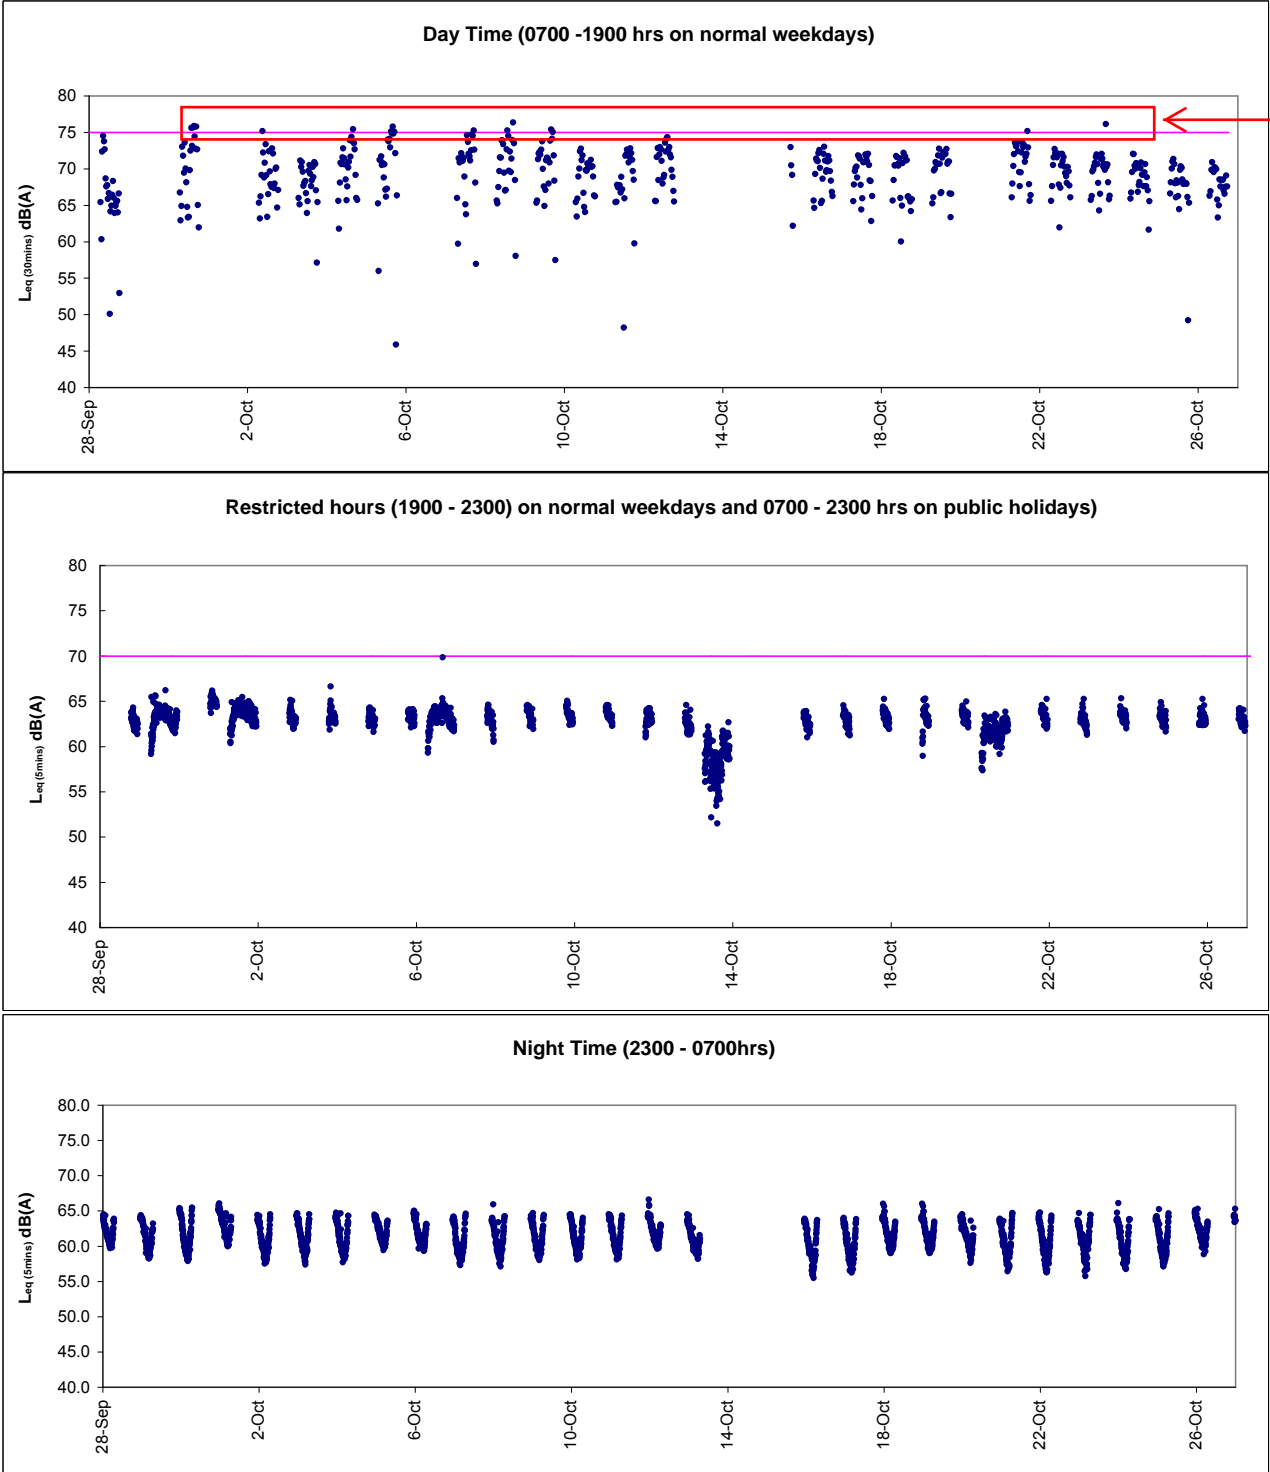
Graphic Presentation of Real Time Noise Monitoring Result (RTN2a- Hong Kong Electric Centre)

After checking with contractor HY/2009/19, no major noisy construction works were conducted at the concerned location during the recorded period. On-going Breaking works and piling works was observed undertaken at adjacent non-CWB Project construction sites. As such, the exceedances were considered to be contributed by non-CWB Project works.

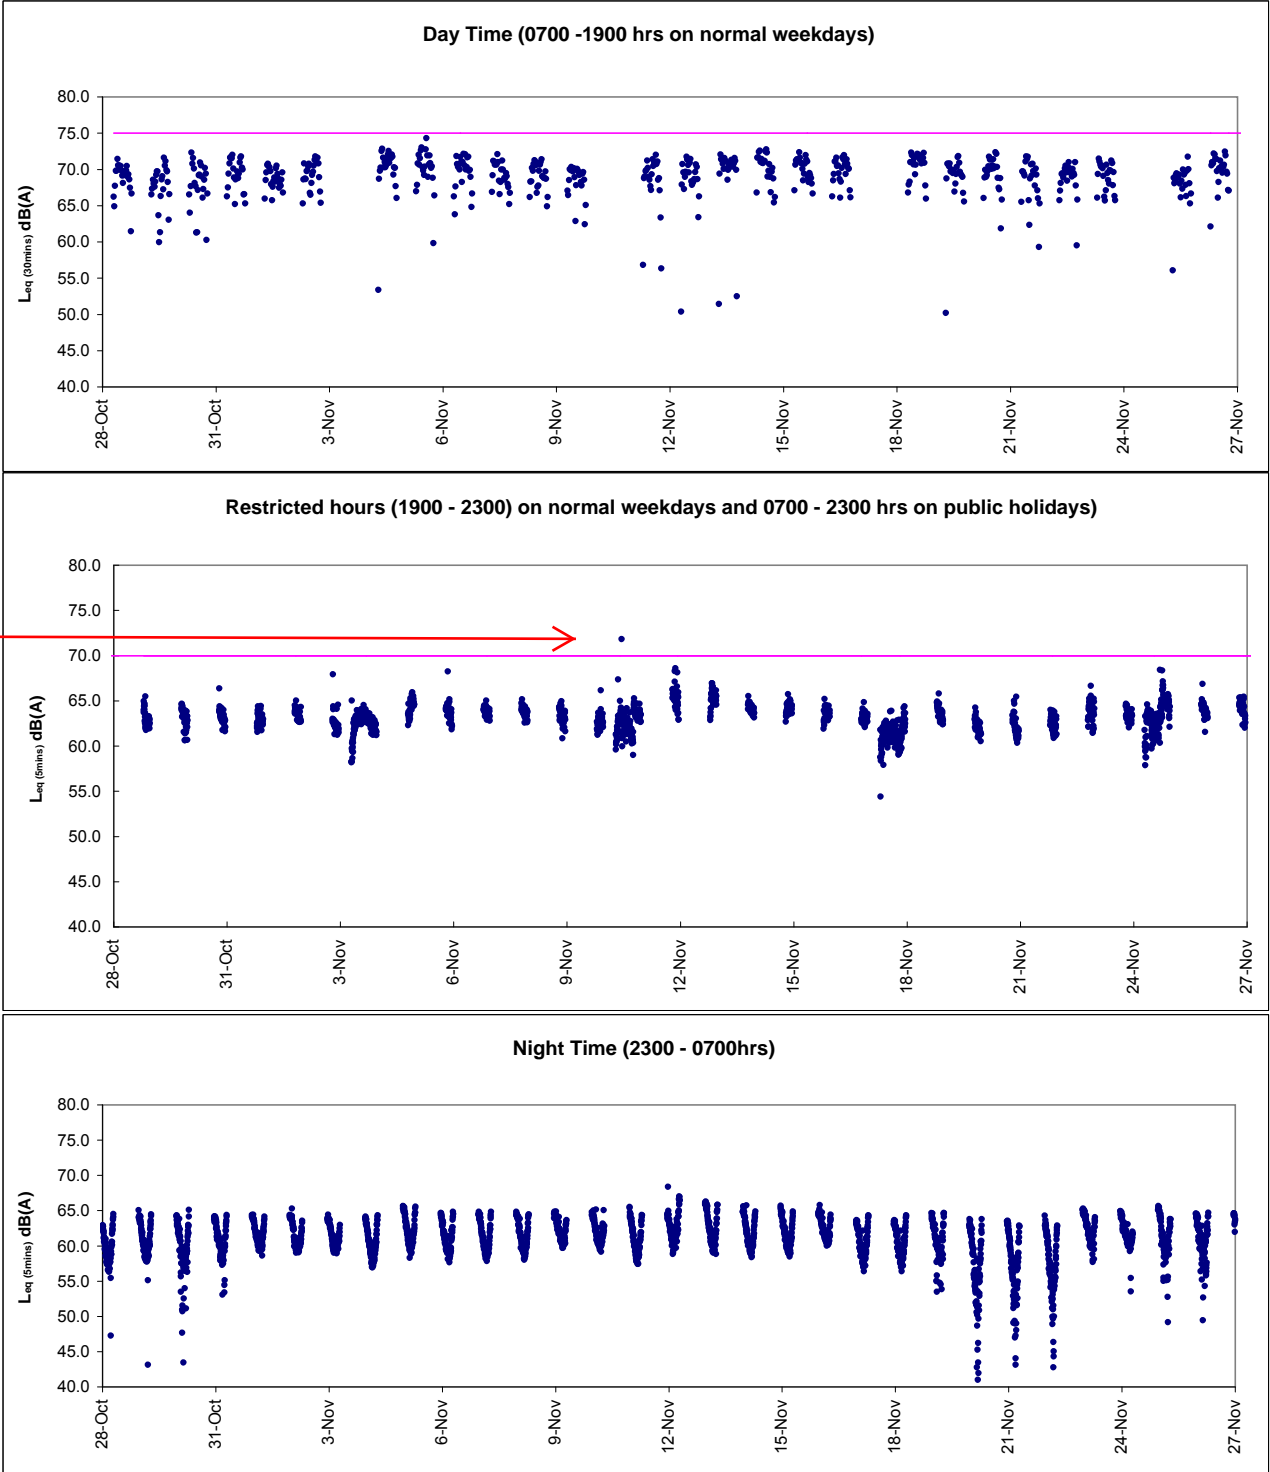
Graphic Presentation of Real Time Noise Monitoring Result (RTN2a- Hong Kong Electric Centre)

After checking with contractor HY/2009/19, no construction works were conducted at the concerned location during the recorded period . As such, the exceedances were considered to be contributed by nearby IEC traffic
